# CHRIS CURLES and ASSOCIATES Inc. INSPECTION SERVICES

## Inspection Report.

DATE: March 20xx.  
CLIENT: Mr. J. Doe  
SITE: ADDRESS: 1xxx .Address  
CITY/STATE/ZIP: Atlanta, GA.  
EMAIL: NA.  
PHONE: NA.

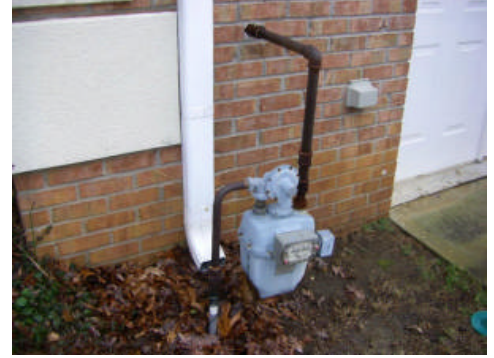
All utilities were on at the time of the inspection. NOTE: The gas service from the gas meter to the house structure should be painted to help prevent rusting. See photo.

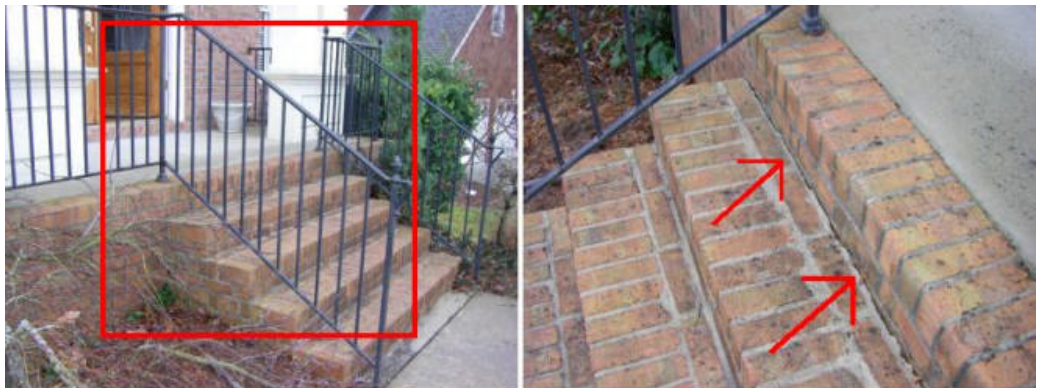
Some minor settlement was noted in the stairs to the front landing. Displacement crack or gap noted between the stairs and landing. Possible cause for the settlement or displacement would be loose and non compacted soil around and or under the landing. Further investigation will be needed by a qualified contractor to determine what, if any, correction will be needed. Recommend repairing the or filling the gap to prevent water

intrusion. See photo.

The left handrail is loose and should be secured.

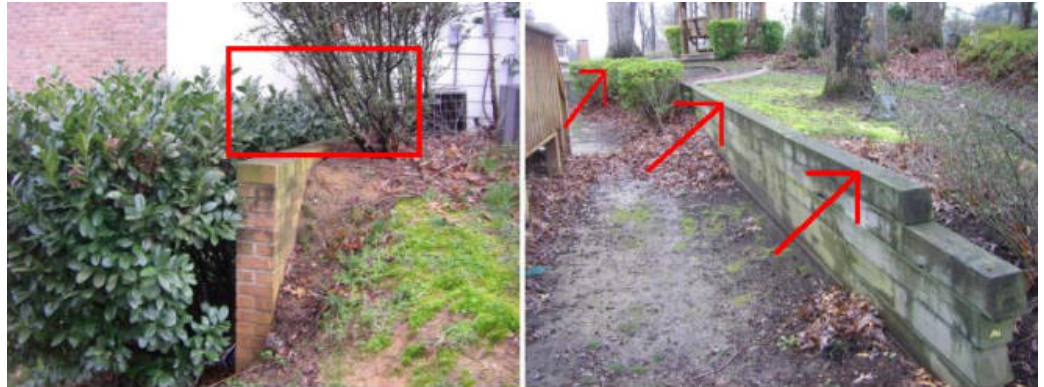
A guardrail is recommended along the top of the retaining walls for safety. See photo. Unsafe condition observed for small children and some adults. The IRC R-312.1 (International Residential Code) building standards require a guardrail around all platforms and along all open sides of elevated surfaces greater than 30" above the ground below. The height of the guardrail shall be not less than 30". Note: This standard may not have been enforced by the local building official at the time of the construction.

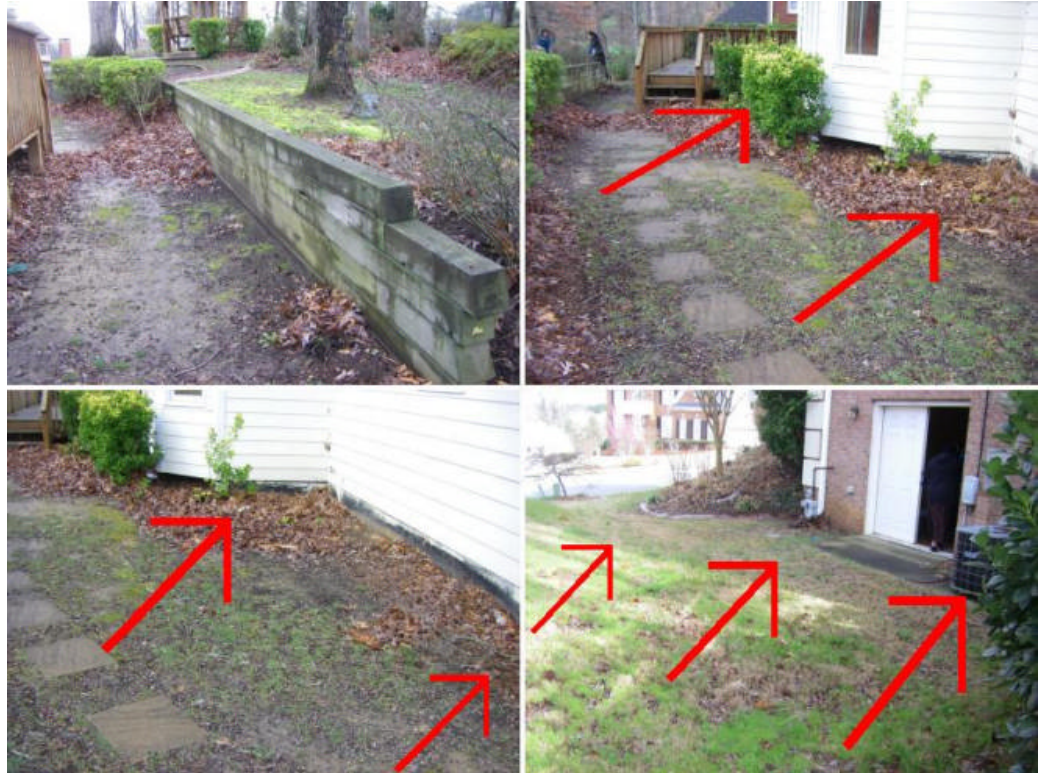
The grade along the back and right side of the home should be corrected/ maintained to drain away from the foundation. Slope should fall away from the foundation at a minimum of 6" in 10' on all sides to help prevent standing water, erosion and/ or intrusion into the structure. Poor drainage is the most common cause for water intrusion into the structure. See photo. See basement inspection. Water intrusion noted.

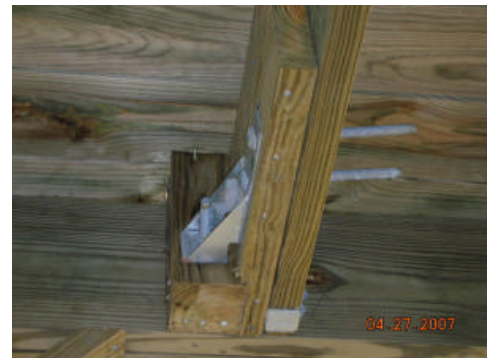
Please visit these web sites to learn more on how to improve and maintain the safety of your deck. The guardrails should be secured to withstand 200 lbs of lateral force and pressure. See attached photo of an example of the recommended bracket.

The standards require that the inside of the guardrails and handrails be constructed to withstand 50 lbs of lateral force. Securing each picket with corrosion resistant screws or ring shank nails will help to correct this condition.

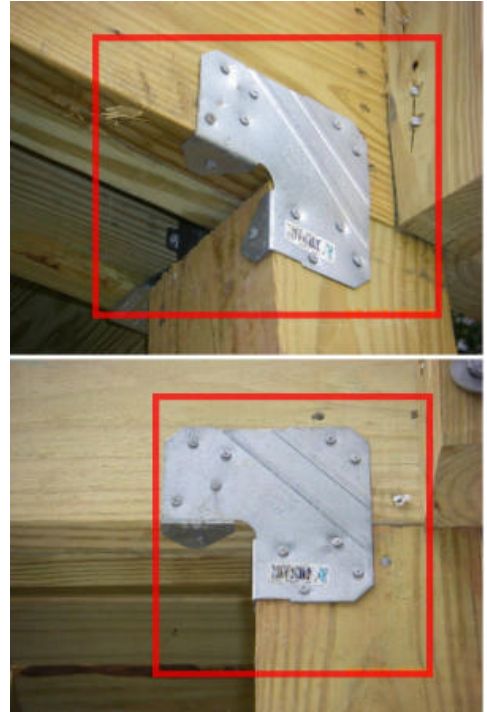
The supporting deck post should have a positive connection at the rim joist and at the footing, or foundation, to prevent displacement as stated in the IRC (International Residential Code). See photo. This can be accomplished by adding metal brackets at the connections. See sample photos of rim joist attachment. These brackets are manufactured by Simpson Strong Tie and can be found at local hardware suppliers. Minor correction.

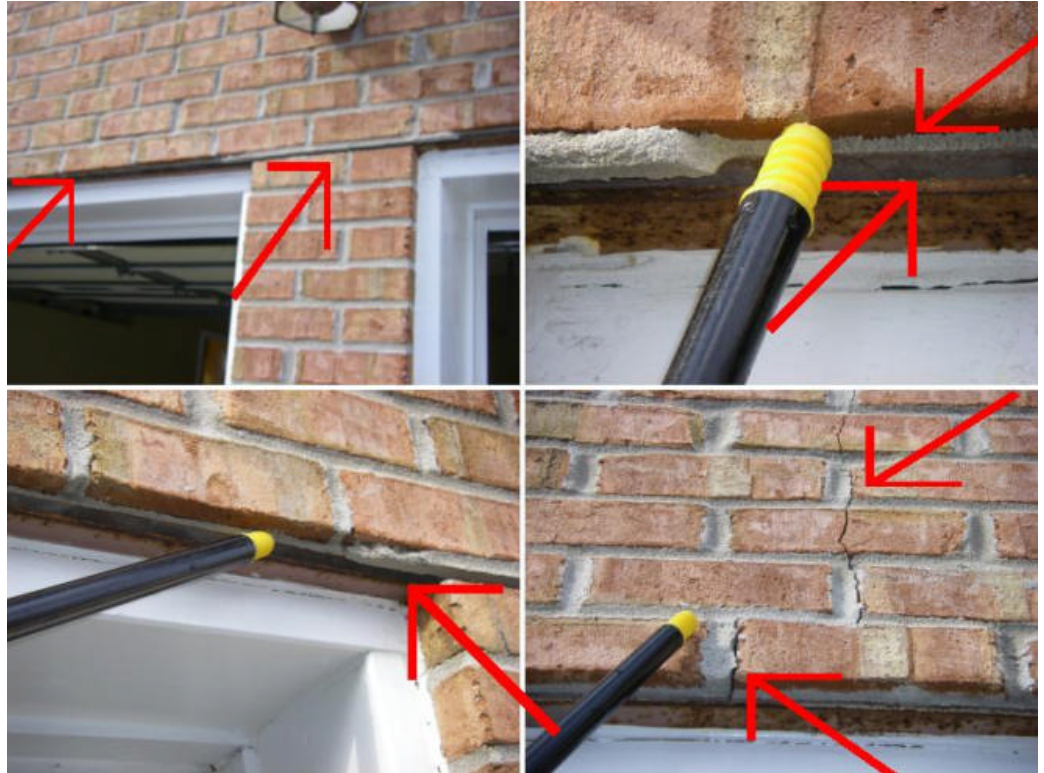
Displacement was noted between the bricks over the garage door. The displacement appears to be caused from deflection in the brick lintel that supports the bricks above the garage door. This appears to be a common problem with homes that were constructed in this time frame. The brick lintel is usually not sized properly to support the brick without deflecting. Monitor conditions and repair as needed. See photos. Have a qualified contractor or engineer address this condition. See photos.

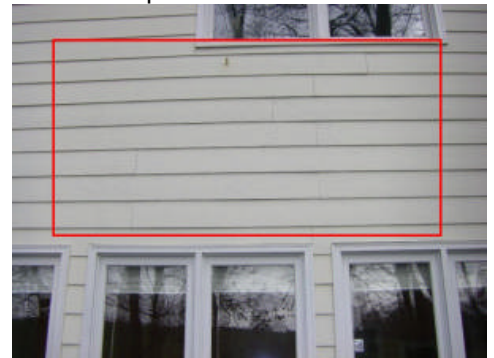
Gaps noted at the butt joints of the siding in several areas. Follow the manufacturers specifications regarding caulking and maintaining the siding. Painting needed.

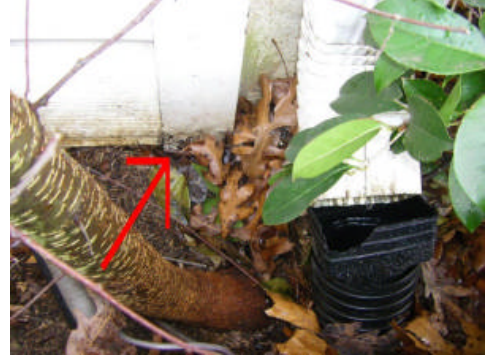
Minor water damage was noted in the corner trim behind the upper A/C units. Repairs and painting will be needed. See photos.

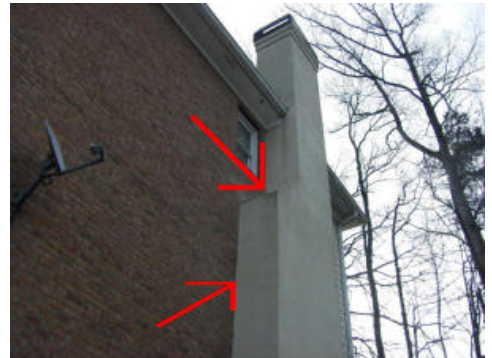
Hardcoat exterior noted on the chimney. The chimney appears to be in good condition, as viewed from the ground. Could not view the back side of the chimney. The roof is not walked on. Recommend filling the gap along the sides between the chimney and the bricks to prevent water intrusion. See photos.

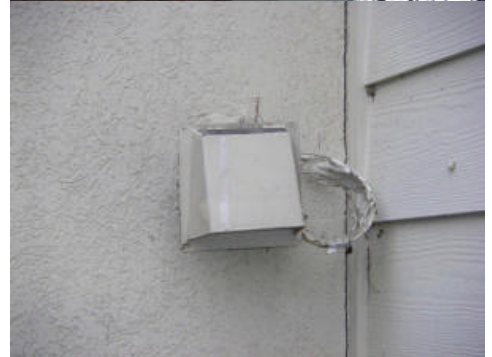
Repair the vent along the side of the chimney. See photos.

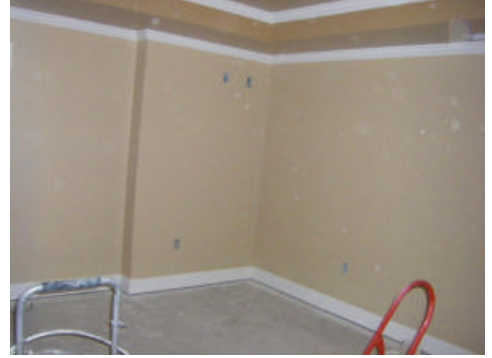
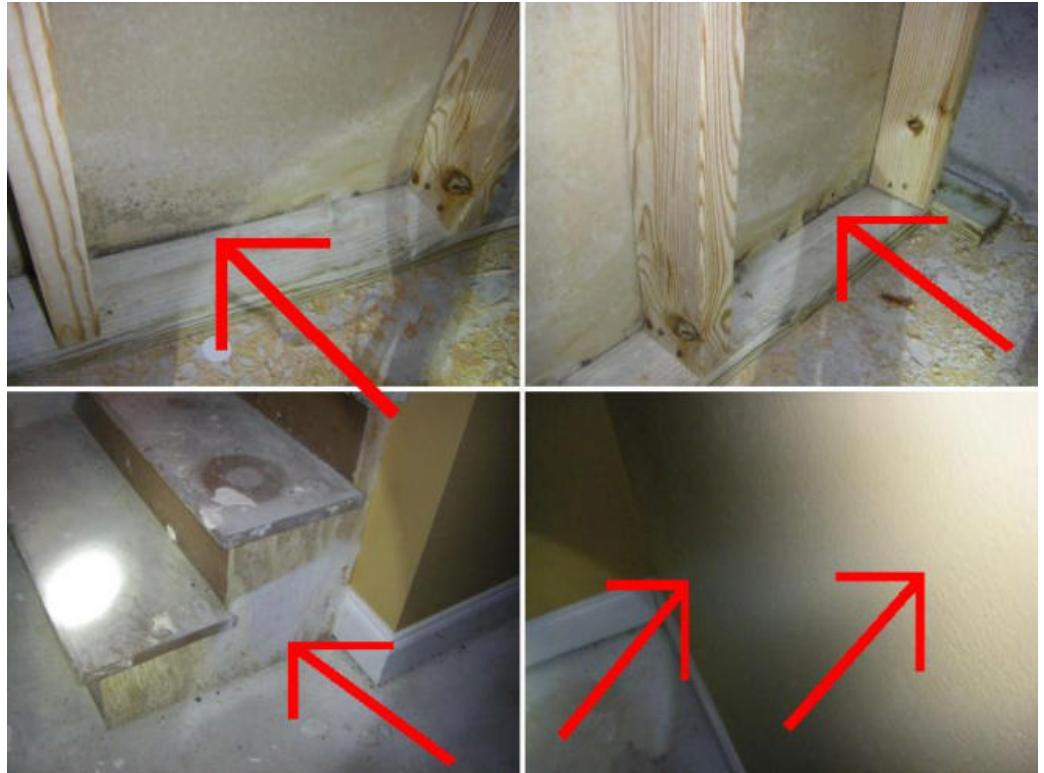
Mold and or Fungus noted in the basement on the exposed framing and walls. See photos. A dehumidifier has been placed in the basement by the owner as an attempt to lower the humidity. Further investigation recommended by a qualified air quality control contractor. To learn more about Mold in the home go to:

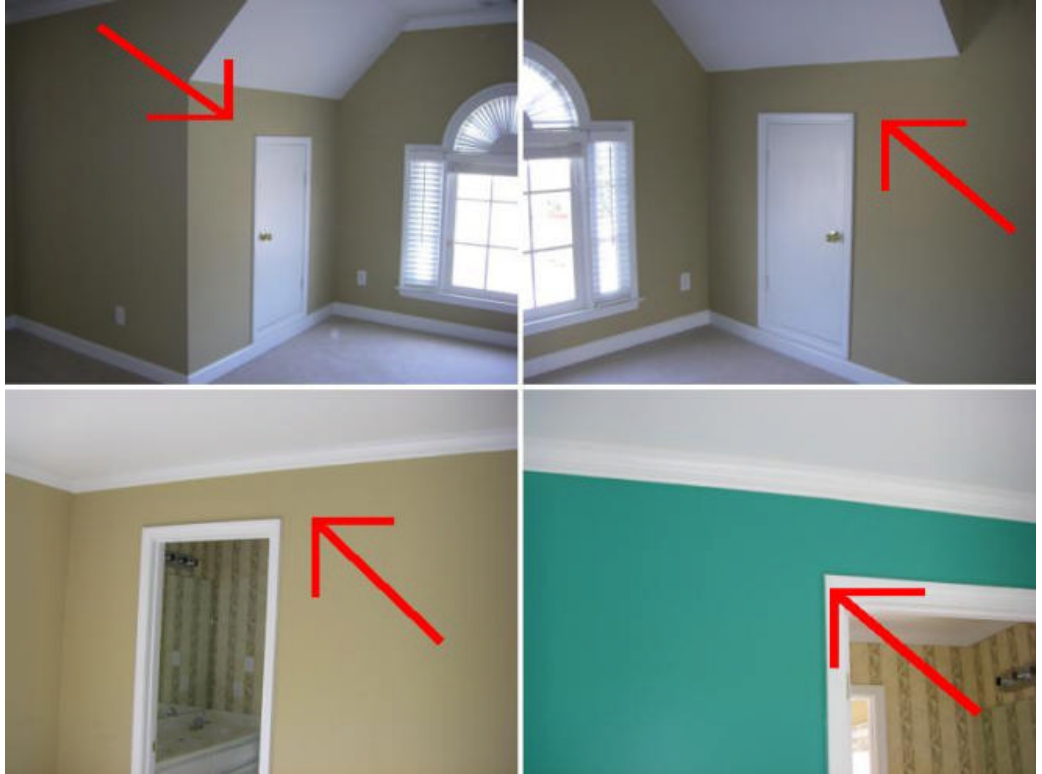
The majority of the framing was concealed with a finished ceiling in the lower living area. Could not properly inspect the lower level framing. Deflection was noted in the floor framing in the bedrooms. Separation cracks were noted in the master bedroom and guest bedroom walls. Without exposure to the framing below, the cause for this condition could not be identified. Monitor conditions and repair the walls as needed. Insulation was not visible for inspection.

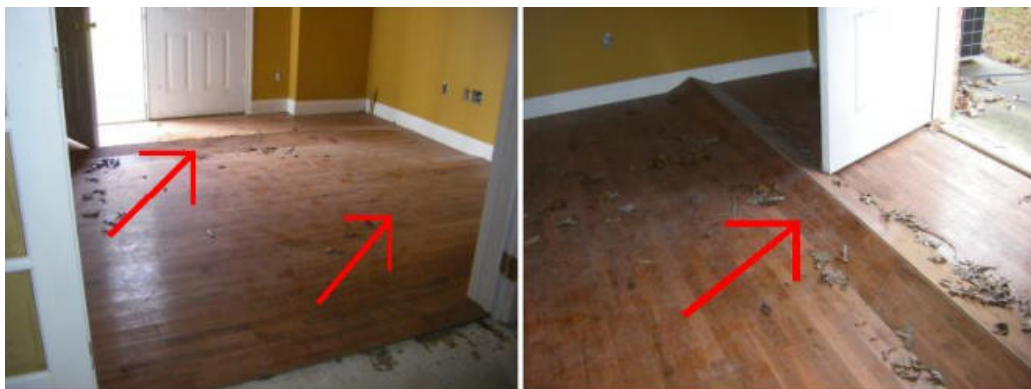
The flooring in the finished basement is water damage and should be removed. The water intrusion appears to be caused from poor drainage along the right side of the home. See drainage report for correction. See photo.

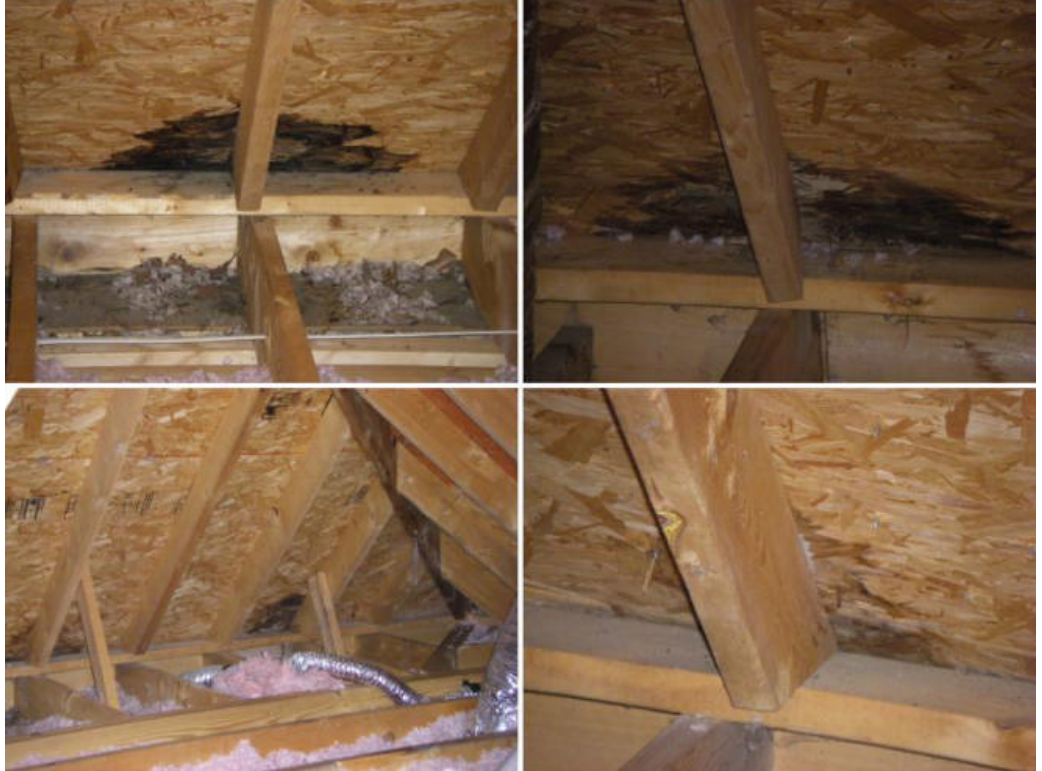
Water damage was noted in the roof decking in several areas. The damage is caused from previous and or active roof leaks. Correction will be needed. See photo. A licensed contractor should be called to make further evaluation and repairs as needed. Roofing appears to be serviceable at this time. A licensed roofing contractor should be called to make further evaluation and repairs as needed. See attic report/ roof leaks.

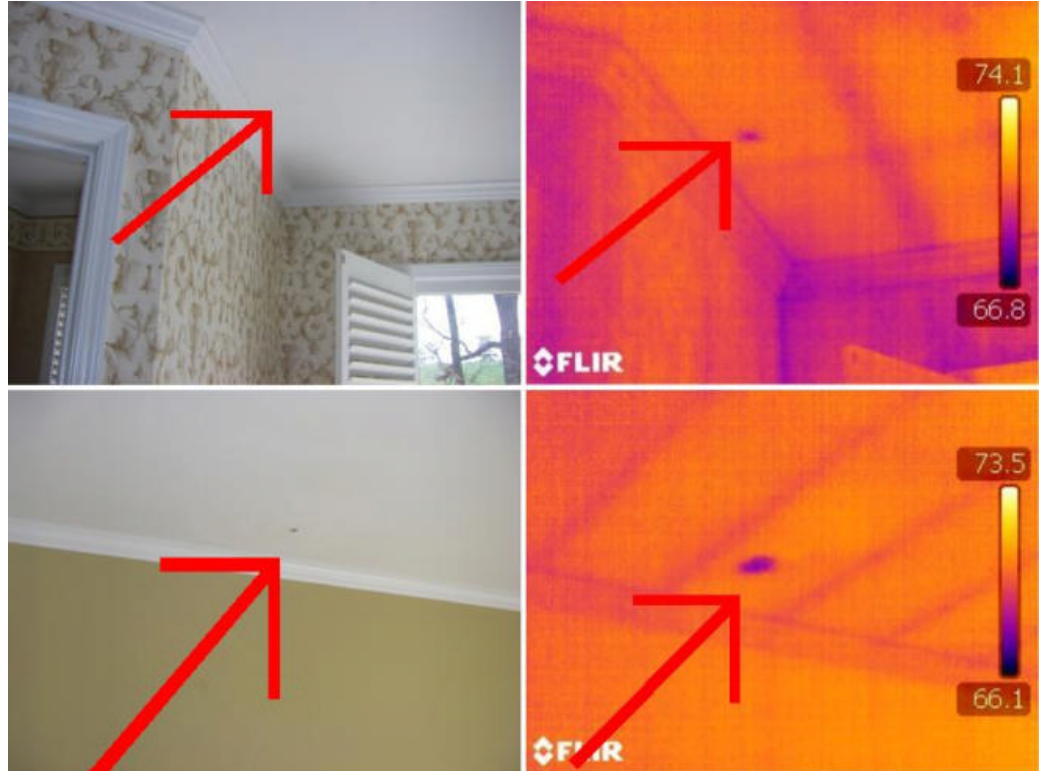
Active leaking noted at the time of the inspection at the plumbing vent flashings. See digital and Infrared photo. These types of plumbing vent flashings will deteriorate over time and will need replacing. A licensed or certified roofing contractor should be called to make further evaluation and repairs as needed.

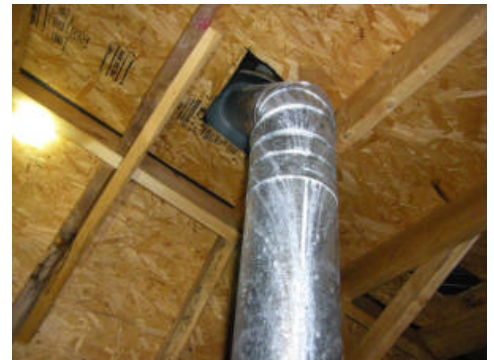
Evidence of previous leaking was noted at the combustible products vent in the attic. See photo. A licensed roofing contractor should be called to make further evaluation and repairs as needed.

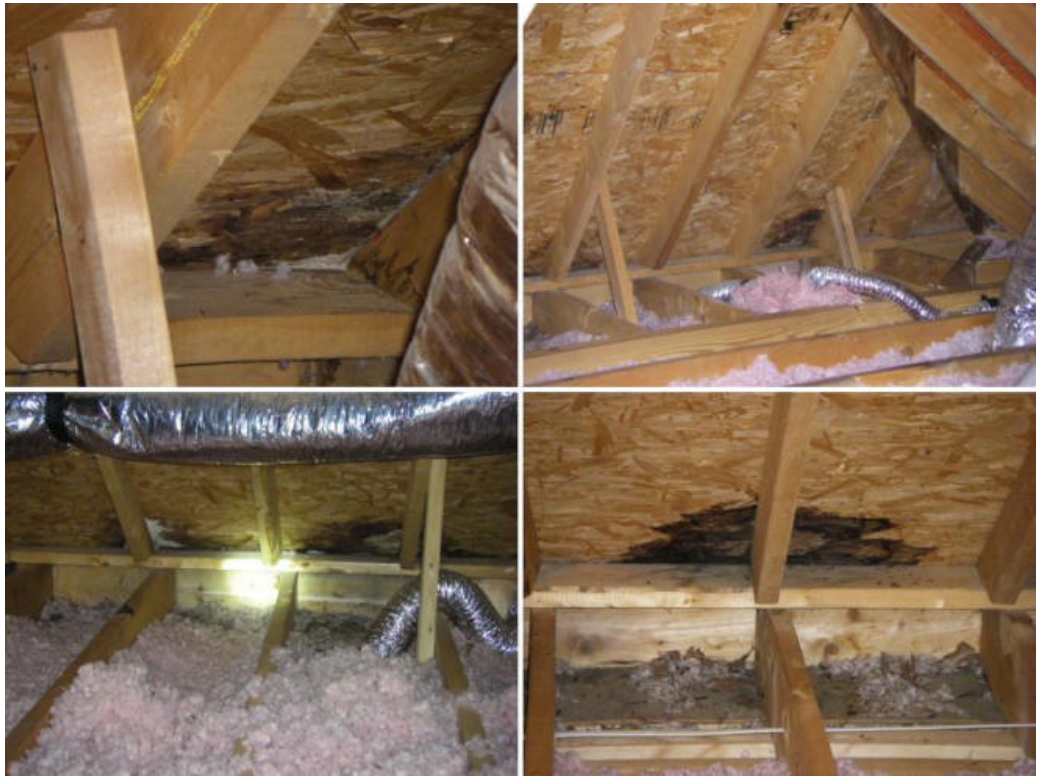
Evidence of active roof leaks noted in several areas of the attic. See photos. A licensed roofing contractor should be called to make further evaluation and repairs as needed. Budget for possible replacement of the roof.

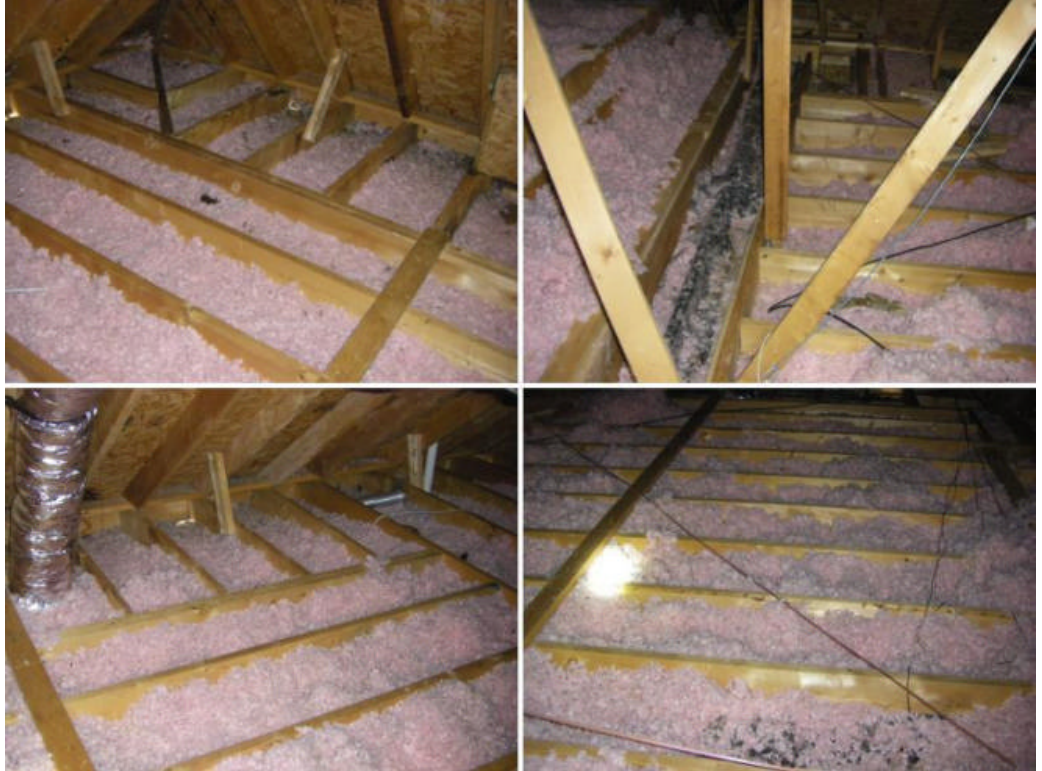
Attic insulation is in poor condition. Budget for additional insulation. When the tops of the ceiling joist can be seen in the attic the R- Value of the insulation is reduced. R-30 is recommended throughout. [WHAT IS R-VALUE?](#) A materials R-value is the measure of its resistance to heat flow. It is important to know the R-value because many states or regions require that a roof system have a minimum amount of thermal resistance. The way it works is simple: the higher the R-value, the more the material insulates.

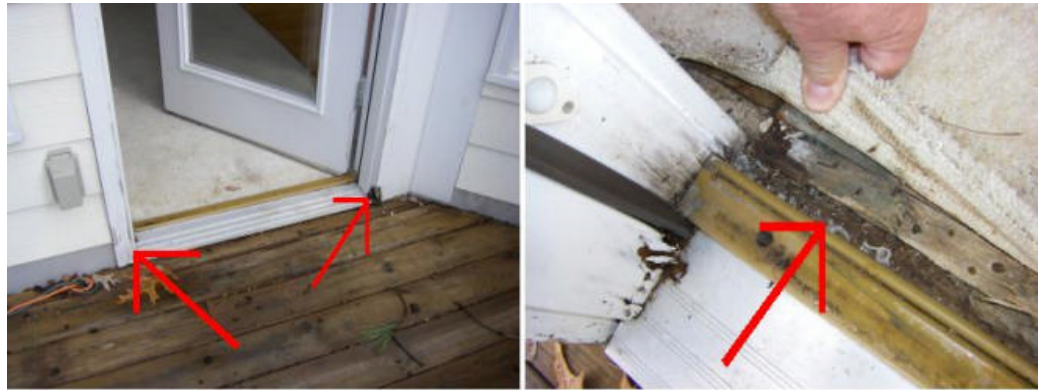
Standard rear door to the deck. Water damage was noted in the trim and threshold. Repairs are needed. Also, water intrusion was noted along the inside of the threshold. See photo.

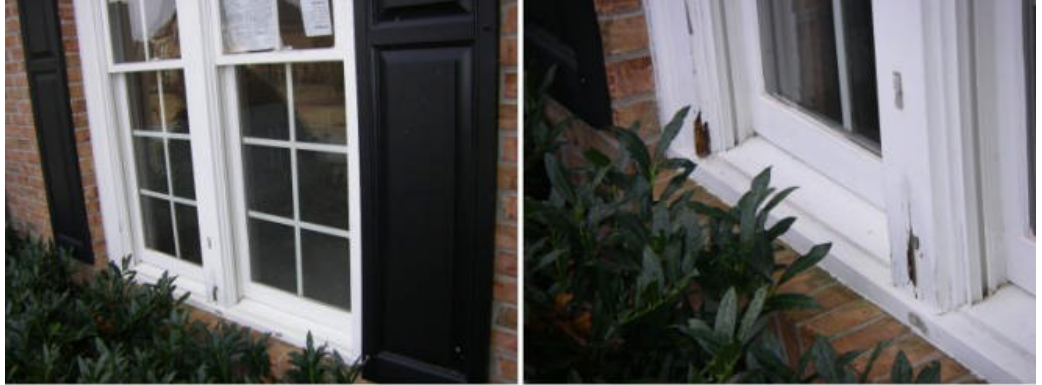
Water damage was noted in the dining room window trim. See photos. Repairs are needed.

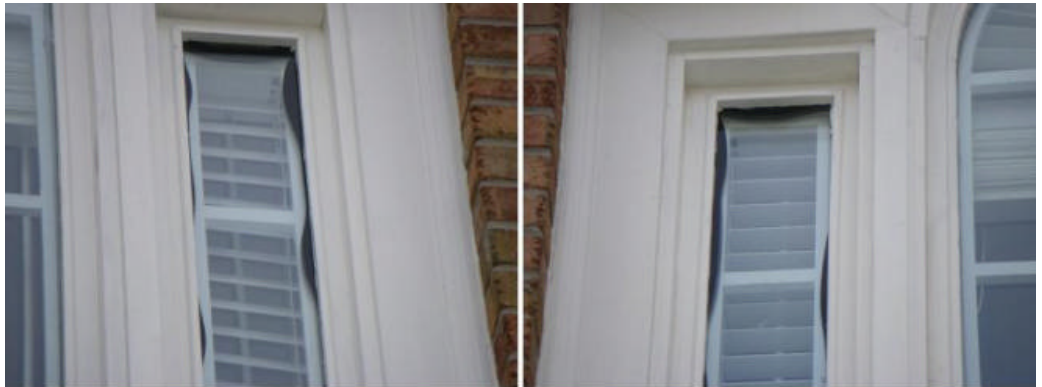
Master bedroom fixed side windows are defective. See photo. Monitor conditions. Replace as needed.

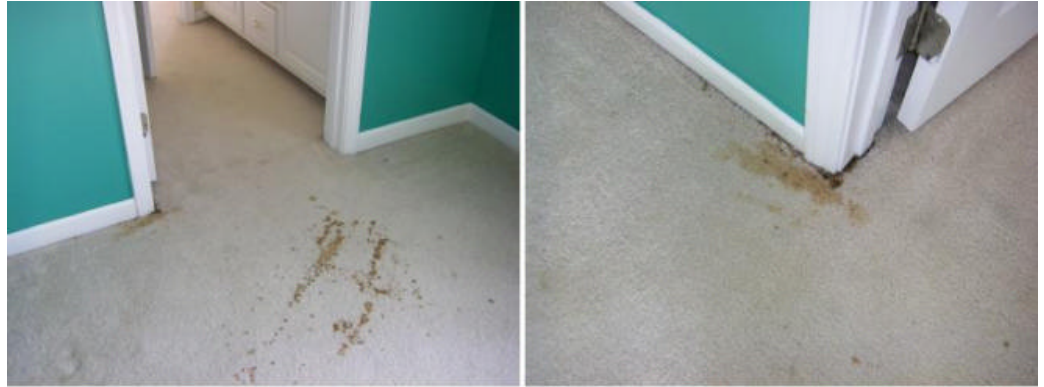
Wood, tile and carpet flooring noted in the home. Overall conditions are poor. Budget for the replacement of the carpet. Conditions are unsanitary. See photos.

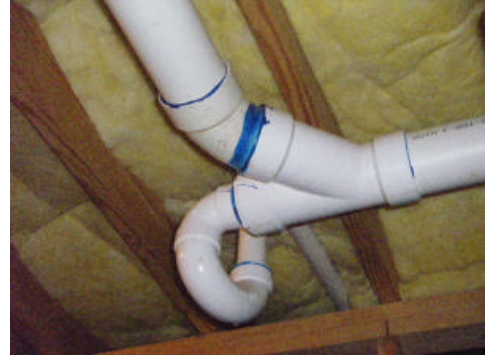
**NOTE:** No primer noted on the drains as required by the plumbing standards. Primer should be purple in color as to P605.21.2 (PVC glue primer). See photograph. No deficiencies/ leaking noted in the drainage systems at the time of the inspection. **NOTE:** **This code standard may not have been enforced by local officials at the time of the plumbing installation.**

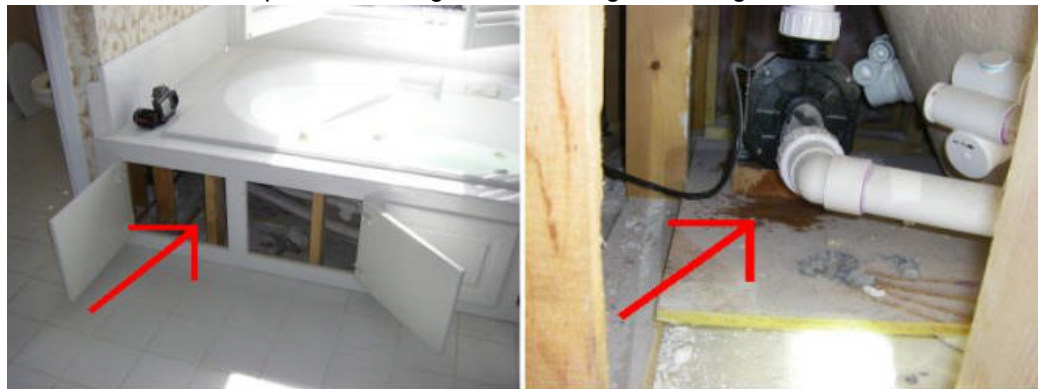
The jetted tub is leaking near the motor. See photo. Repairs needed by a qualified plumber.

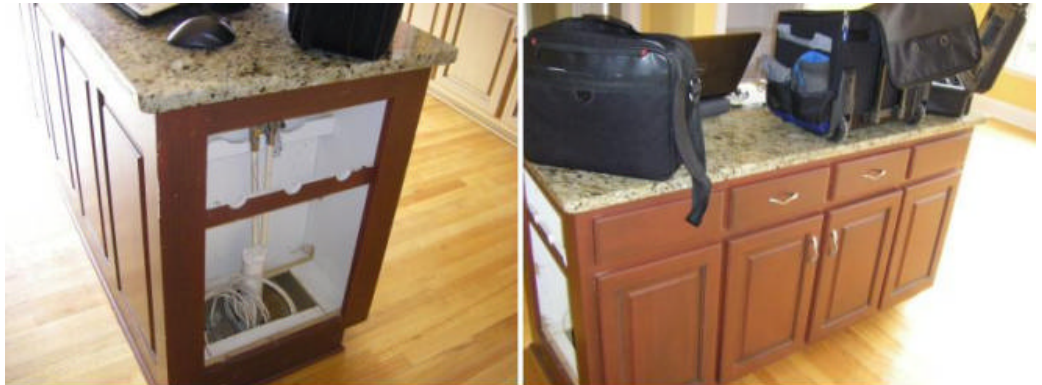
The island cabinet is not wired for a receptacle as required by the NEC. Correction needed.

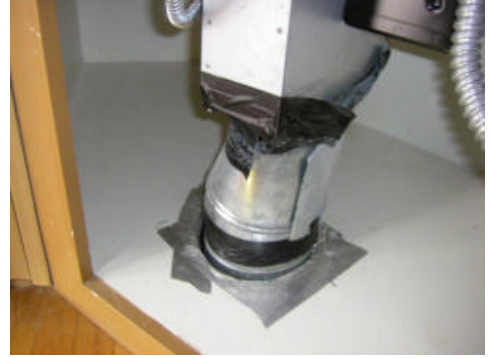
External ventilation vent noted at the surface unit. Budget for repairs to the tape on the vent. See photo.

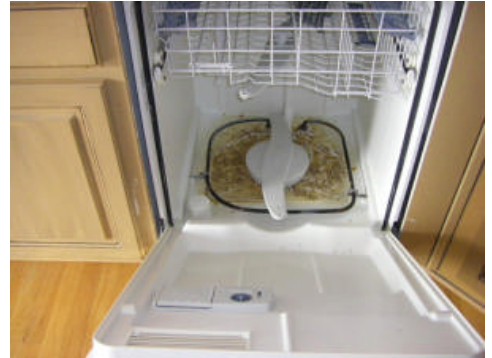
The dishwasher was serviceable at the time of the inspection. No leaking noted at the time of the inspection. Budget for cleaning the insides. See photo.

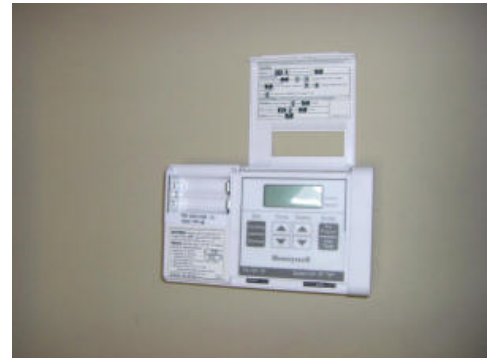
The thermostat for the upper floor was not functional.

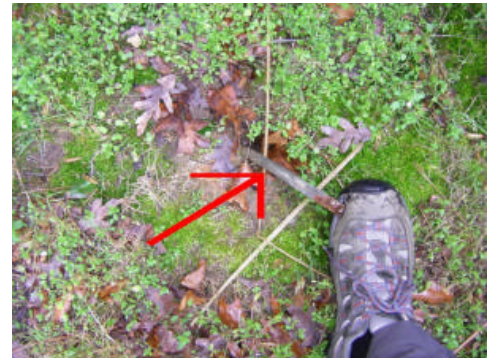
Grounding rod has been installed above final grade approx 6". The rod should be flush with the ground to help prevent injury to the occupants.

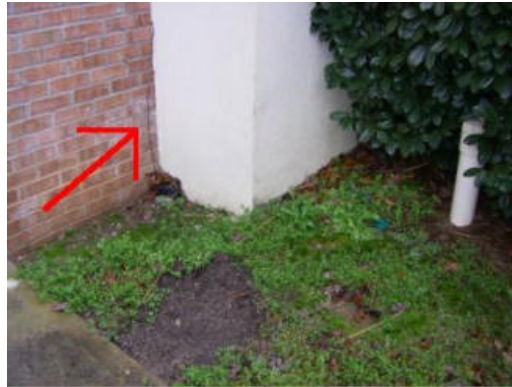
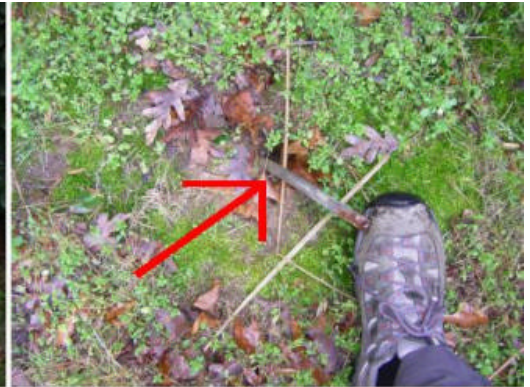
Could not determine if the grounding wire was connected to the grounding rod. See Photo. Have a licensed electrician make further evaluation and corrections as needed.

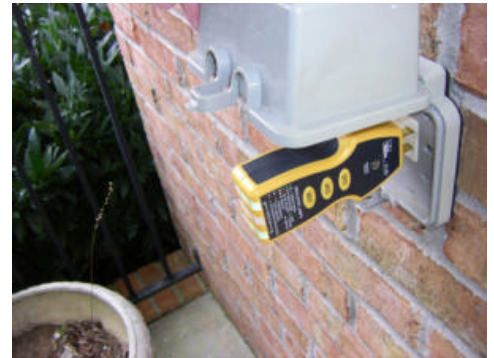
The GFCI receptacles on the exterior of the home are defective and will not trip. Replacement needed.
