CHRIS CURLES and ASSOCIATES Inc. INSPECTION SERVICES

XXXX Smith Lane Atlanta GA XXXXX

The Smith Family Inspection Report.

DATE: June XXXXX.
CLIENT: The Smith Family.
SITE: ADDRESS: XXXX Smith Lane.
CITY/STATE/ZIP: Atlanta, GA. XXXXXX.

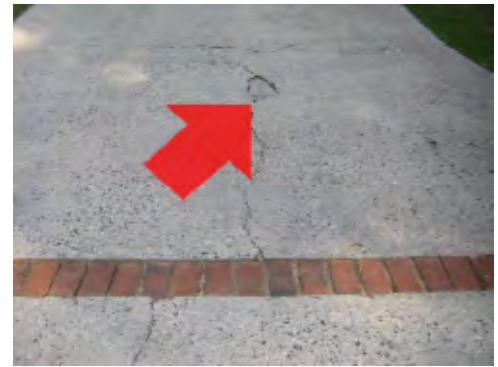
Driveway appears to be serviceable at this time. Cracks noted appear to be typical for the age. Repair as needed.

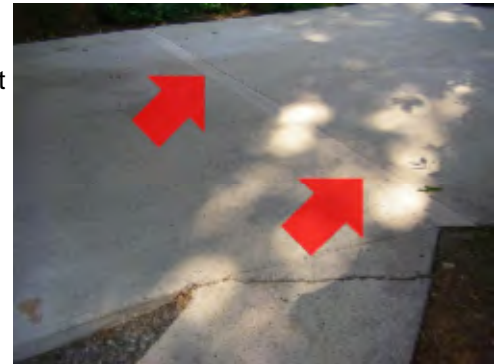
NOTE: The excavation or repair in the driveway near the garage is the result of a drainage system (french drain) that was installed along the front of the home.

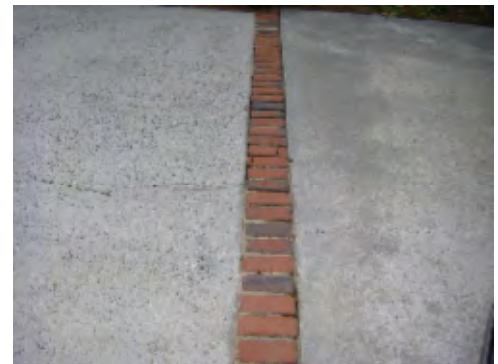
The bricks in the driveway should be pointed with cement to help prevent deterioration. Minor maintenance and repair.

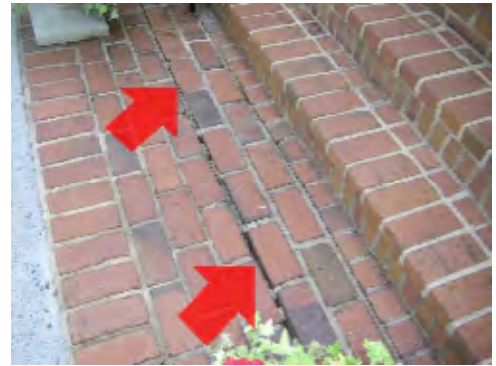
Loose mortar and bricks noted in the walkway to the front entrance. Correction recommended to help prevent additional deterioration.

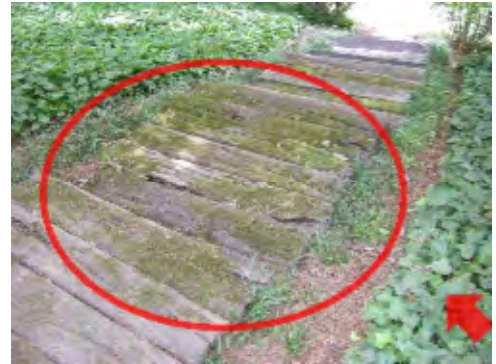
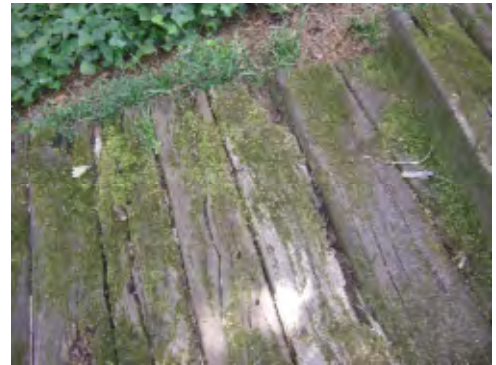
Water damage was noted in the cross tie walkway to the lower yard. Some areas of the walkway are hazardous. Budget for replacement.

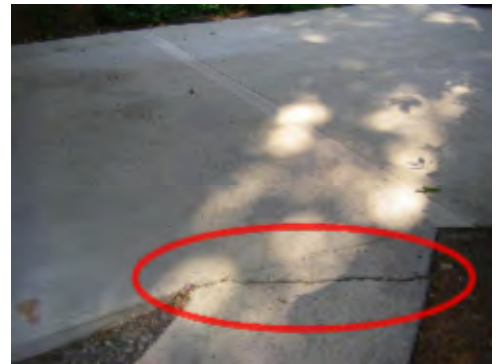
Settlement was noted in the sidewalk along the left side of the driveway. The settlement has caused a trip hazard. Access with caution and budget for repairs.

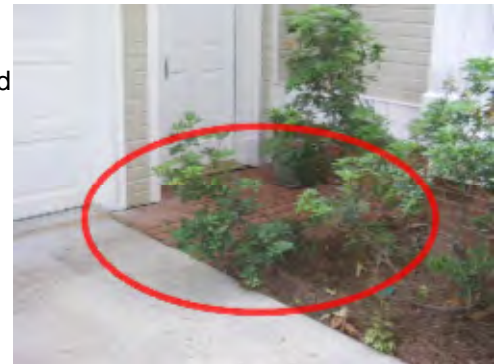
Settlement was noted in the brick pavers in front of the side entrance near the garage. Monitor conditions and repair as needed.

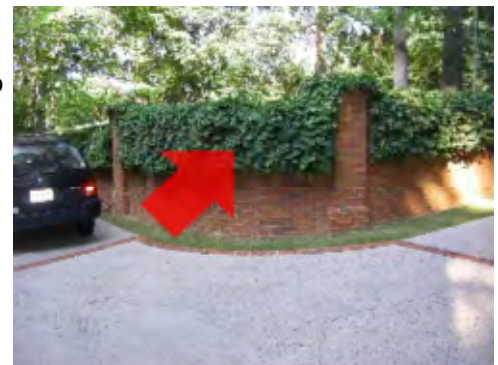
Water damage was noted in the cross ties along the left side of the driveway. Replace as needed.

Lateral displacement was noted in the retaining walls on either side of the driveway. The displacement appears to be caused by a build up of water and hydrostatic pressure along the back side of the wall. No drainage or weep holes were noted in the wall to help relieve the pressure. Possible failure noted in the left retaining wall, as viewed from the front of the home. Conditions should be monitored in both walls. Budget for repairs. See photographs.

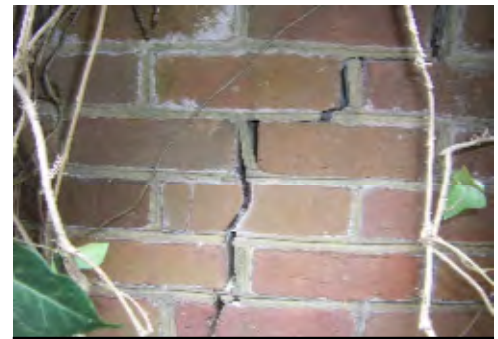
Displacement in the left retaining wall

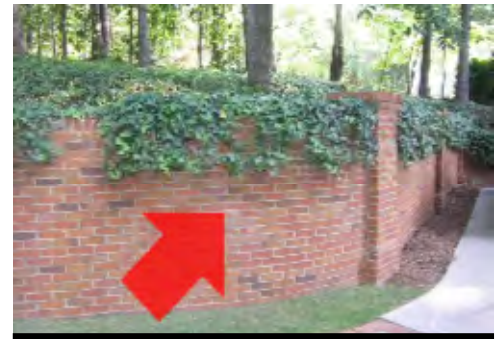
Right retaining wall. Displacement

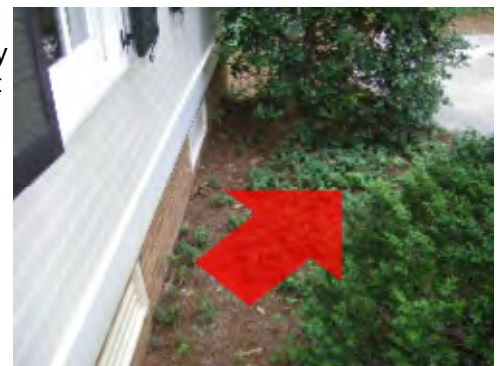
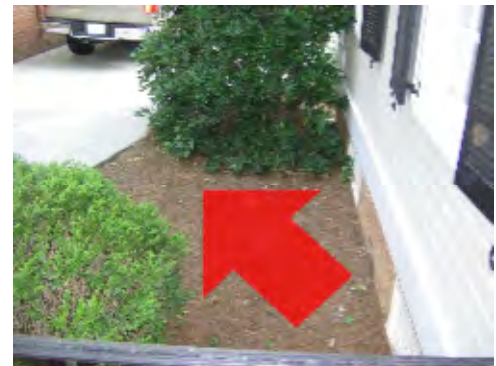
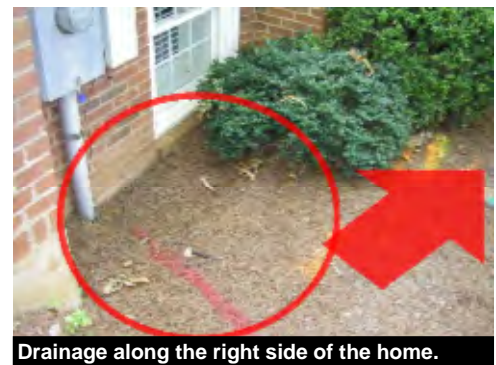
Ground or surface drainage should be improved and maintained to drain away from the foundation along the front, left side and right side of the home. Slope should fall away from the foundation at a minimum of 6" in 10' on all sides to help prevent standing water, erosion and/ or intrusion into the structure. NOTE: It is understood that a french drain has been installed to address this condition. However, maintaining a positive drainage is important.

Drainage along the right side of the home.

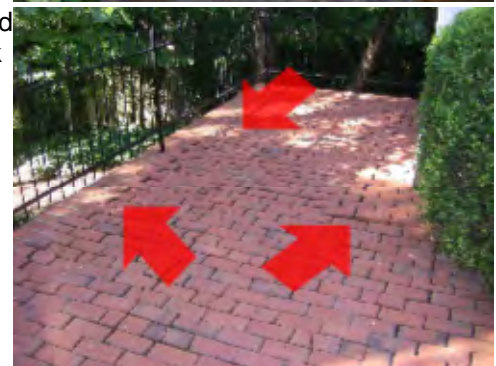
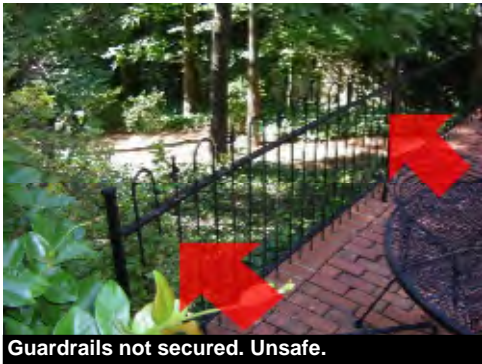
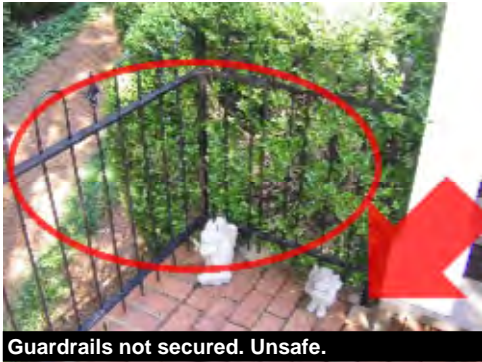
Settlement and displacement was noted in the brick patio at the foot of the deck stairs. The displacement has caused trip hazards in several areas. Also, the guardrails are not secured and are unsafe. Budget for correction to the patio and rails.

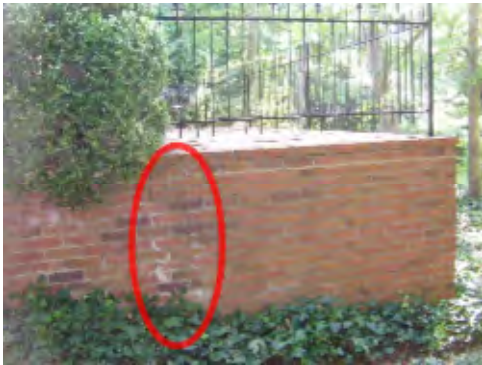
Minor settlement and displacement was noted in the foundation supporting the lower patio. Monitor conditions.

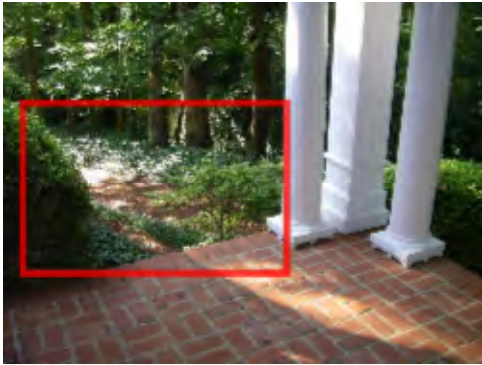
A guardrail is recommended along the corner of the patio under the deck for safety. The drop off is greater than 30". **Safety concern.**

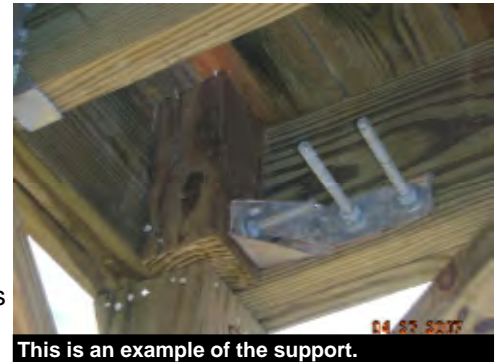
NOTE: The deck at the inspected property was constructed at a time before there were codes that governed the construction and safety of decks. There are now several retrofit products on the market that are designed to improve the safety of your deck. They are provided by: www.deck-lok.com, and www.strongtie.com/safedeck/index.html. Please visit these web sites to learn more on how to improve and maintain the safety of your deck. The guardrails should be secured to withstand 200 lbs of lateral force and pressure.

This is an example of the support.

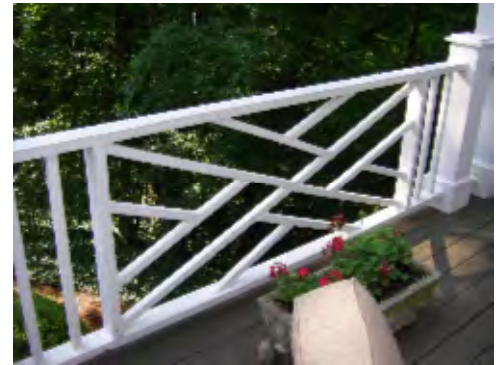
The openings in the guardrails are greater than 4" as recommended for safety. The ladder style of rail may pose a safety hazard to children. Recommend additional pickets or lattice or redesign. **Safety concern.**

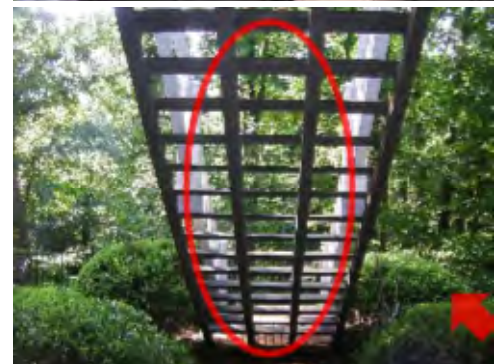
Minor lateral movement was noted in the deck stairs. Adding a kick plate to each stair will help to stabilize. Repair as needed.

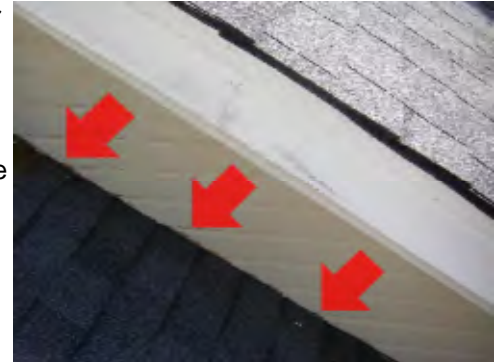
Appears serviceable at this time. Minor painting touch up is recommended to the edge of the siding where the siding was trimmed back when the roof was replaced. These areas were noted where the siding was in contact with the roof shingles over the garage and sunroom. Minor repair needed.

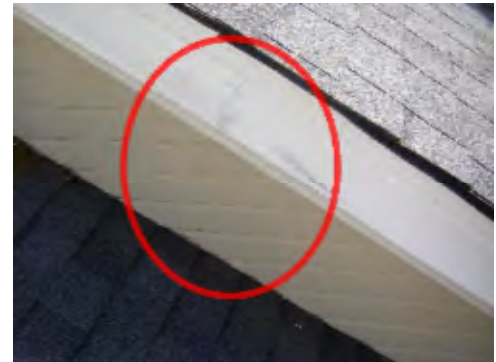
Appears serviceable. Minor repair needed to the fascia board along the right side of the sunroom.

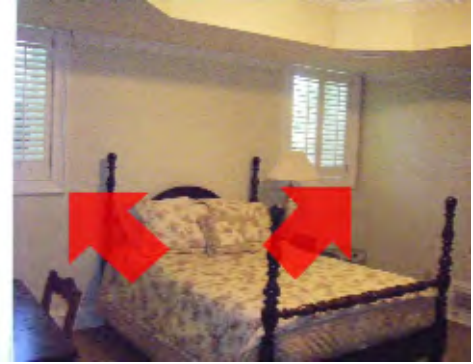
NOTE: The windows in the basement bedroom are not accessible as to building and safety standards. The window sill should not be greater than 44" from the floor. Use caution in this room.

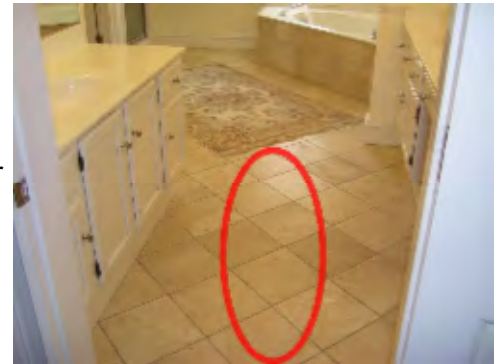
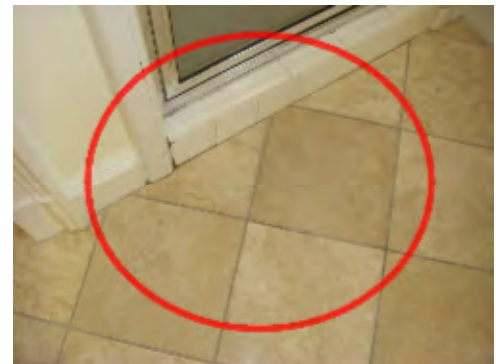
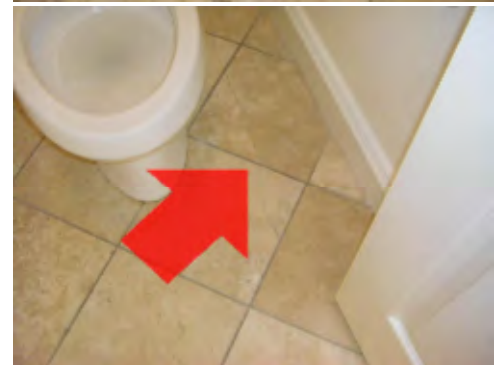
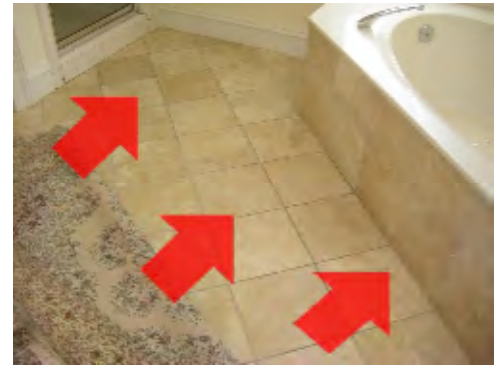
Deflection was noted in the flooring in the master bathroom area. Several cracked floor tiles were noted. Loose sub flooring was noted in the children's bedroom. The floor joist could not be viewed to determine the grade, span or size. Replace the cracked tiles as needed. See photos.

Wood and carpet flooring noted throughout. Overall conditions are good. The master bath floor tiles are cracked and will need to be replaced after determining the cause.

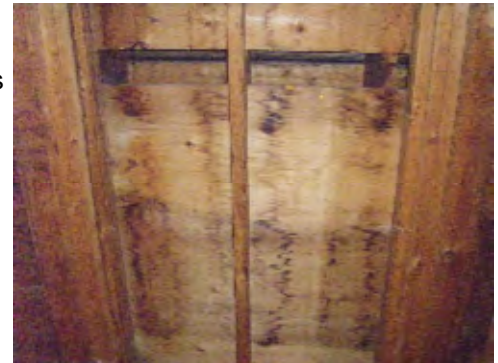
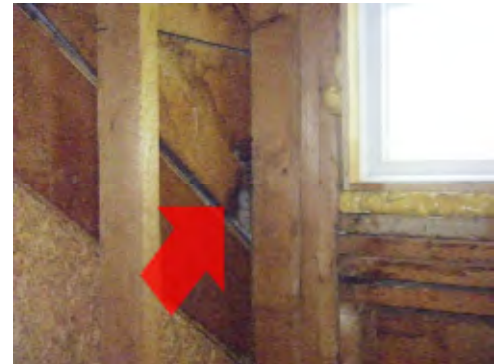
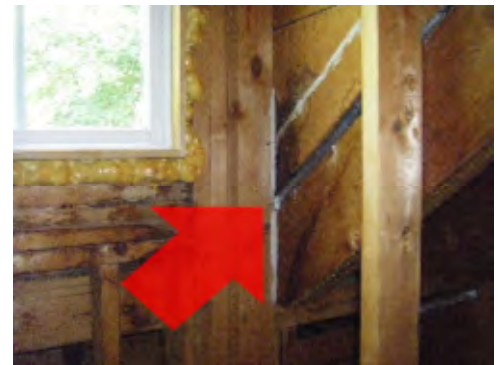
No evidence of roof leaks noted at the time of the inspection. Evidence of previous leaking noted in several areas of the attic. Roof recently replaced.

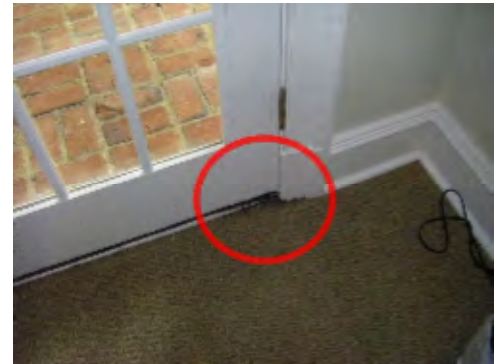
Water stains noted in the carpet in the lower family room at the french doors. Cause for the stain unknown.

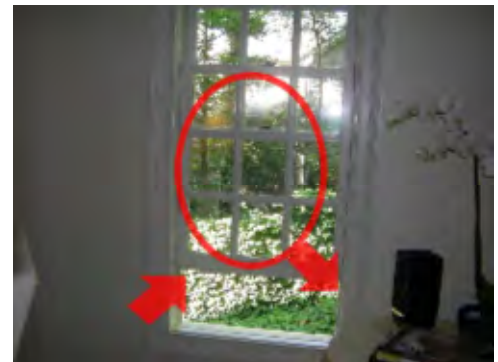
The front right living room window will not stay up. The sash spring may need to be adjusted. Also, the weather strip and sash guide is damaged. Repair needed.

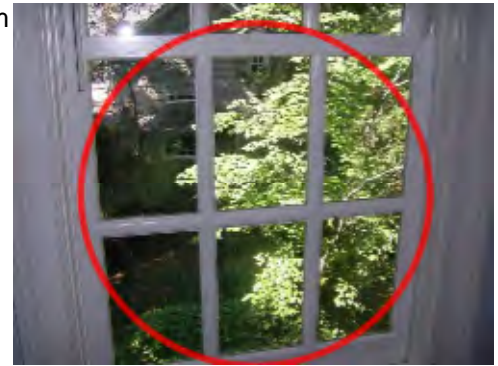
The insulated glass has lost its vacuum in the front right master bedroom window.

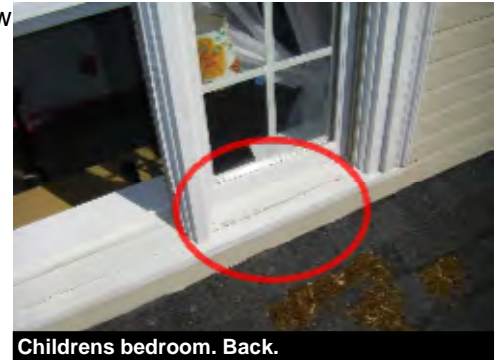
Children's bedroom. Back.

Water damage was noted in the window sills of the children's bedroom, master bedroom and in the lower family room. See photos. Repair needed.

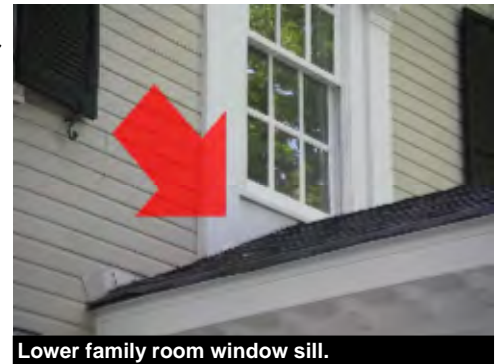
Lower family room window sill.

Minor water damage was noted in the trim under the front center second floor window. Repair as needed.

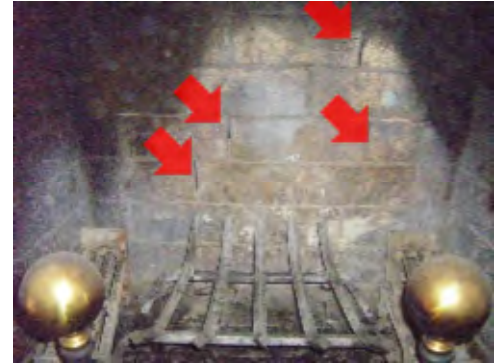
Pointing will be needed in the back of the upper family room fireplace. Minor repair.

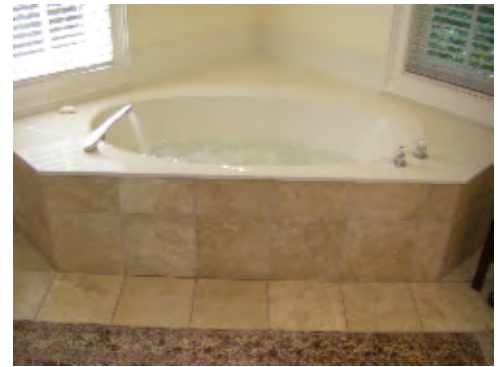
No access noted to the master bath jetted tub motor. An access panel is required. Correction needed.

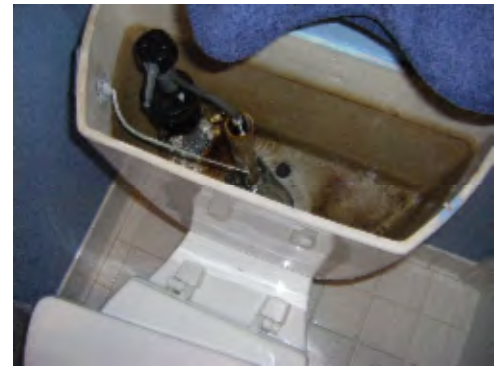
The commode in the blue bath is hard to flush. Repair needed.

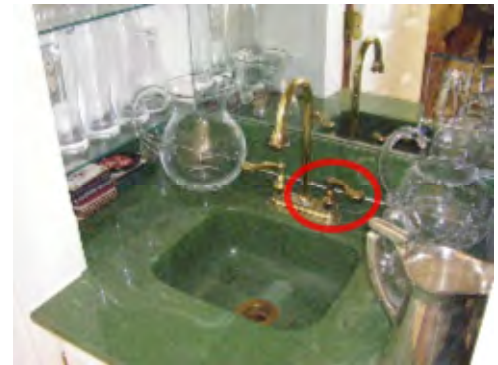
The cold water is off to the bar sink. Cause unknown.

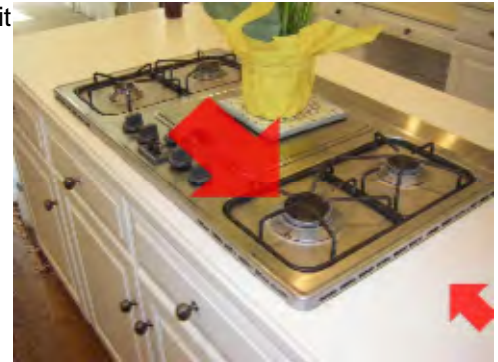
CONDITION: The front right burner of the surface unit is hard to light. Adjustment needed.

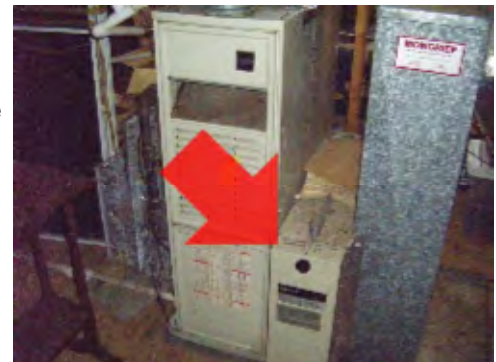
The electronic air filter is not functioning as intended. Possible replacement needed. Have a qualified HVAC contractor investigate and make the necessary repairs.

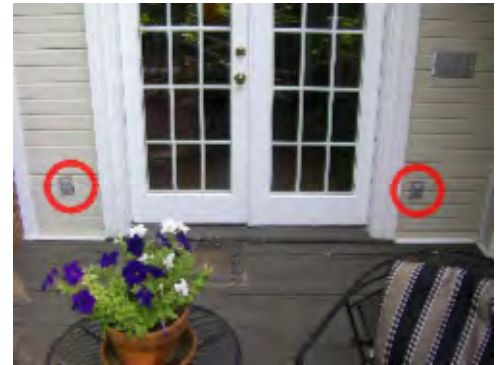
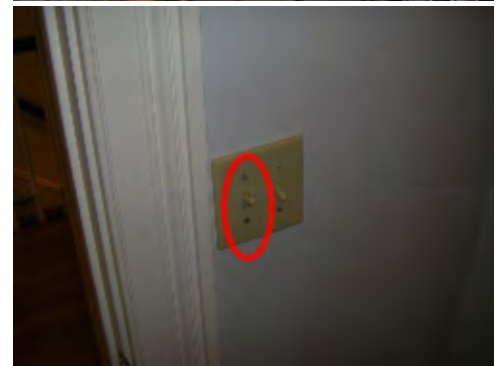
The half bath wall switch is defective and should be replaced.

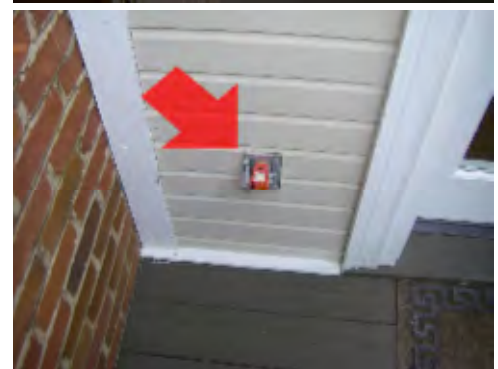
No ground fault protection found at the side entrance door. Also, the outlet cover should be replaced with a weather and water proof cover. Have a qualified electrician make the necessary repairs.

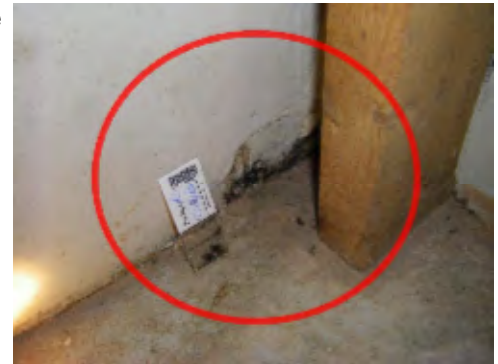
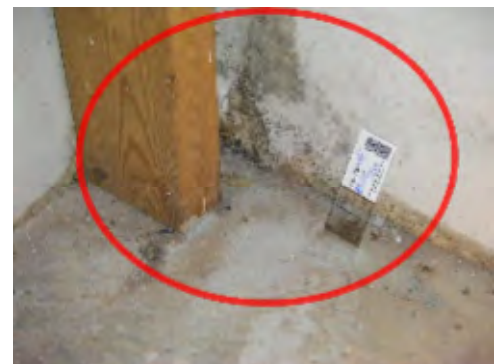
A mold like substance was found in the utility room near the electrical panel. Two samples was taken. The results of the samples will be provided at a later date. To learn more about Mold in the home go to: www.epa.gov/mold/moldresources.html.
