CHRIS CURLES and ASSOCIATES Inc. INSPECTION SERVICES

Inspection Report.

DATE: January.
CLIENT: The Grand Family.
SITE: ADDRESS: 12345 Address.
CITY/STATE/ZIP: Marietta, GA .
EMAIL: XXXXXXXXXXXX.com.
PHONE: 770-xxx-xxxx.

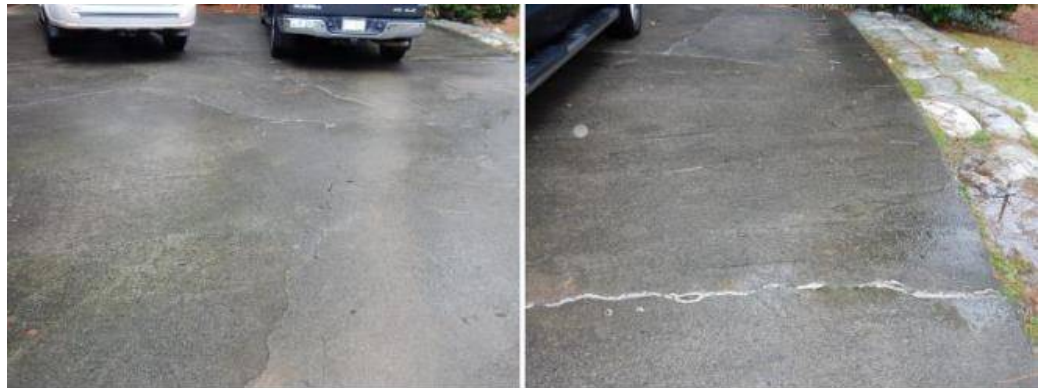
Some settlement was noted in the driveway. Monitor conditions for displacement and possible trip hazards and make repairs as needed. NOTE: A trip hazard is defined as a change in elevation from one level to the next of more than 3/4". This can be a safety concern when accessing these areas. See photo.

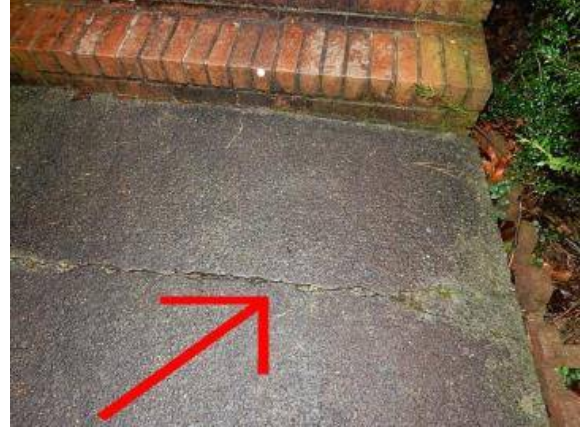
Some settlement was noted in the sidewalk. The sidewalk extends under the front stairs and landing. See front entrance report. Correction will be needed.

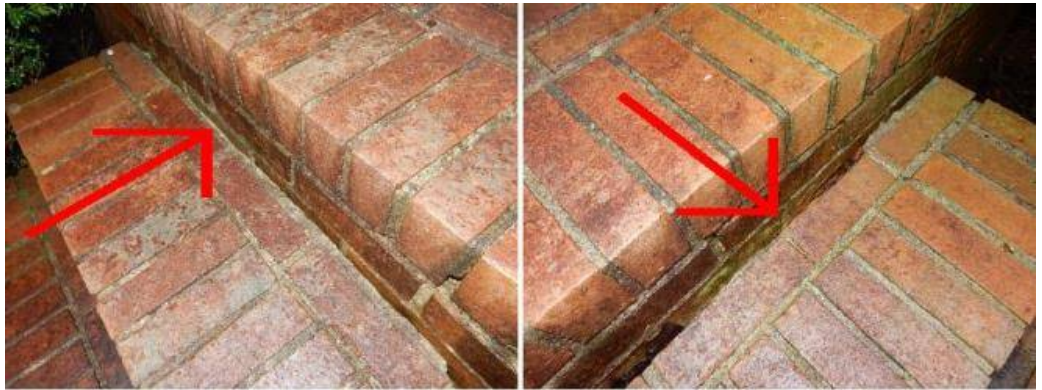
Settlement noted in the stairs to the front landing. Displacement cracks or gaps noted between the stairs and landing. Possible cause for the settlement or displacement would be loose and non compacted soil around and or under the landing. Also, the sidewalk extends under the sidewalk and front entrance. Further investigation will be needed by a qualified contractor to determine what, if any, correction will be needed.

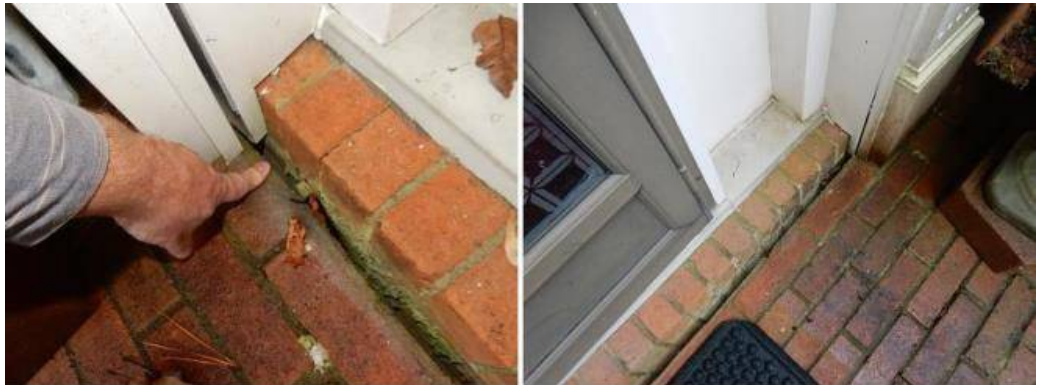
Settlement noted in the front landing. Displacement cracks or gaps noted between the landing and the structure of the building. Possible cause for the settlement or displacement would be loose and non compacted soil around and or under the landing. Further investigation will be needed by a qualified contractor to determine what, if any, correction will be needed.

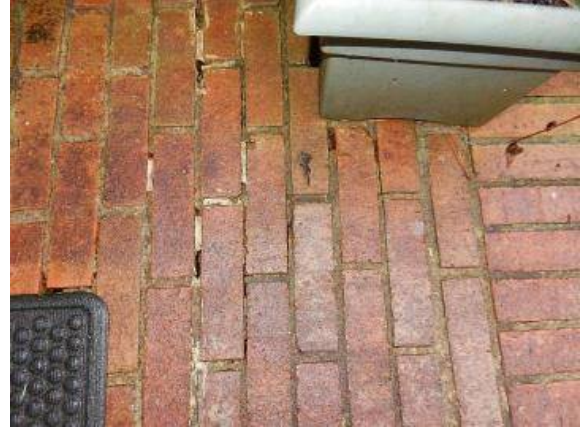
Pointing needing between the bricks in the front landing. See photo.

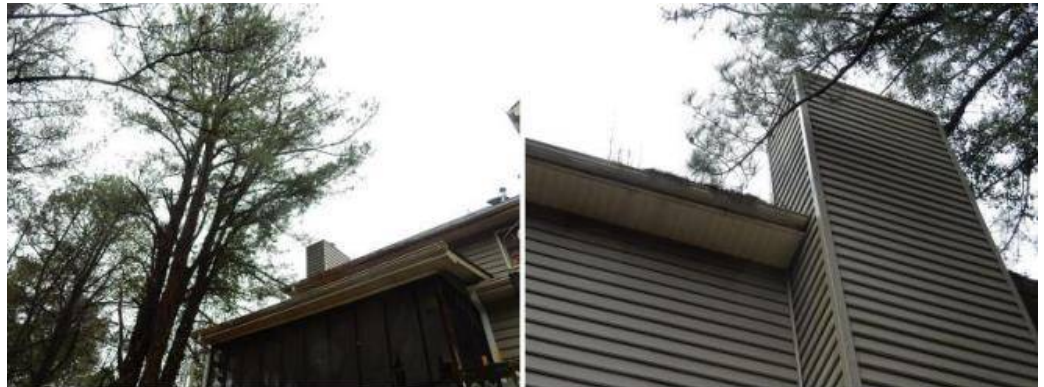
Trees are touching or overhanging the roof. Damage may be possible. Removal or pruning is needed. See photo.

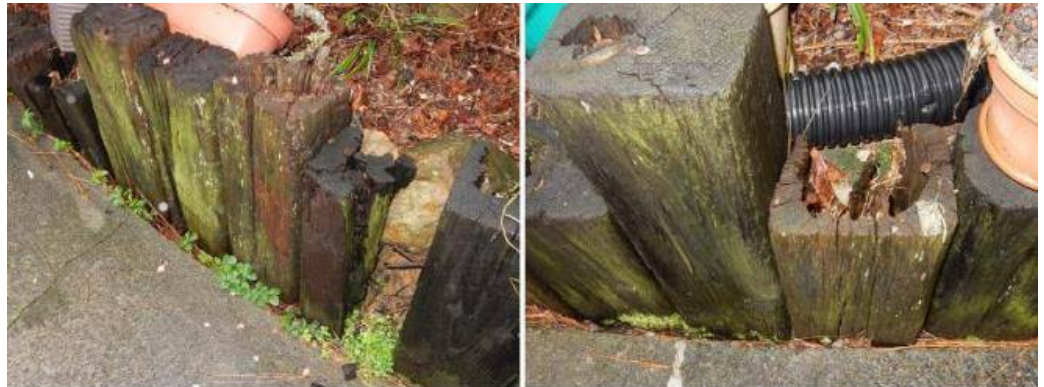
Water damage was noted in the crosstie retaining wall. It should be mentioned that most cross ties used for retaining walls and landscape timbers are 30 to 50 years of age. The decay noted in the cross ties should be monitored. Replacement will be needed. See photo

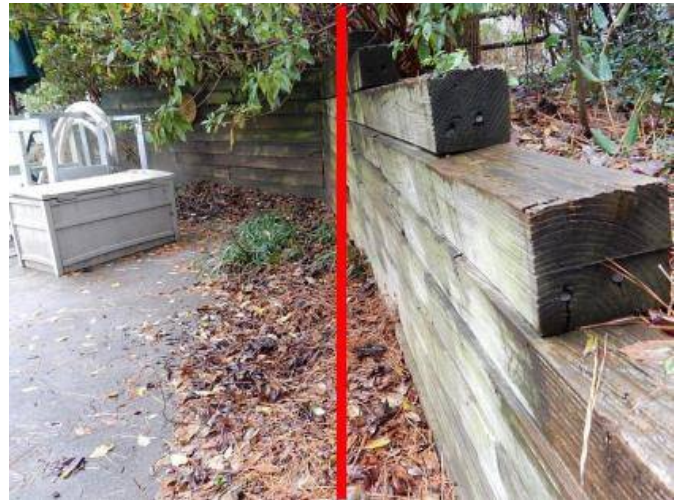
The retaining wall at the pool have failed and should be investigated by a qualified contractor. See photos. Replacement needed.

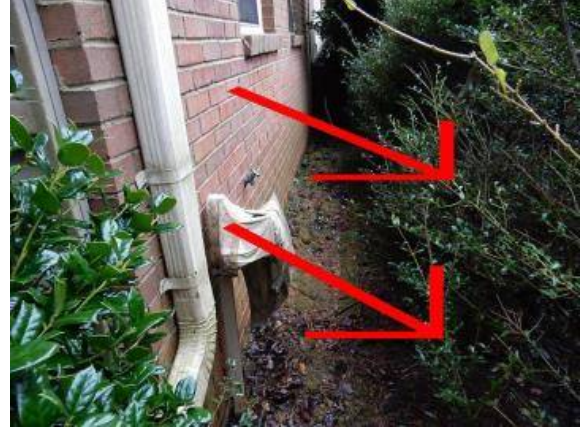
The grade along the front of the home should be corrected/ maintained to drain away from the foundation. Slope should fall away from the foundation at a minimum of 6" in 10' on all sides to help prevent standing water, erosion and/ or intrusion into the structure. Poor drainage is the most common cause for water intrusion into the structure.

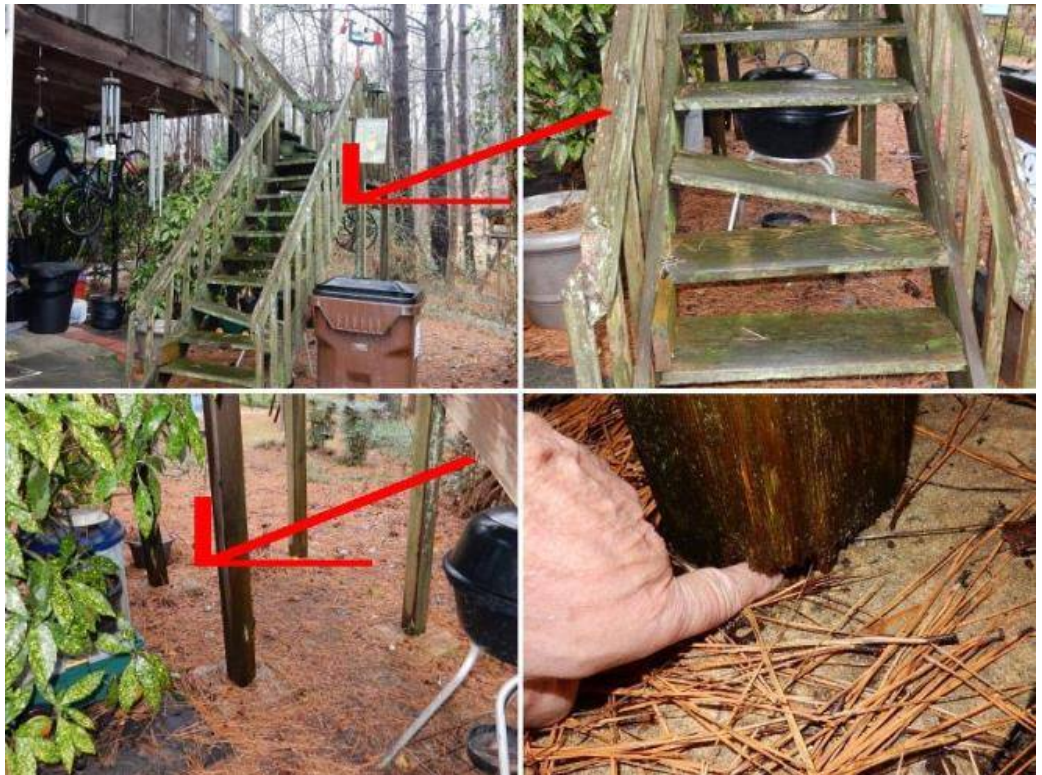
The deck, stairs and supporting post are in poor condition and should be replaced. Unsafe condition noted. See photos. No deck bolts noted in the rim joist of the deck at the time of the inspection. Properly installed deck bolts will help secure the deck to the structure and prevent displacement. Deck bolts should be installed on 12" to 24" centers as recommended by local standards. The placement of the deck bolts in the deck ledger should be staggered as outlined in the IRC R502.2.2.1. If the bolts are aligned in a straight line across the ledger there is a high probability that the ledger board may split and fail.

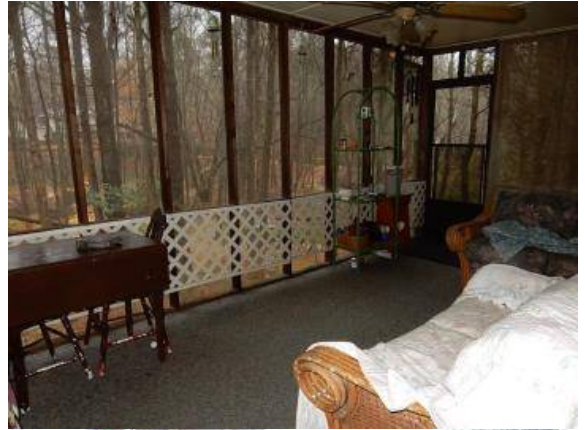
The screen below the guardrail should be protected and secured with guardrail type framing to help prevent children from passing through. Latticework or lattice-like structure or 2x2 pickets 4" on center or similar framing is recommended.

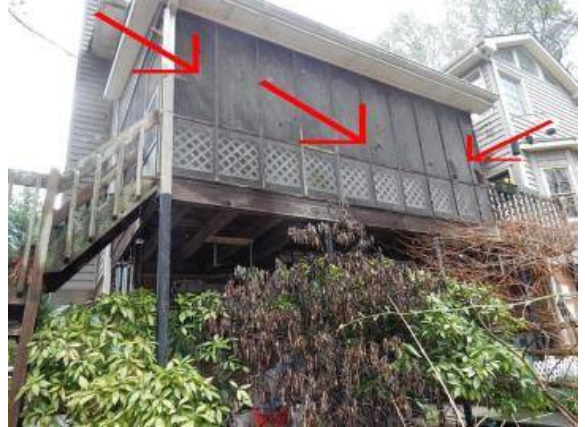
The screen is damaged and should be replaced.

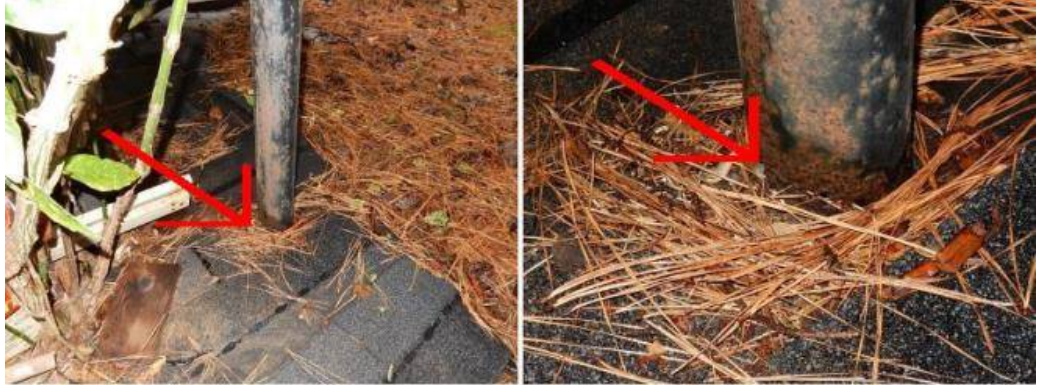
The base of the steel columns are rotting. Unsafe condition noted. Budget for replacement ASAP. See photo.

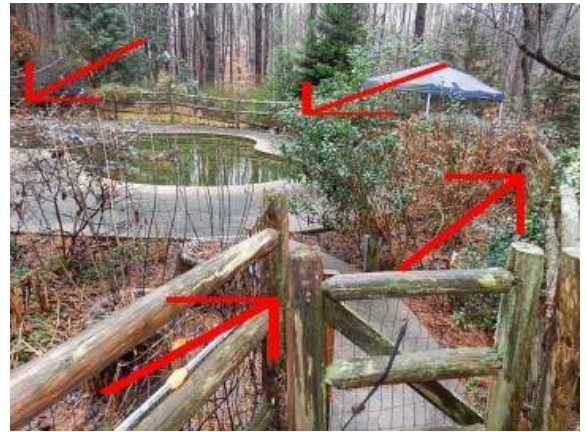
Wood fence noted on the property. Recommend installing a lockable gate to prevent children and some adults from entering the pool area. Unsafe condition noted. Budget for repairing or replacing the wood fence. Water damage noted in several places. See photo.

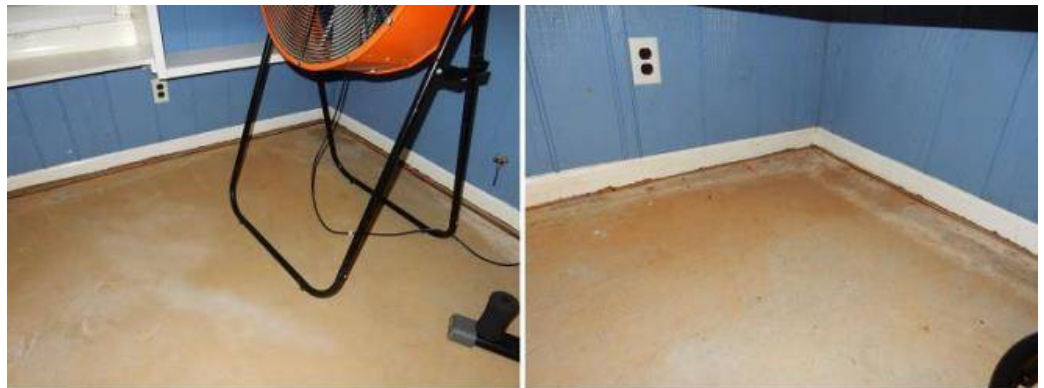
The foundation was not visible for inspection. NOTE: It is understood the basement flooded. The cause for the flooding was not determined. Have the owner address this. Appears serviceable and in good condition where visible. The ceiling tiles were not removed to inspect the framing.

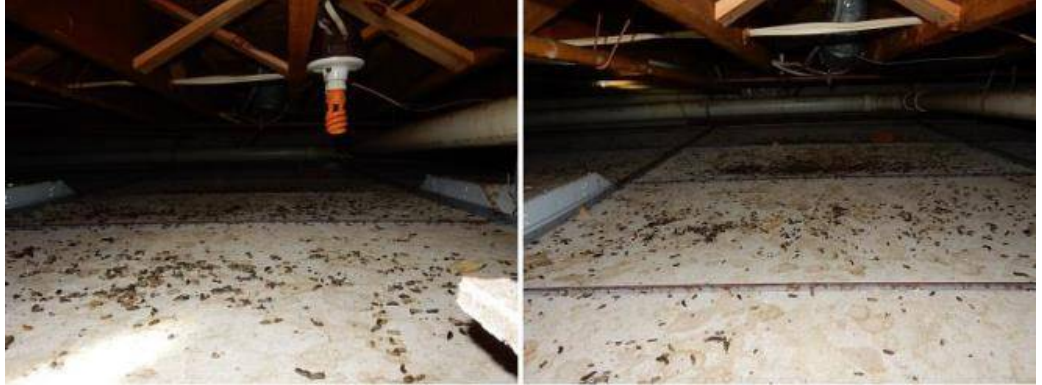
The framing in the finished areas of the basement was concealed with a drop ceiling. Evidence of excessive rodent activity in the drop ceiling. Unsanitary condition noted. Health hazard noted. This condition should be addressed by a qualified pest control contractor. The ceiling tiles should be properly disposed of. See photos.

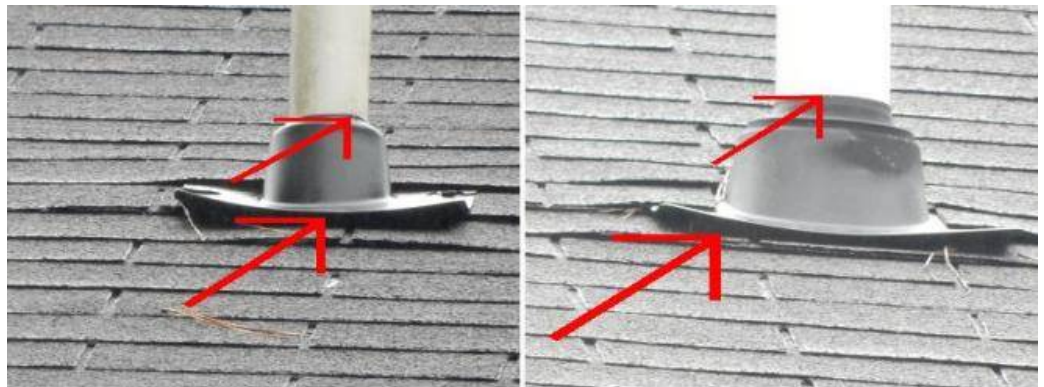
The plumbing vent flashings are damaged and should be replaced. See photos.

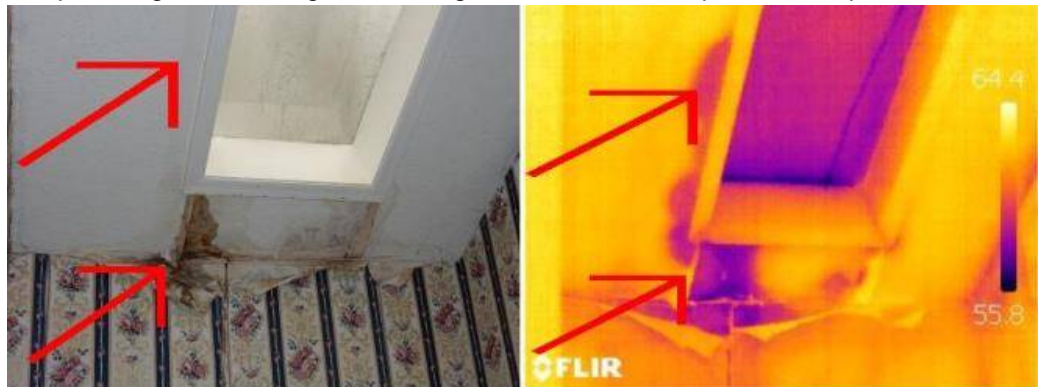
Active leaking noted at the master bath skylight flashing. See Infrared photo. A licensed roofing contractor should be called to make further evaluation and repairs as needed.

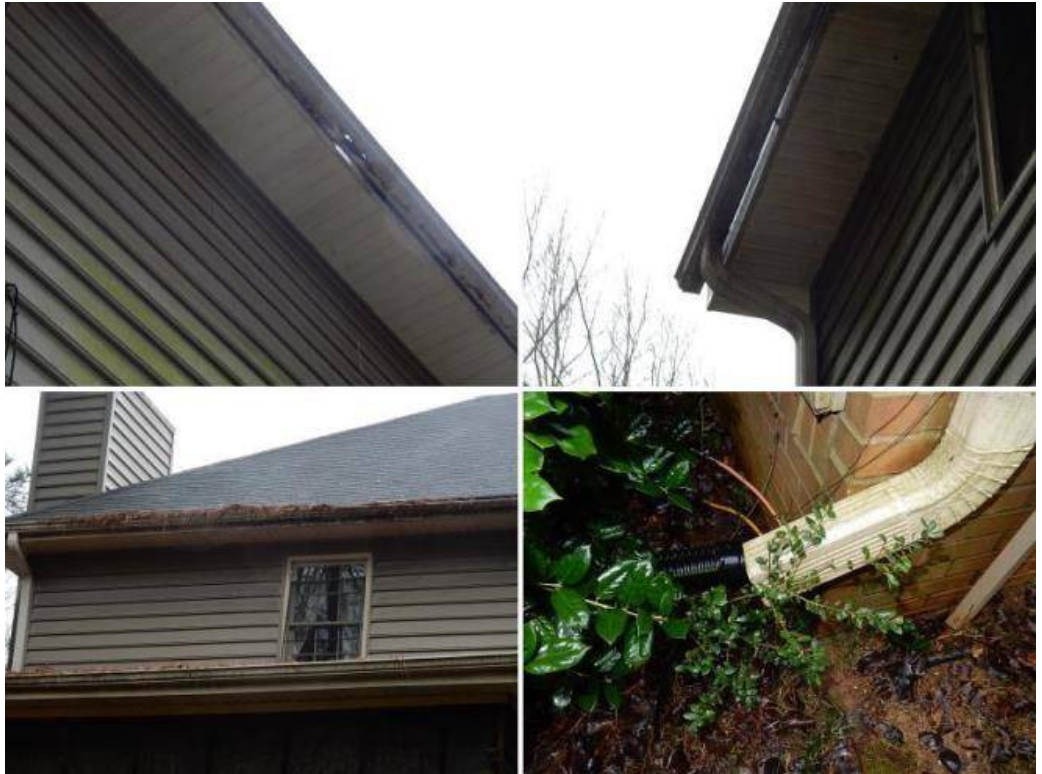
Gutters are at the end of their normal life expectancy. Deterioration noted in several places. Budget for replacement. Downspouts should be diverted away from the foundation 10 to 20 feet to help prevent water intrusion into the structure.

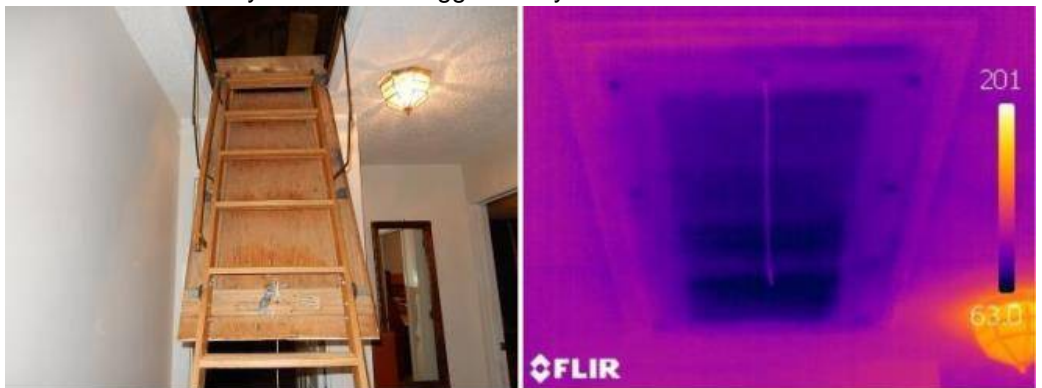
Pull-down stairs are installed for the attic access. No weather stripping installed around the hatch perimeter. To reduce air leakage, recommend installing weather stripping and an insulated hatch cover. There are several insulating products that are designed to help prevent heat loss into the attic in the winter and heat transfer from the attic to the

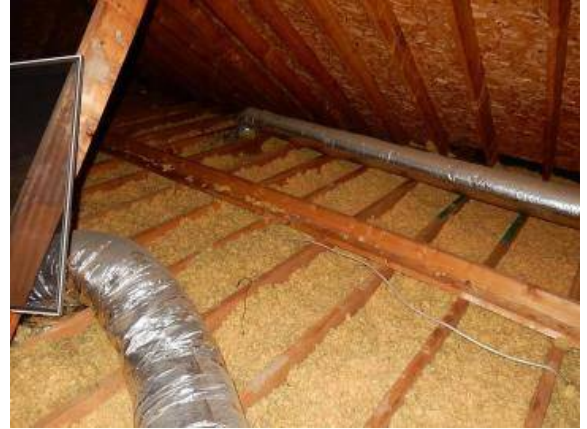
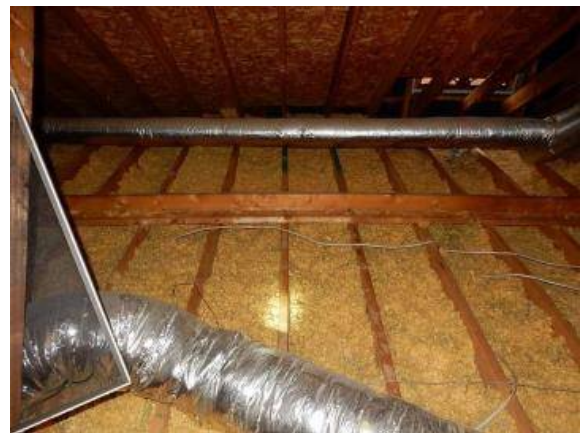
Evidence of prior rodent activity was noted. You may wish to have treatment carried out by a licensed exterminator. Recommend having a qualified contractor close all openings in the soffits and fascias or any openings into the attic that will or could allow rodents to enter the attic space. NOTE: Inspecting for rodents and insects is beyond the scope of services of our company.

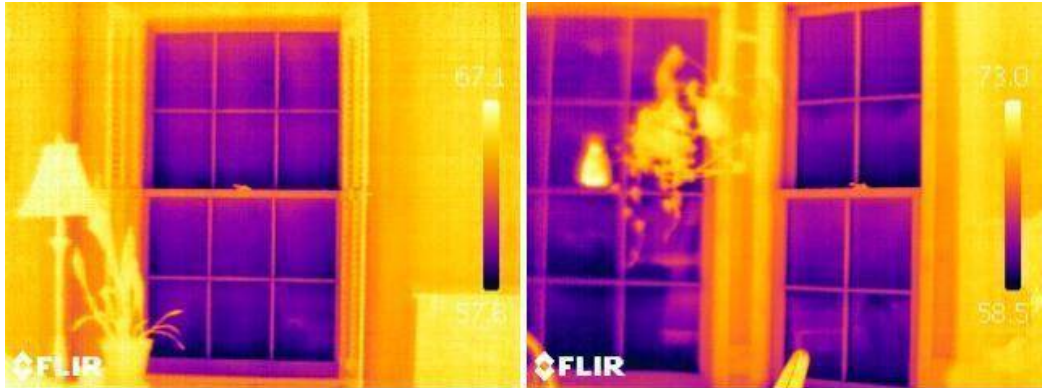
Single pane glass noted in the windows throughout the home. Recommend installing storm windows or replacing the single pane glass windows with Insulated Thermal Pane windows to help save energy. See InfraRED Photo. The blue indicates heat or energy loss from the window areas.

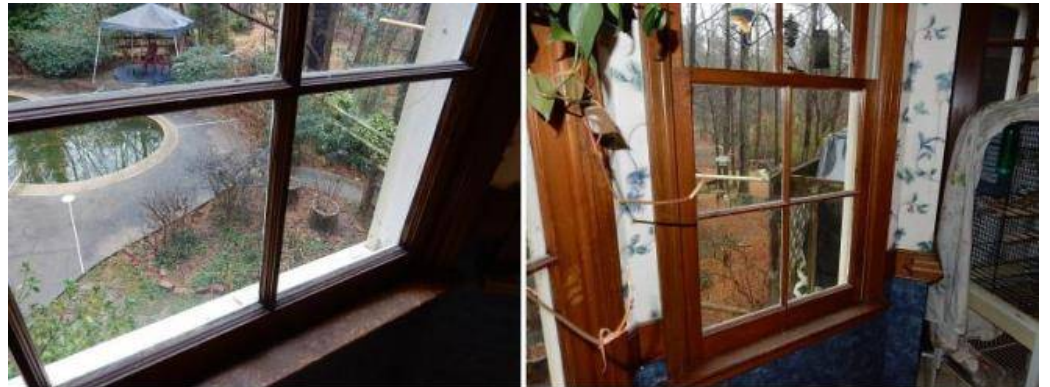
Caulking/glazing deteriorated in most windows. Budget for correction.

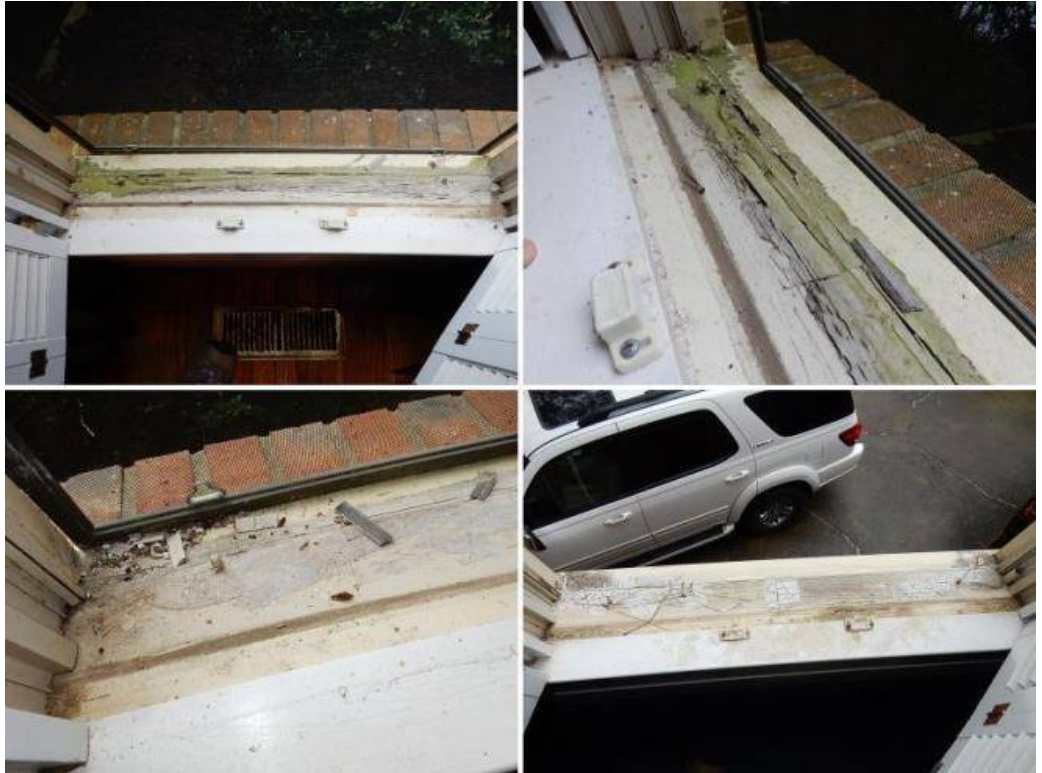
Water damage was noted in several window sills along the front, back and sides of the home. See photos. Budget for repairs and or replacement. Have a qualified contractor address this.

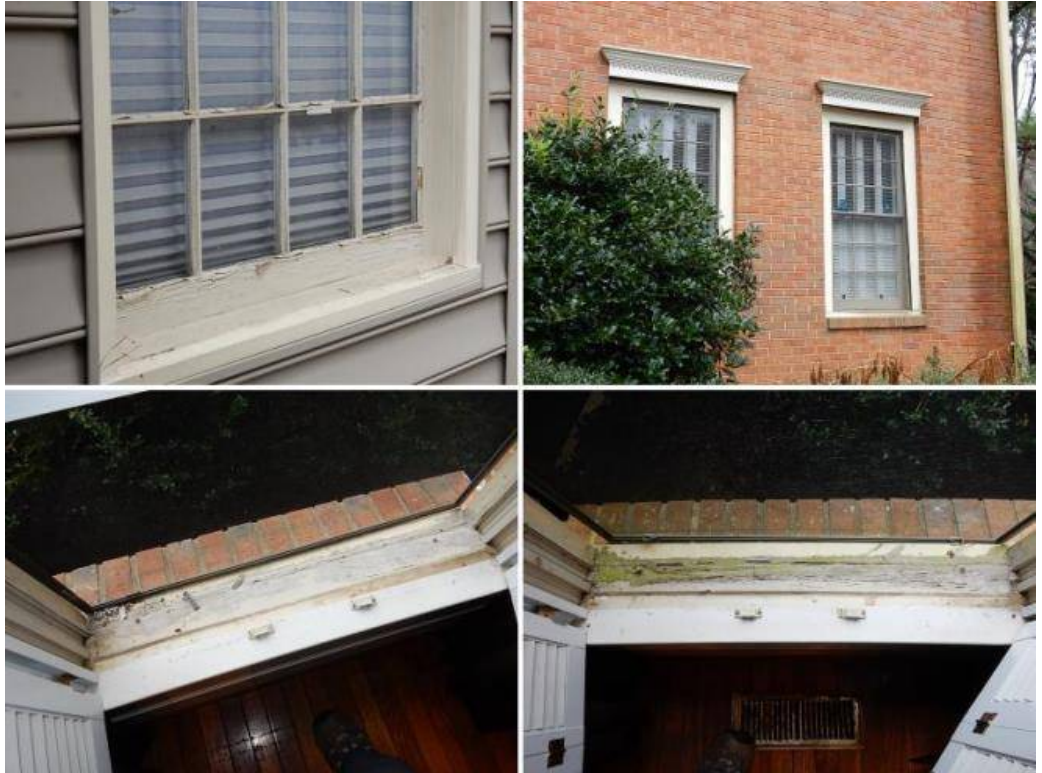
The sash springs are not connected in several window units. Repair needed.

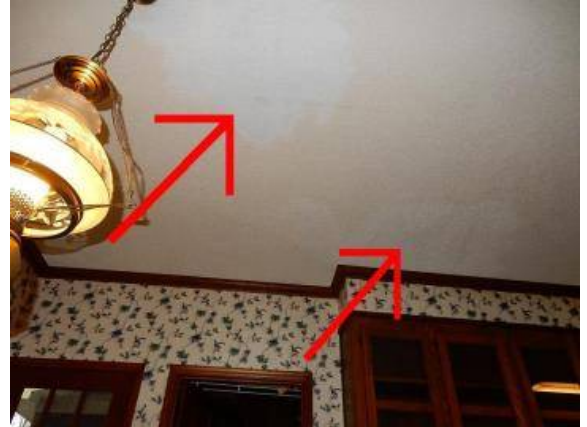
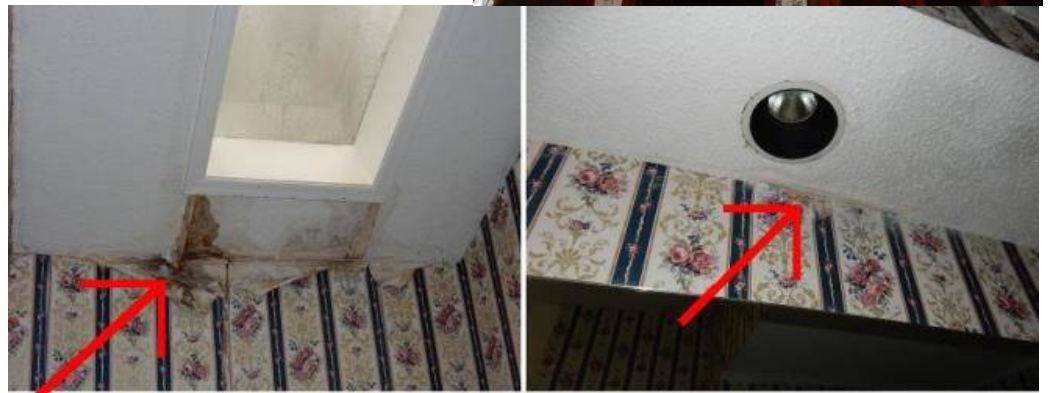
Water stains and repairs noted in the family room and breakfast room ceilings under the master and hall baths. Have the owner address this.

Water damage was noted in the master bath ceiling at the skylight and recessed light. Repair are needed. Also, a mold like substance was noted and should be addressed by a qualified mold contractor. See photo.

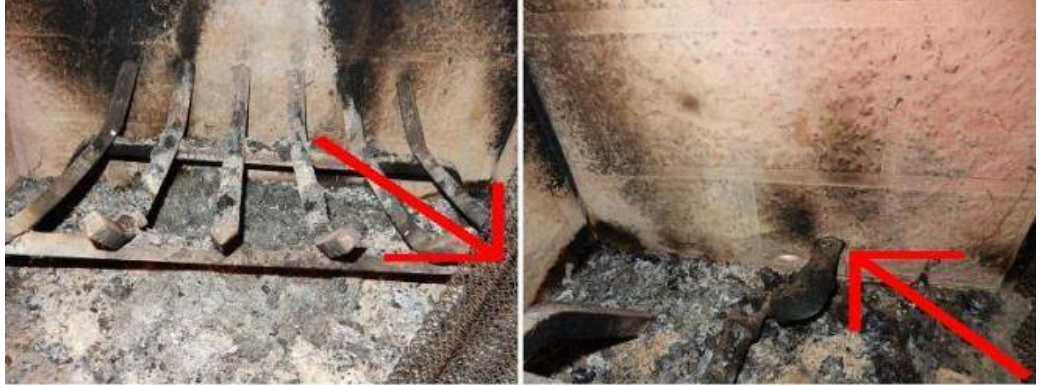
The opening in the side wall at the gas service should be filled with an approved sealant that is recommended for fireplaces and high temperatures.

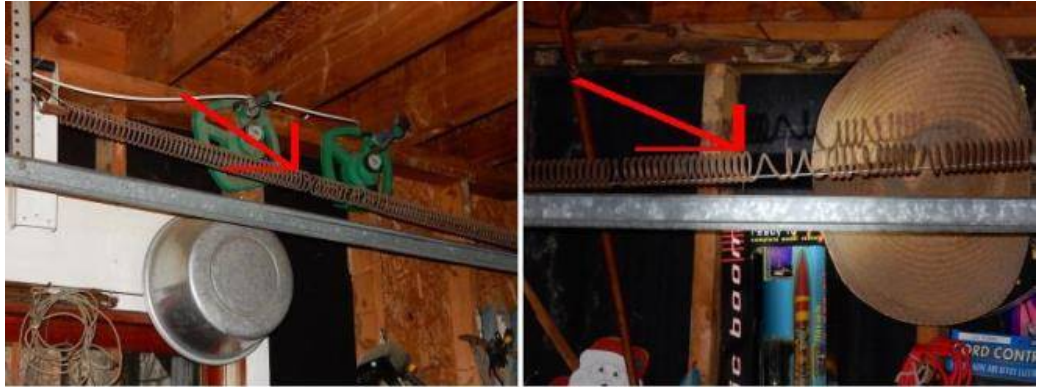
The tension springs on the garage doors are damaged and should be replaced. See photo.

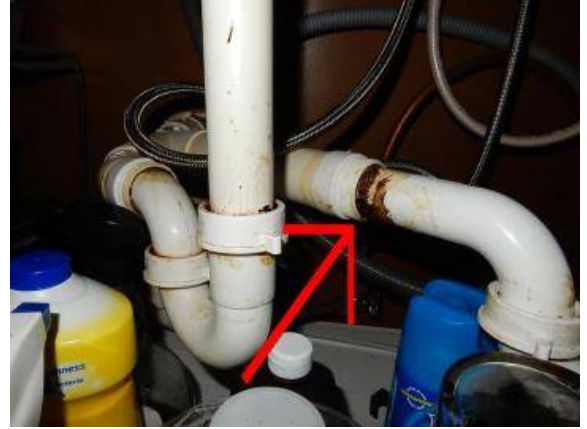
Leak noted under the kitchen sink.
See photo.

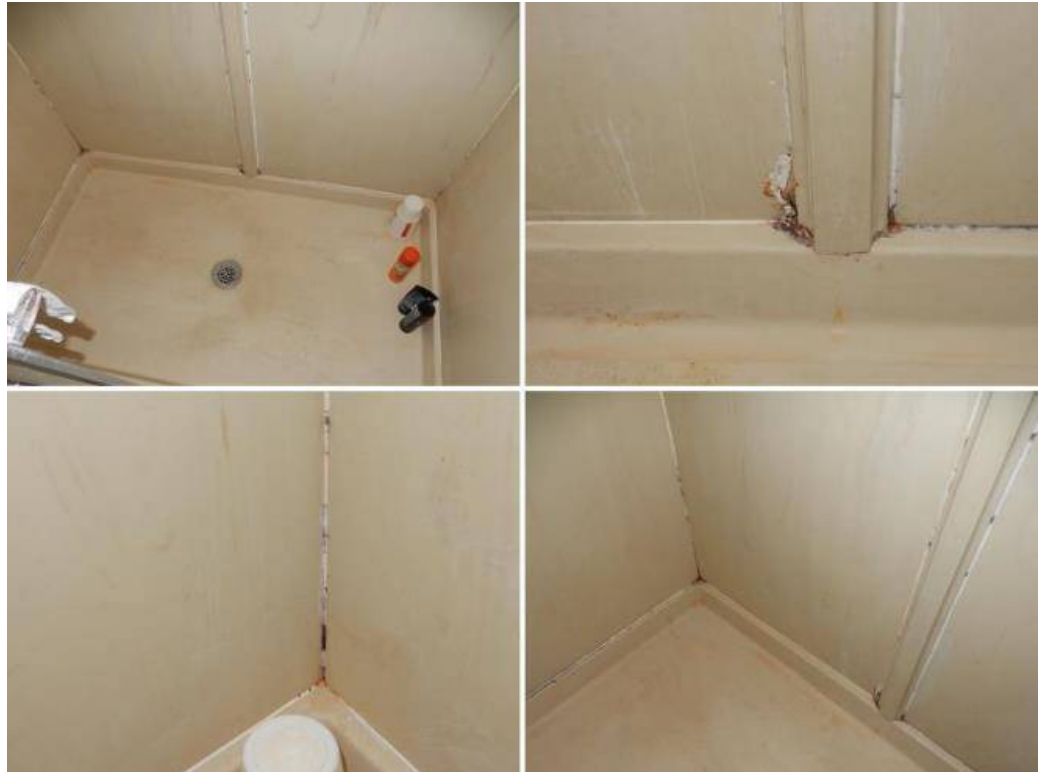
Budget for improving and maintaining the caulking and grouting in the master bath shower stall around the drain and sides to prevent leaking into the ceiling or framing below. NOTE: Water tightness of the shower pan is impossible to determine since normal usage could not be simulated.

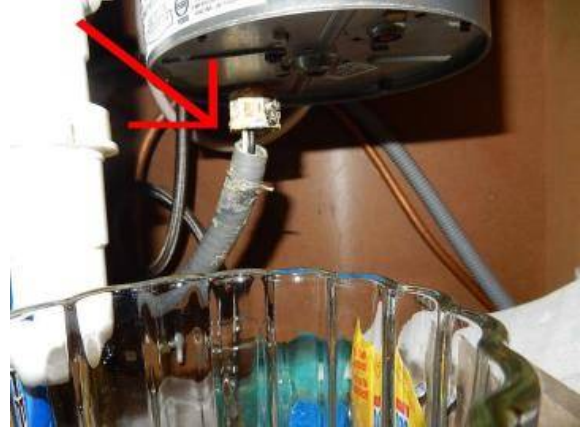
The electrical service to the garbage disposal should be properly secured at the bottom of the disposal. See photo.

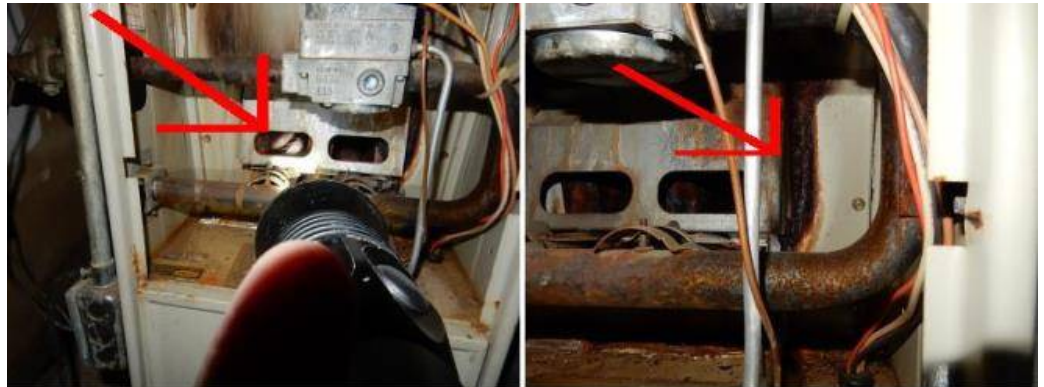
Excessive scale/corrosion/rust flake noted in the heating chamber and around the burners. Burn marks noted on the front of the heat exchanger. Heating chambers should be cleaned. Rust debris removed. The heating chambers should be cleaned and tested for cracks and carbon monoxide leaks by a licensed and qualified HVAC contractor. Budget for replacement. See carbon monoxide alarm recommendations in the report.
