CHRIS CURLES and ASSOCIATES Inc. INSPECTION SERVICES

Inspection Report.

DATE: March xx, 20xx.
CLIENT: Mr. Biz Owner, LP.
SITE: ADDRESS: 400 Industrial Drive.
CITY/STATE/ZIP: Alpharetta, GA 30004.
EMAIL: hcccc@comcast.net.
PHONE: 800.xxx.xxxx.

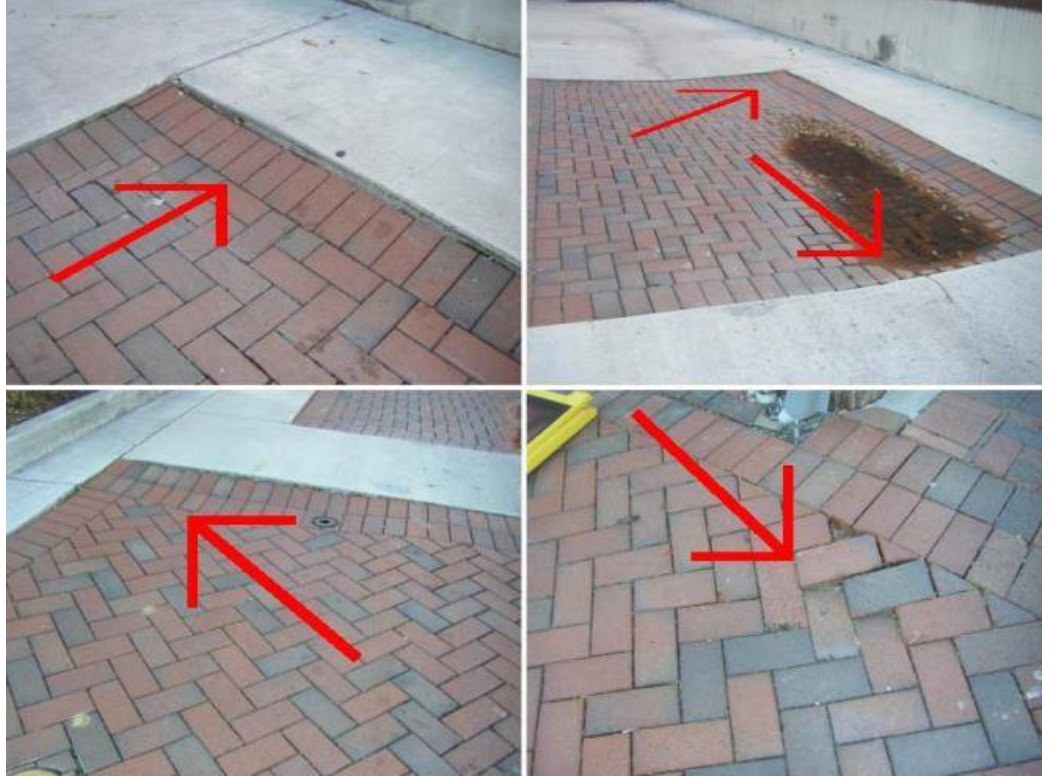
Settlement and brick displacement was noted in several places in the driveway along the right side of the building. The displacement in the bricks is excessive and is causing a trip hazard. (A trip hazard is defined as a change in elevation from one level to the next of more than 3/4". This can be a safety concern when accessing these areas.) See photo. The cause for the settlement and displacement is unknown. However, the common cause is non compacted soil under the affected areas. Also, it could be caused by an underground plumbing leak from the water service or sewer drain. Further investigation will be needed by qualified contractors. The bricks will need to be excavated to expose the soil and water service.

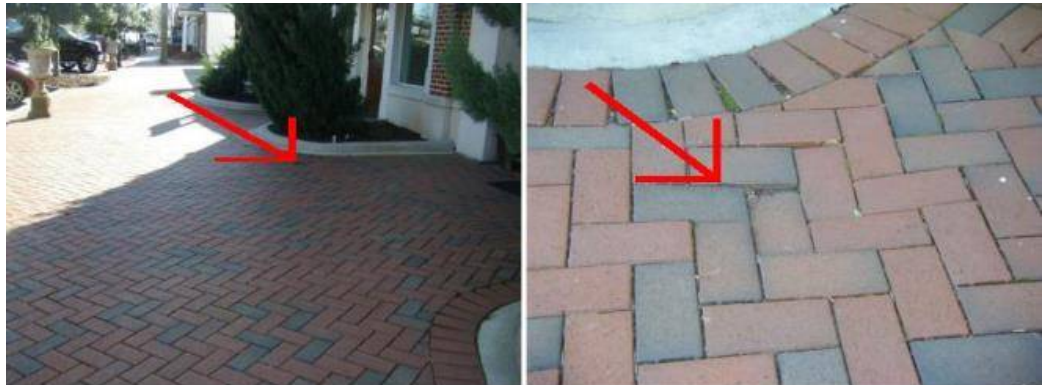
Settlement noted in the sidewalk to the front of the building. The settlement has caused a trip hazard near the front entrance. Correction recommended for safe access. See photo. NOTE: A trip hazard is defined as a change in elevation from one level to the next of more than 3/4". It is unknown if the sidewalk is the responsibility of the building owner or the city. Further investigation will be needed.

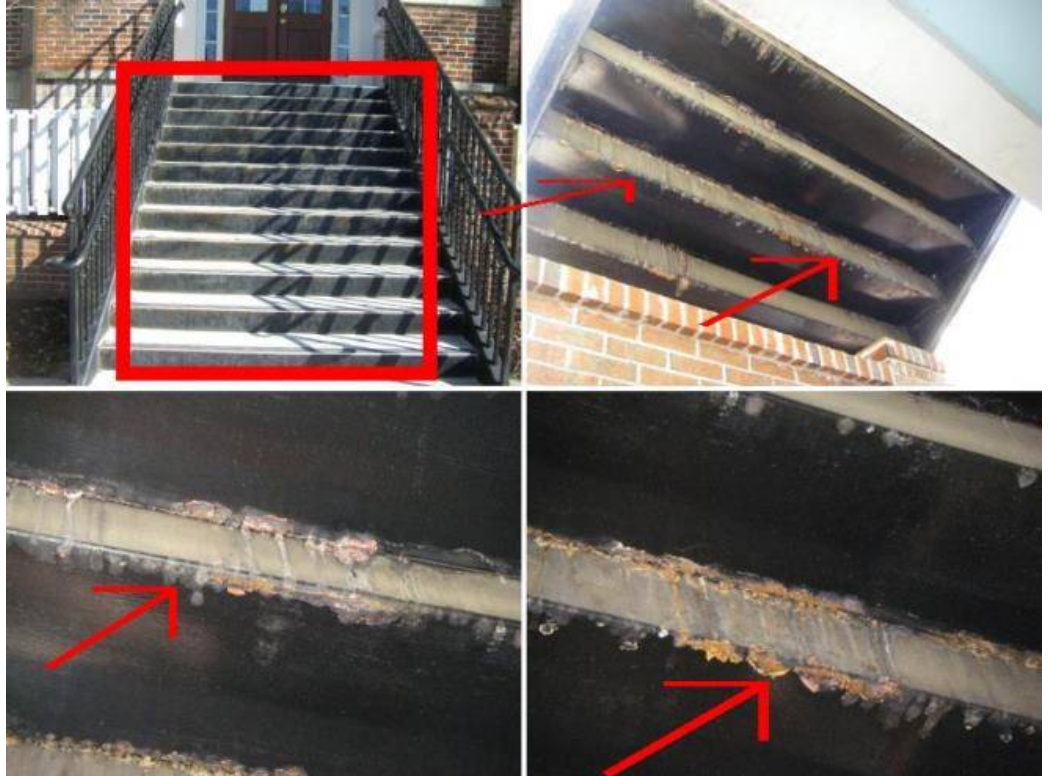
Excessive rust and stains noted under the stairs to the south entrance to the building. This is caused from water seepage from the stairs into the steel framing. The seepage should be stopped before additional rusting or damage is caused. Have a qualified contractor address this. See photos. Damage appears to be minor at this time.

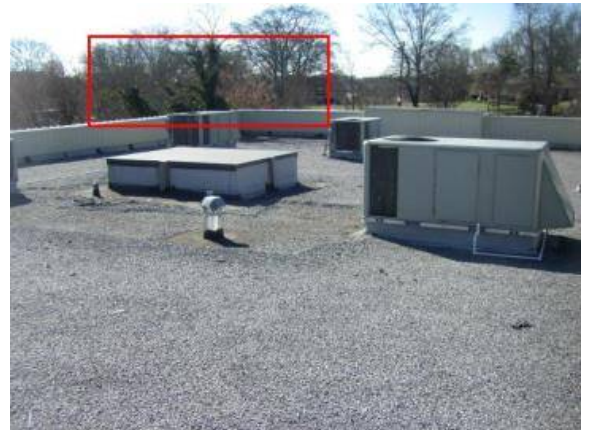
Trees are touching or overhanging the roof at the back left corner of the building. Damage may be possible. Removal or pruning is needed. See photo.

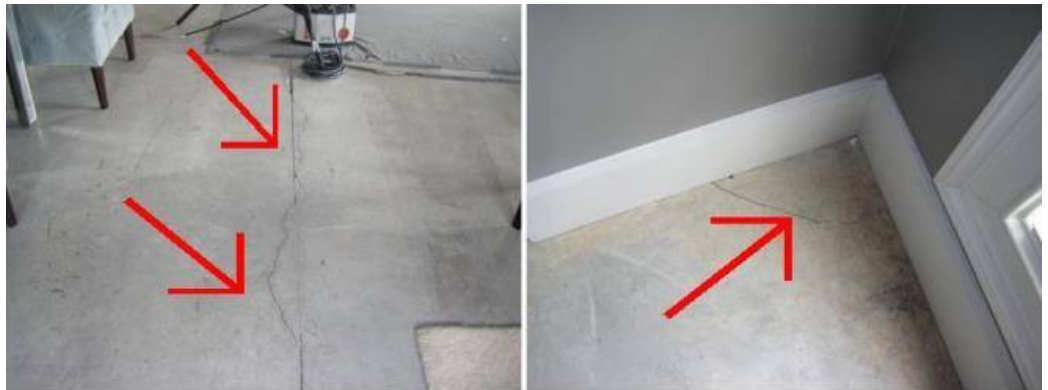
Slab appears serviceable on both floors. Minor settlement/drying cracks noted primarily on the second floor over the parking area under the building. Structure appears to be sound at this time. See photos.

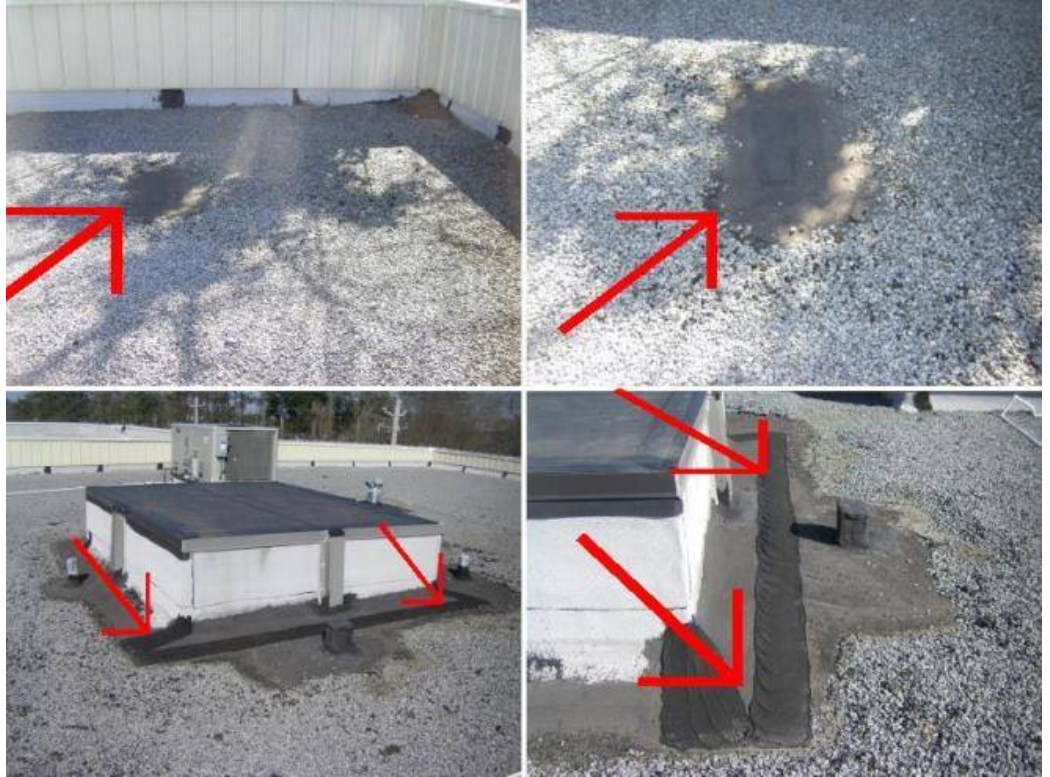
Several repair were observed at the time of the inspection. See photo. Evidence of previous leaking noted in the interior second floor restrooms and in the ceiling tiles in the front office. Other water stains were noted in the first floor ceiling tiles over the restrooms, mechanical room where the server is located and in the lower back offices. The stains were dry at the time of the inspection of 3/12/2014 and at the inspection of 3/13/2014 after rain fall of 3/11/2014. This was determined using Infrared Scanning and a moisture meter.

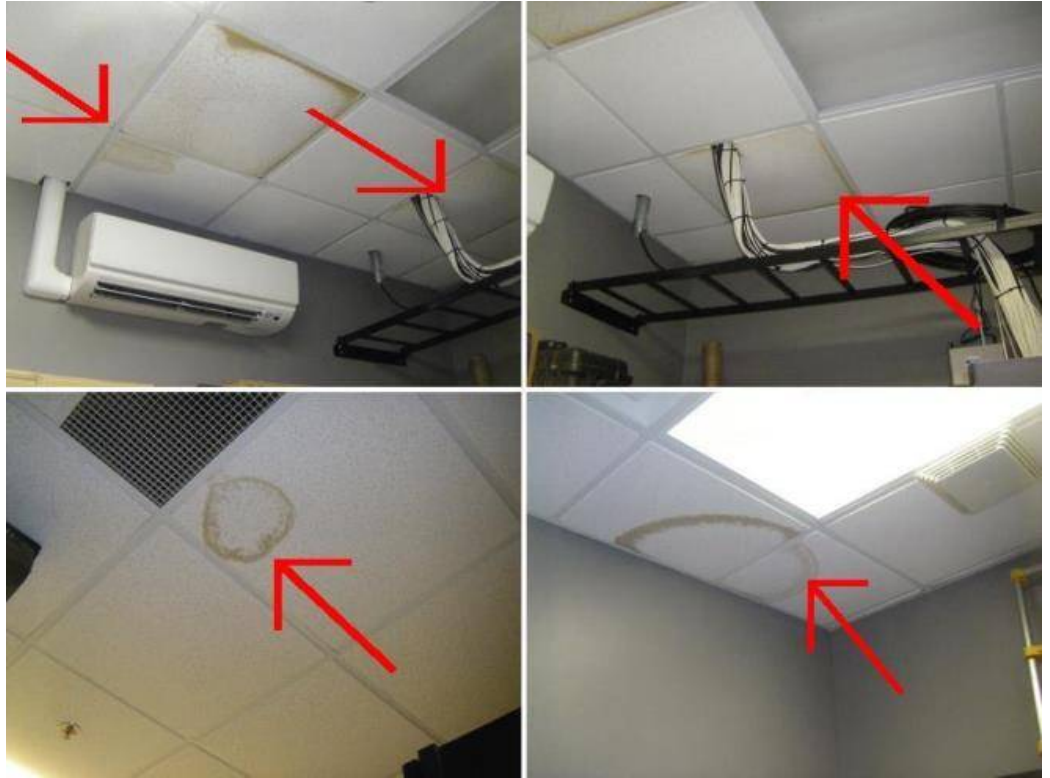
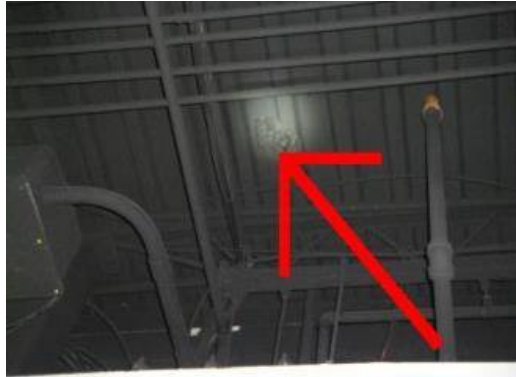
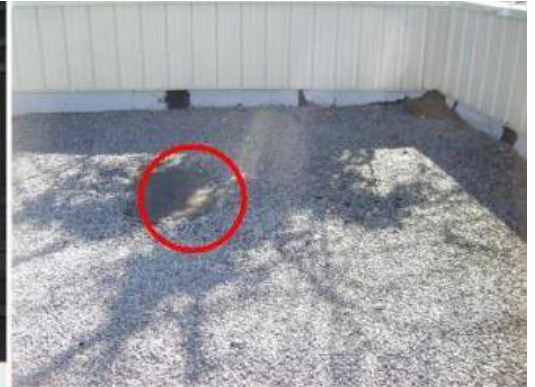
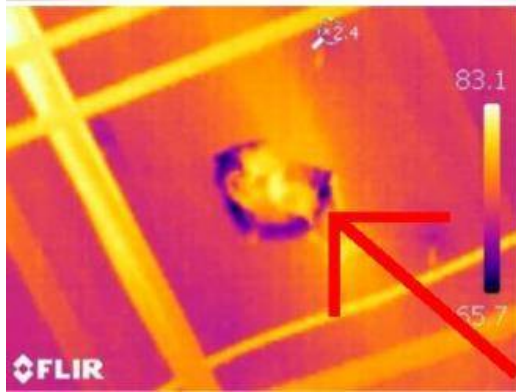
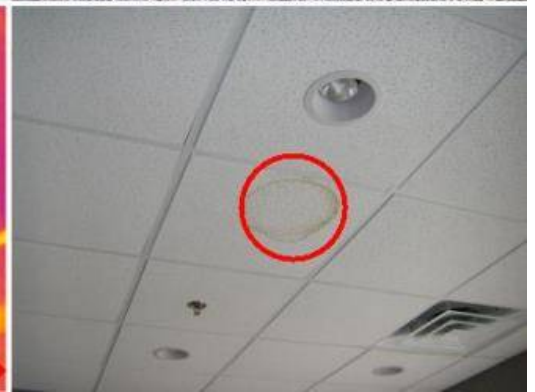
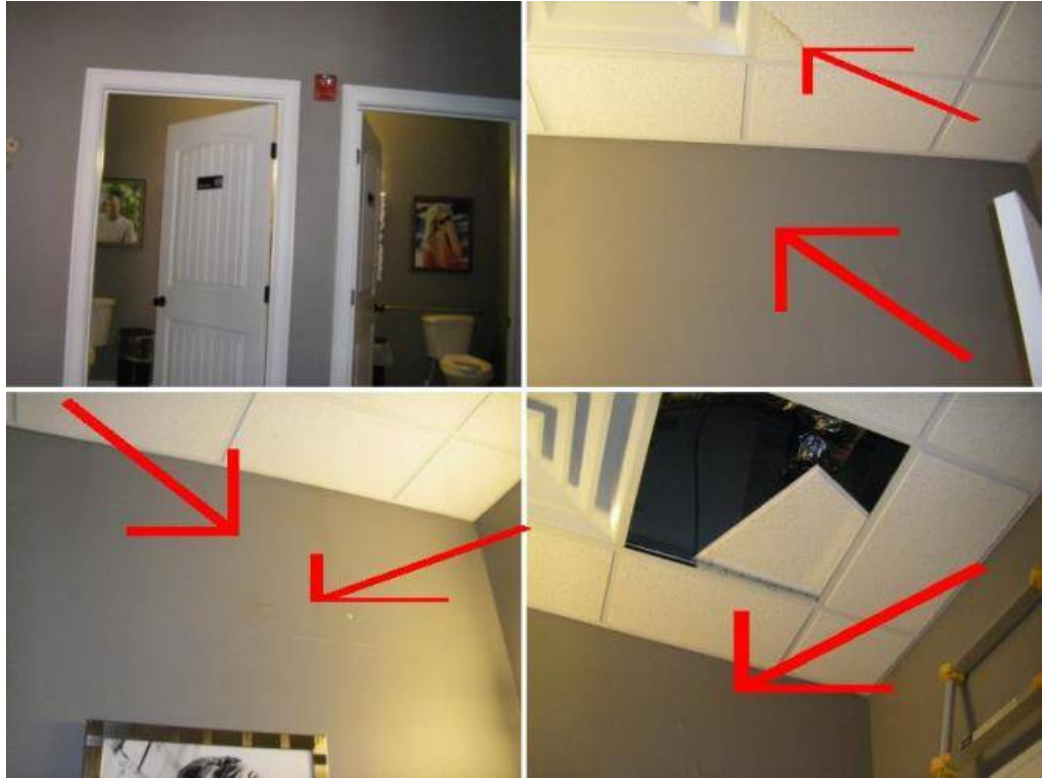
I have attached several photos of the areas in question. Repairs will be needed to the water damaged areas. I suggest you retain the services of a qualified contractor to address the cost of repairs. The photos may not represent all areas of needed repair.

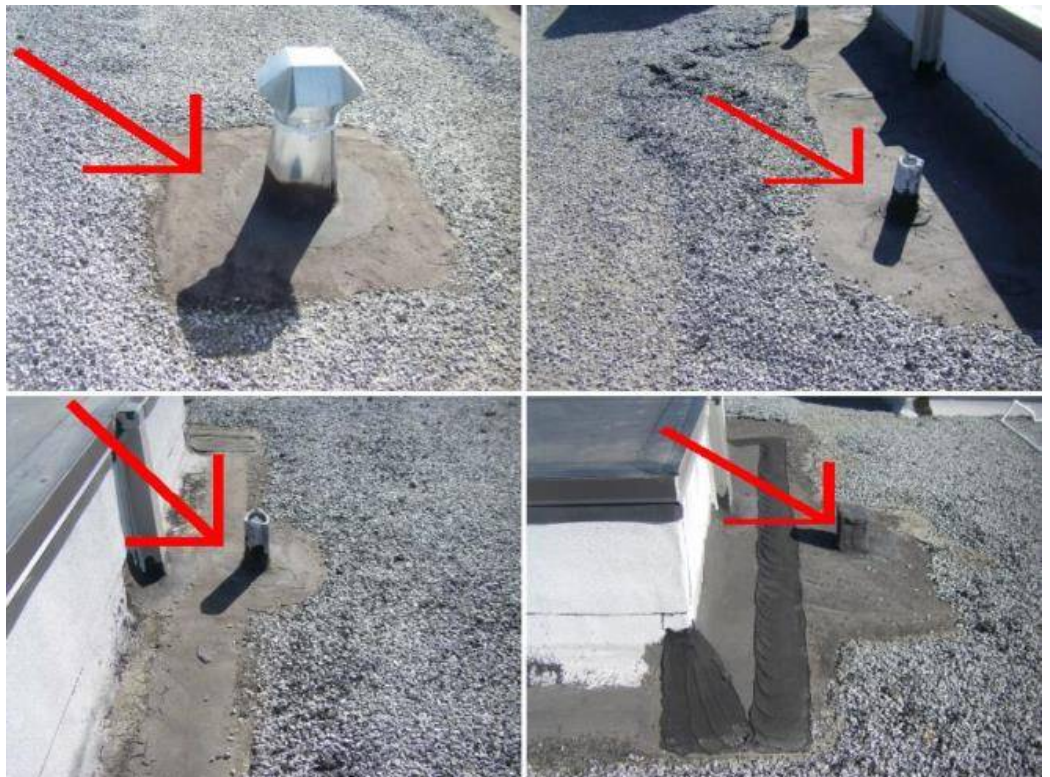
Metal or lead flashing noted on the plumbing vent stacks. Standard metal flashings noted on the combustable vents. Repairs noted at several flashings. It is recommended

that you have the owner provide you with any information regarding any roofing repairs. Flashings appear to be serviceable at this time.

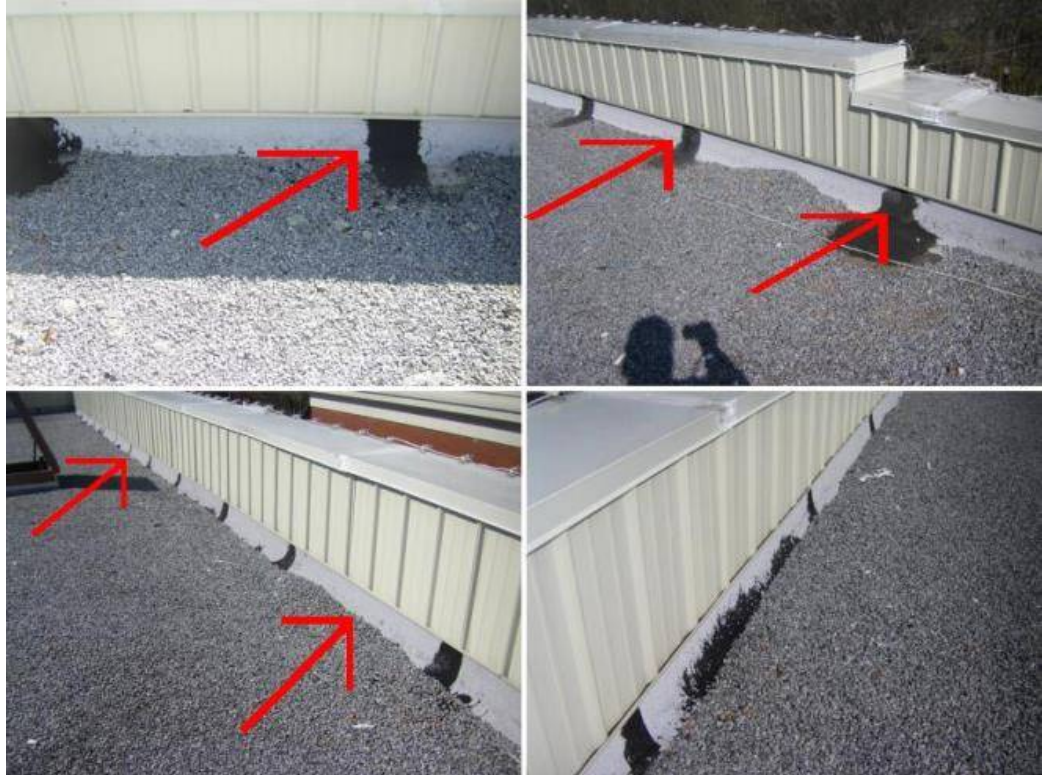
The flashing along the four walls appears to need minor repairs to the vertical seams. See photos. See your roofing report.

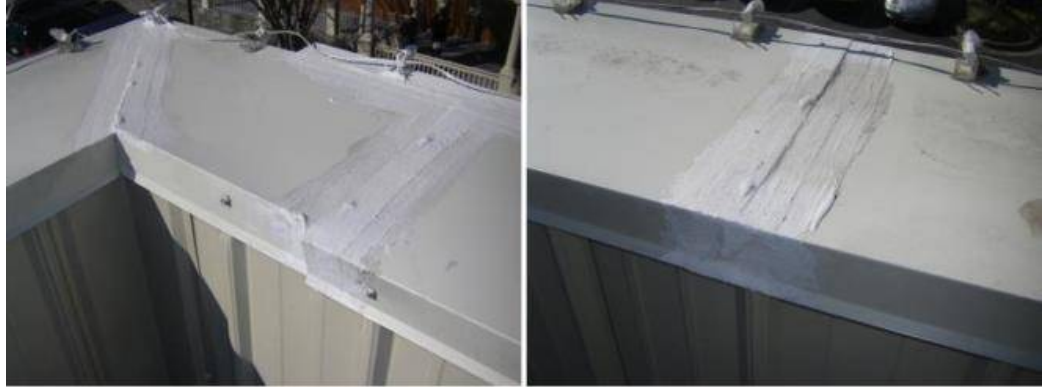
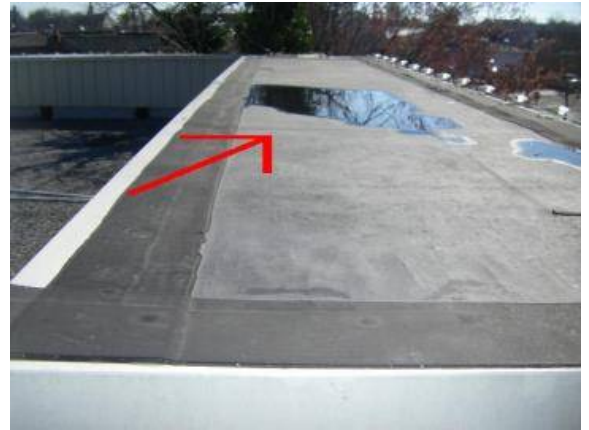
The flashing along the top of the four walls has been repaired in several places. Have the owner address this. See photos. The roofing material on the south roof over the front office appears to be concave and is holding water. Have your roofer address any need to have this area sloped to facilitate the movement of rain water off the roof. See photos.

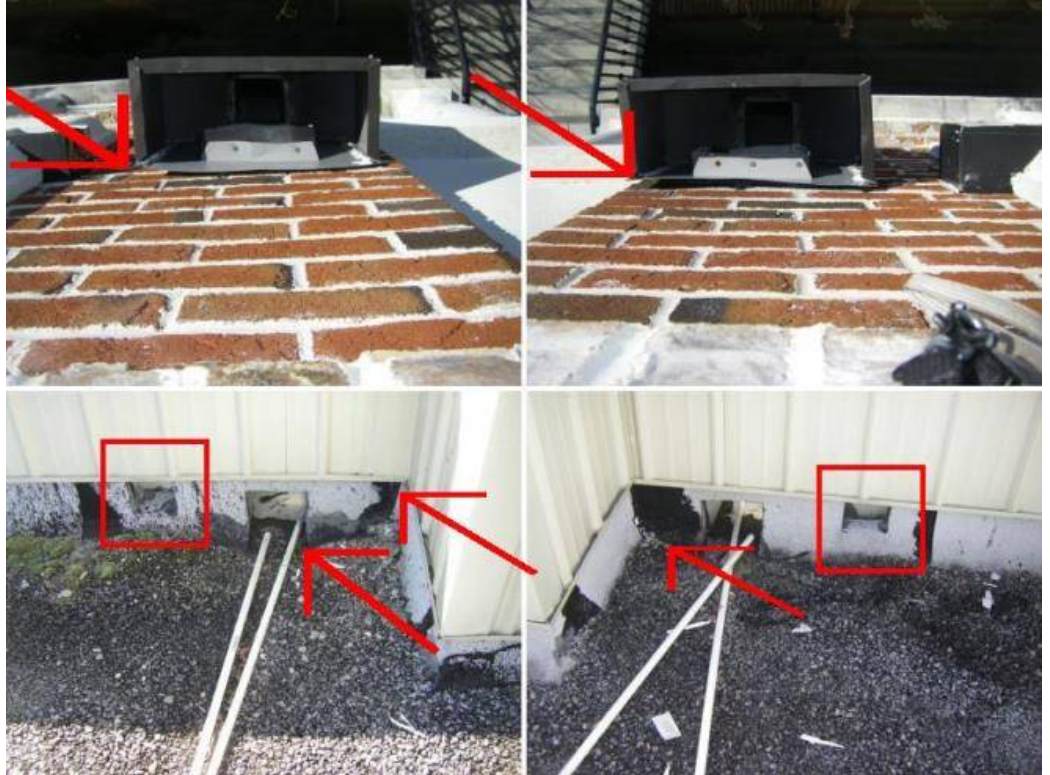
Scupper drains noted along the south wall. The drain boxes are not properly secured to the wall. The openings in the wall should be sealed and maintained to help prevent water intrusion into the wall cavity. NOTE: The two openings in the wall approx 5" off the roof surface, to the right and left of the primary drains are for overflow in the event the main drains stop up. See photos.

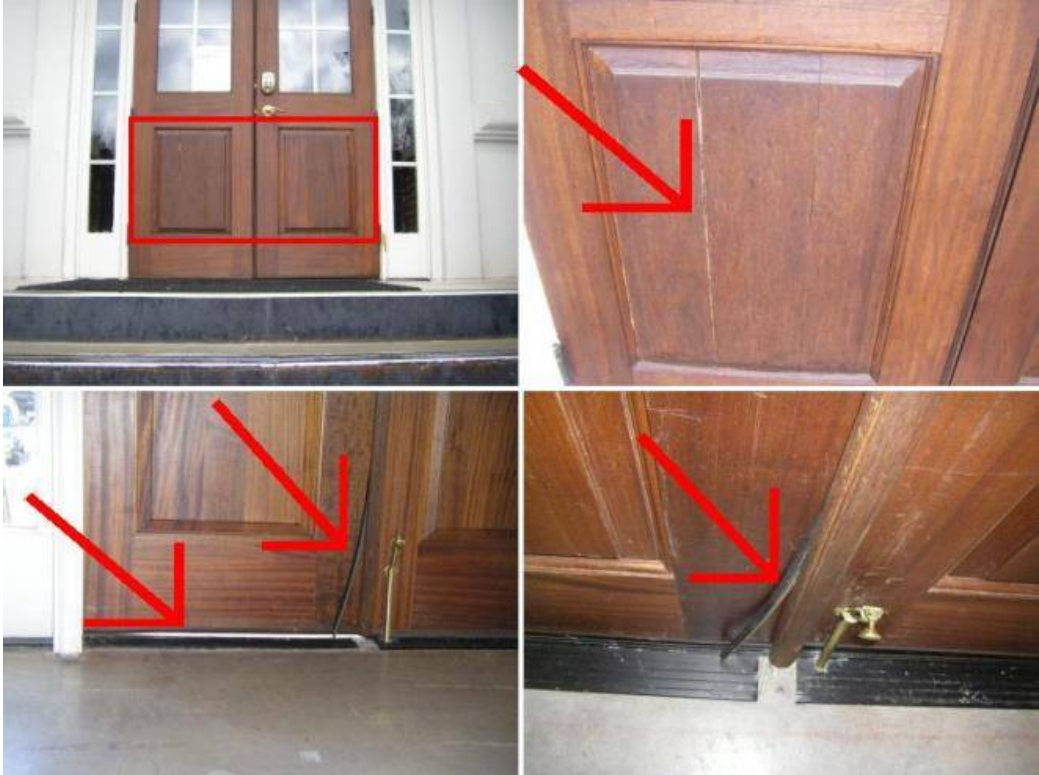
The main entrance door on the south side of the building is in poor condition. Budget for repairs or possible replacement. The panels are cracked. The weatherstripping is in poor condition. Air gap noted under the door. See photo.

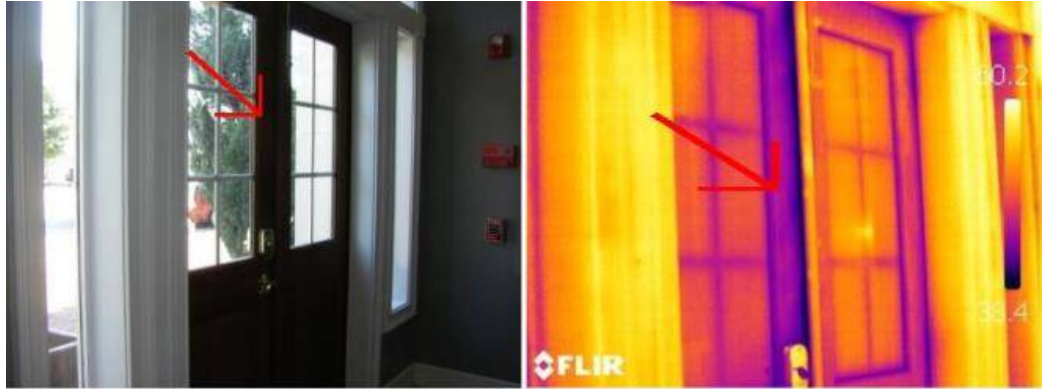
Budget for the minor repair to the weatherstripping at the north entrance main door. The goal of weatherstripping is to prevent rain and water from entering dwelling. A secondary goal of weatherstripping is to keep interior air in, thus saving energy with heating and air conditioning. See Infrared photo.

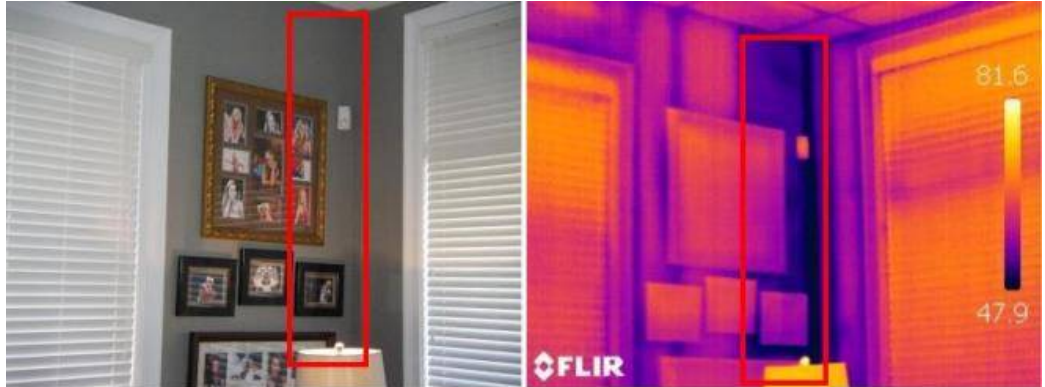
Exterior walls appears to be well insulated for the most part. Insulation is missing in the front right corner office. See Infrared photo. This will be difficult to correct without removing the sheetrock.

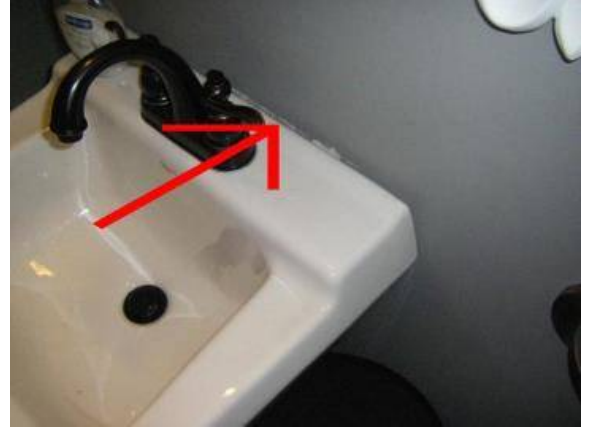
The wall hung lavatories in the several of the restrooms were loose on the wall and should be secured. Minor repair.

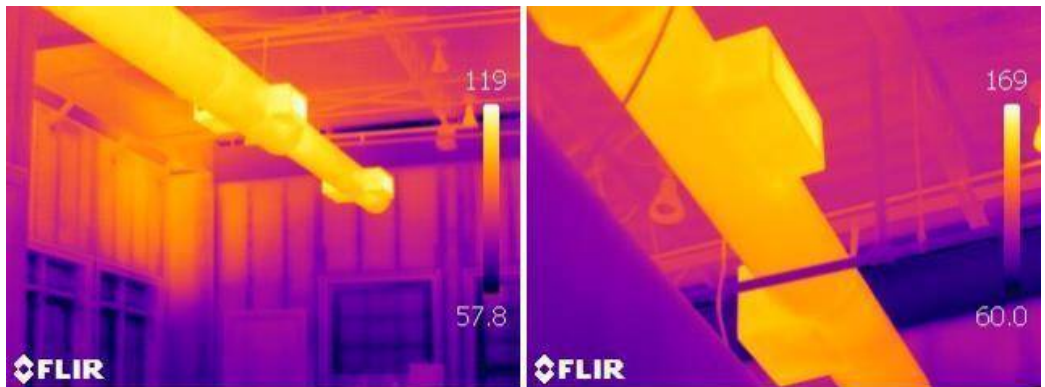
Three of the four HVAC unit on the roof for the top floor appear to be functioning as intended at this time. Minor servicing will be needed. See carbon monoxide alarm recommendations in the report.

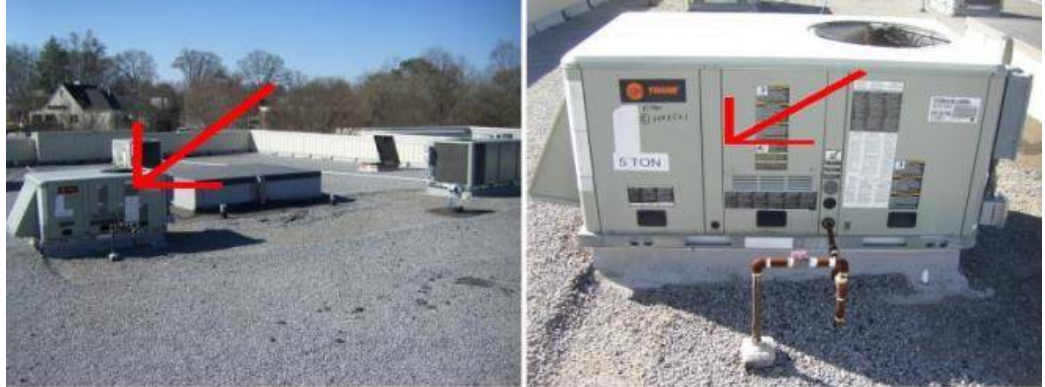
The unit for the top floor south east corner of the building is not functioning as intended at this time. This unit should be serviced by a qualified HVAC contractor. See photo.

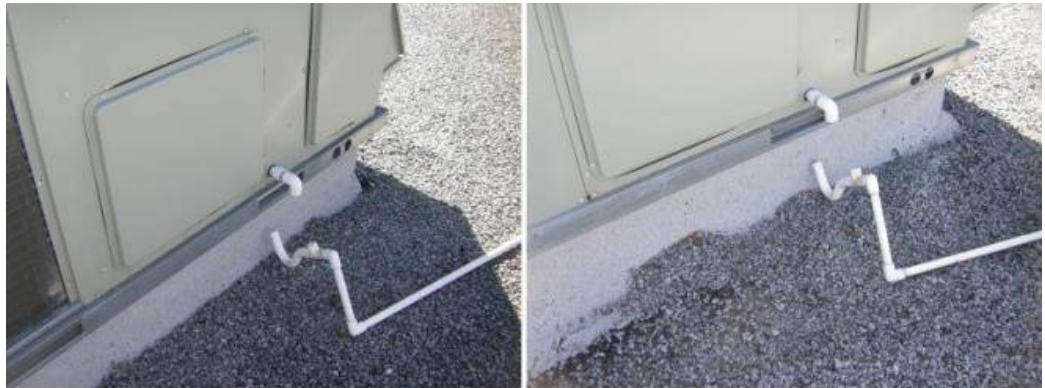
The condensation drains are not connected to the roof top units. Correction is needed by a HVAC contractor. See photo.

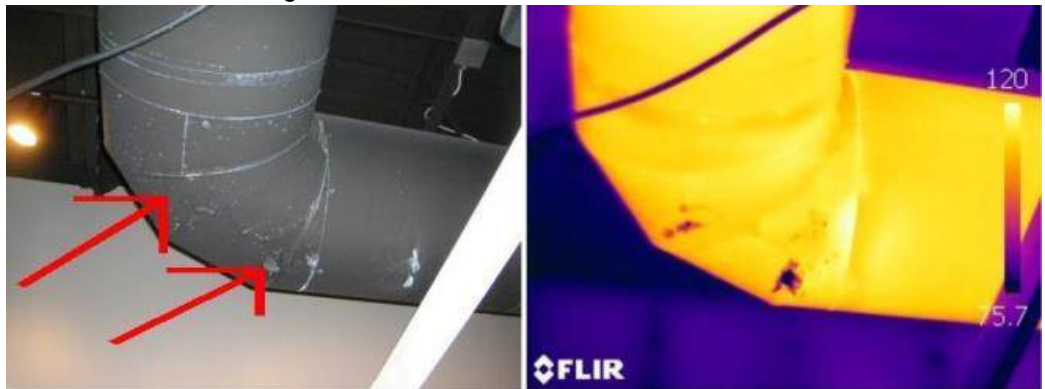
Infrared Scan of an air duct along the north wall on the top floor. The deterioration appears to be caused for condensation inside the duct. Have a qualified HVAC contractor address this.

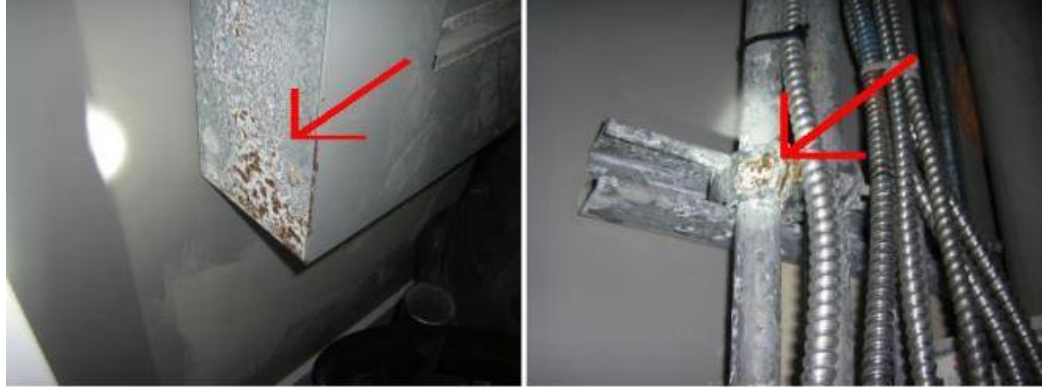
The panel covers were not removed. The potential for arc flash appears high with three of the panels. Excessive rust caused by moisture was noted on the lower floor panel in the utility room and on the conduit above the panel. It is recommended that you have a qualified electrician address this.

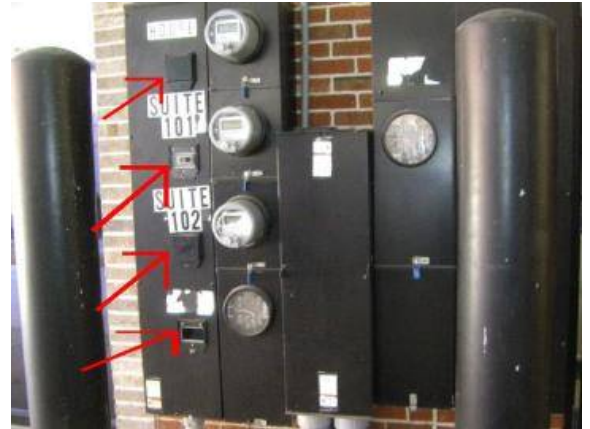
The size of the main electrical disconnect panels are 200 amps each.
Unused openings in the panel are missing covers. **NEC 312.5** -
Openings through which conductors enter the panel shall be adequately closed.

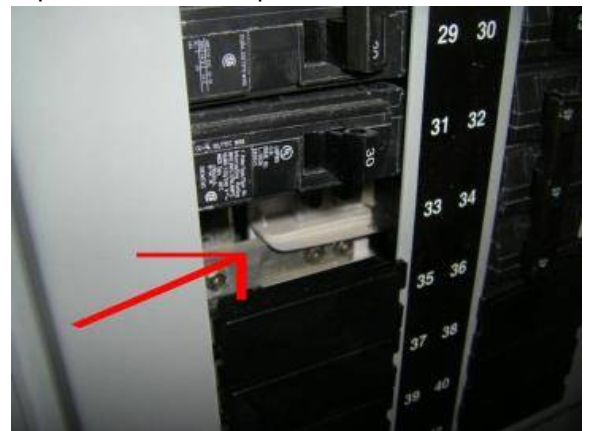
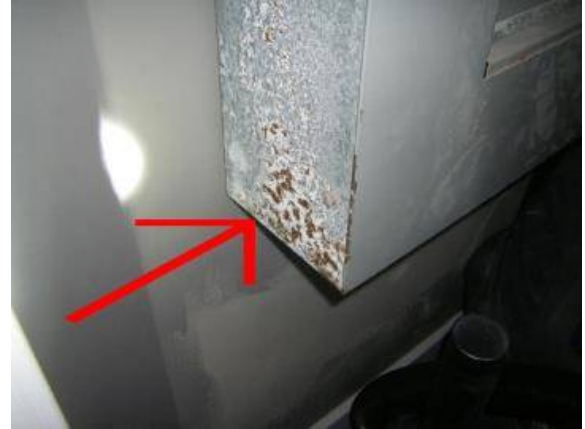
NEC 110.12(B) Damage or Contamination- Internal parts of electrical equipment, including busbars, wiring terminals, insulators, and other surfaces, shall not be damaged or contaminated by foreign materials such as paint, plaster, cleaners, abrasives, or corrosive residues. You may want to have your electrician inspect the panel to determine what corrections are needed.

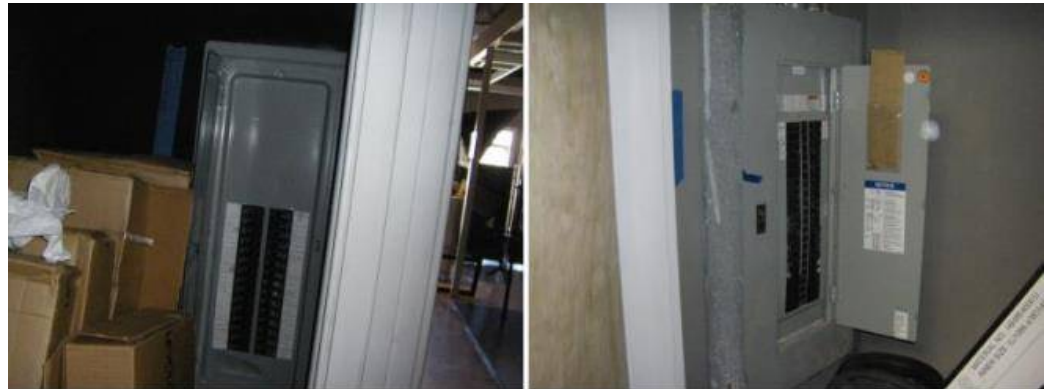
Light are required in the utility closets where electrical panel are located for safe access. The top floor utility closet and the first floor storage/ utility room are without light fixtures. Have a qualified electrician address this.
