# CHRIS CURLES and ASSOCIATES Inc. INSPECTION SERVICES

## First ABC Corp.

DATE: August 28, 20xx  
CLIENT: First ABCCorpxxxx address  
Suite 123  
Duluth, GA 30096.  
SITE: ADDRESS: 2First ABCCorpxxxx address  
Suite 123..  
CITY/STATE/ZIP: Duluth, GA 30096.  
EMAIL: [fABC@hotmail.com](mailto:fABC@hotmail.com).  
PHONE: \_\_\_\_\_

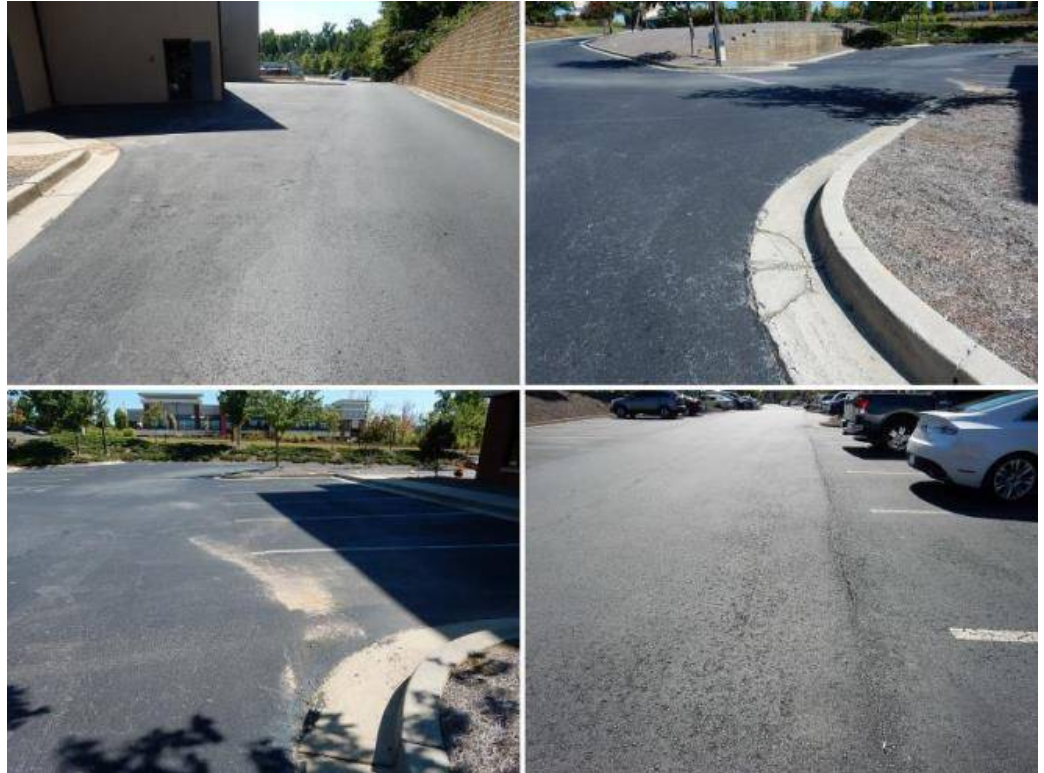
The driveway appears to be in good condition at this time. Cracks noted appear to be normal.

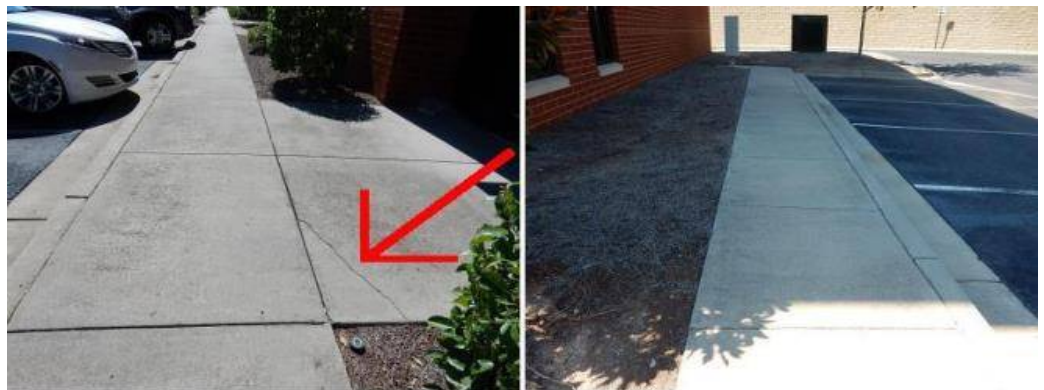
The sidewalk appears to be in good condition at this time. Cracks noted appear to be normal.

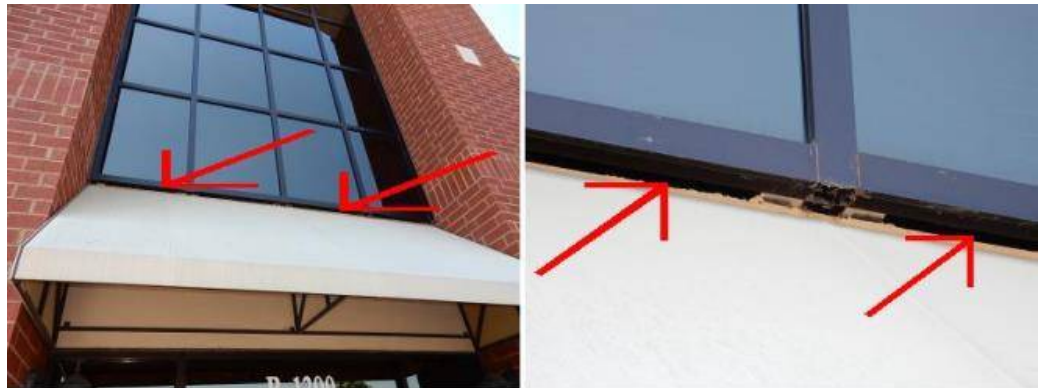
The gap above the front entrance awning should be filled to prevent insects from entering the wall or building. See photos.

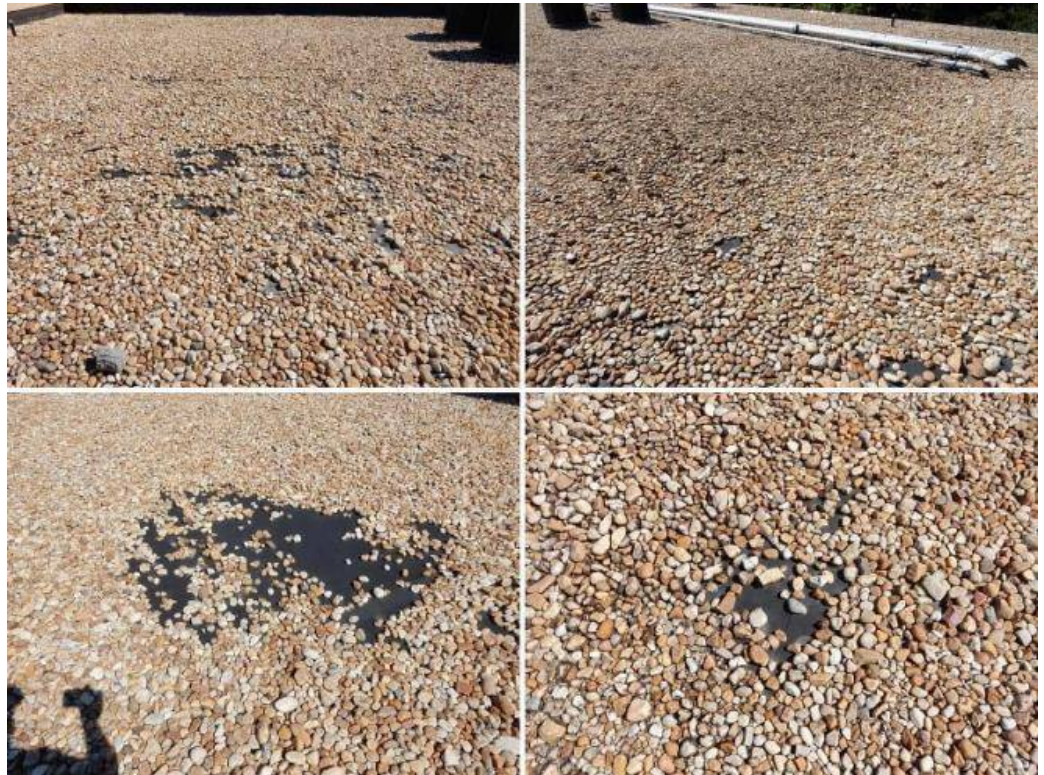
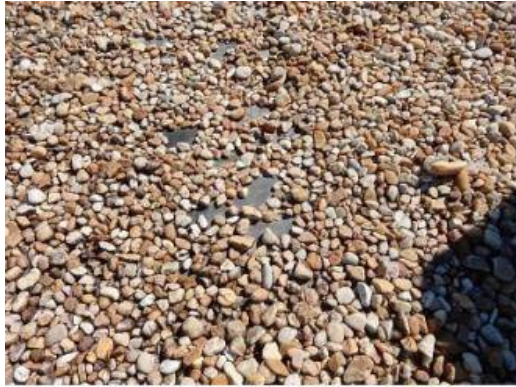
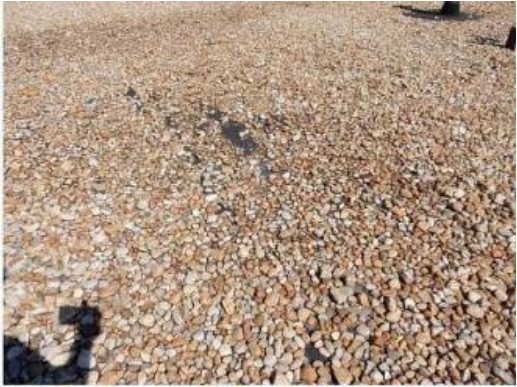
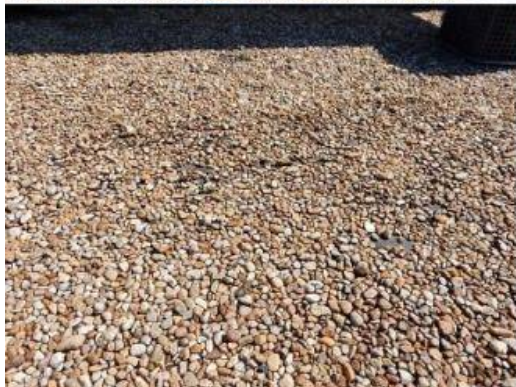
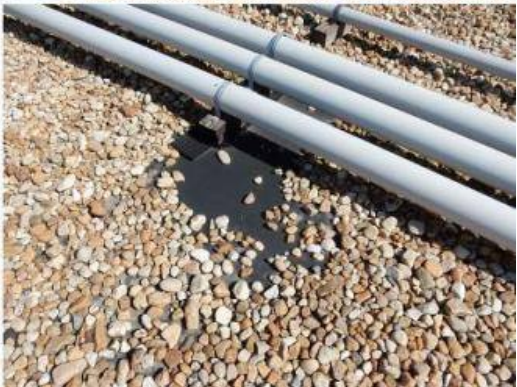
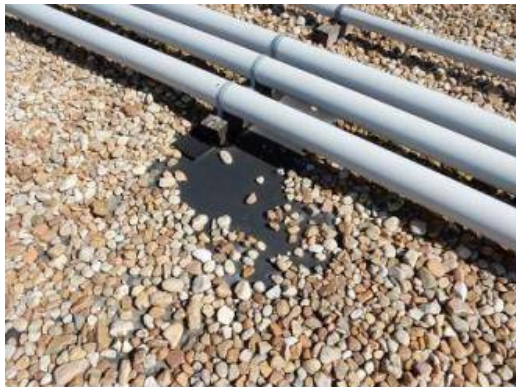
The gravel is missing in several places. Also, a low area was noted in the roof, back center. See photos. Have the POA provide you with any information regarding pending assessments for repairs to the roof. A licensed and qualified roofing contractor should be called to make further evaluation and repairs as needed.

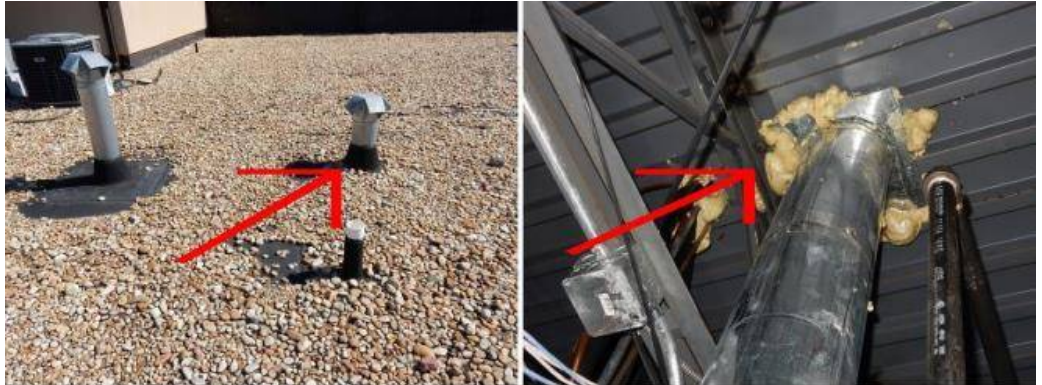
Evidence of previous leaking noted at the vent flashing as noted in the photos. An attempt has been made to repair this problem from the inside with expandable foam. The repair should have been made from the outside by a qualified roofer. Have the POA or seller address this. See photos.

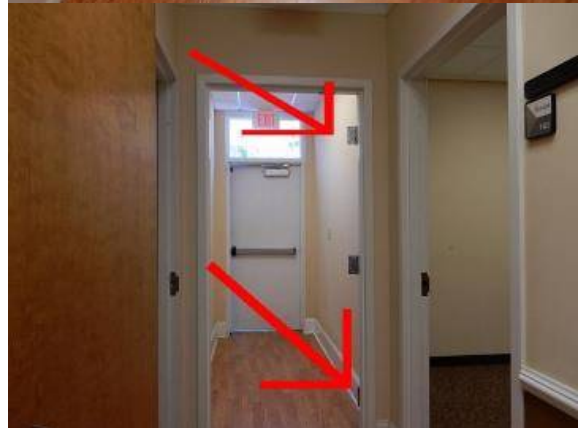
The hall door at the back of unit 1300 is missing. See photos. Have the seller address this. This should be a self closing door.

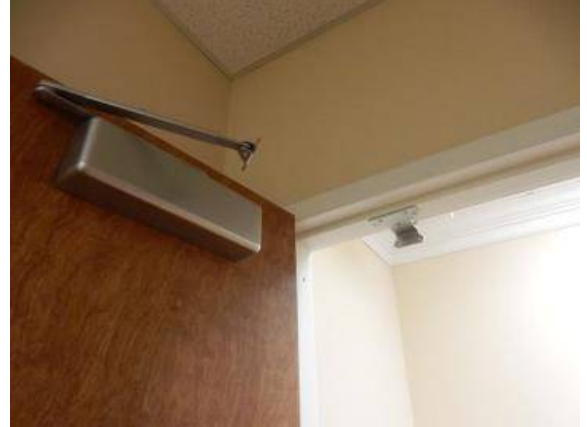
Door closure not connected to the door in the back of unit 1200. Second floor.

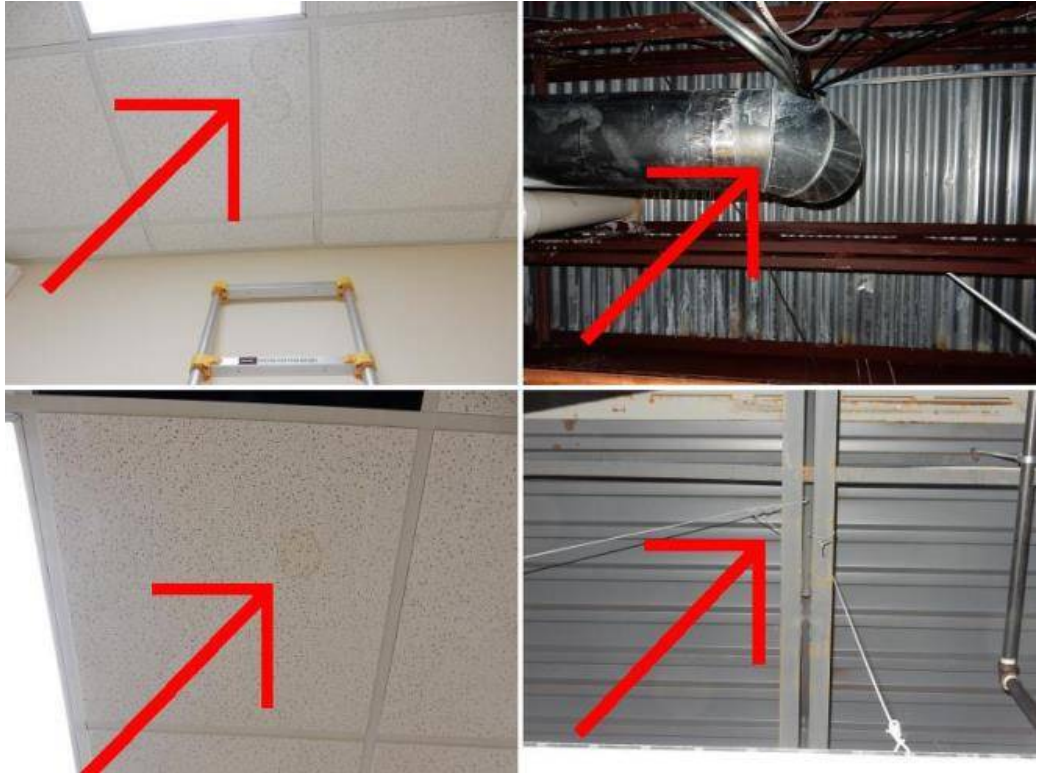
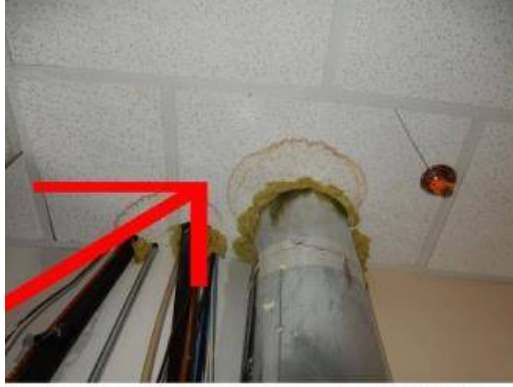
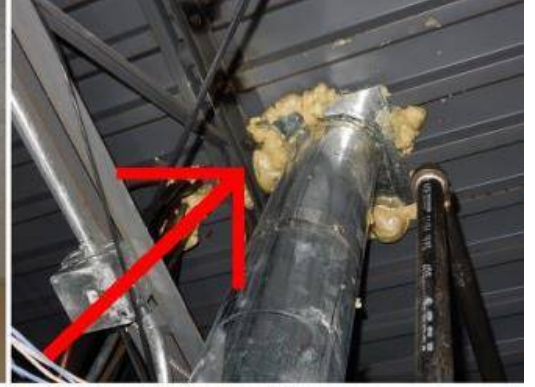
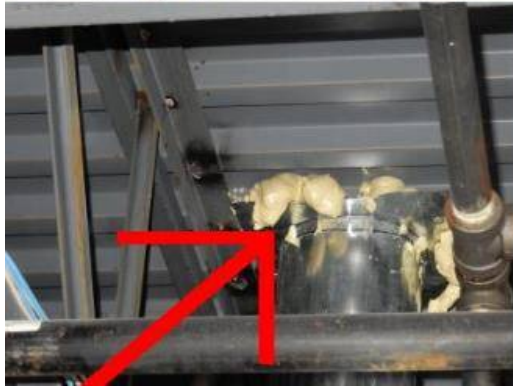
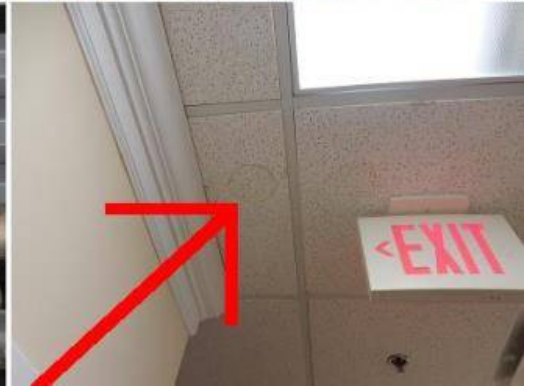
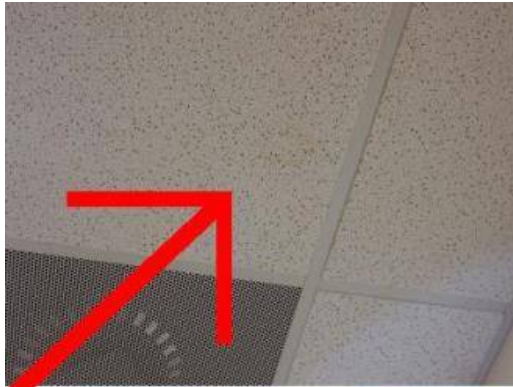
Water damage ceiling tiles noted in several offices and bathrooms on both floors. The cause for the majority of the water damage appears to be roof leaks. Unable to determine if active leakage exists. See photos. Have the owner address this. You should have a qualified roofer address this.

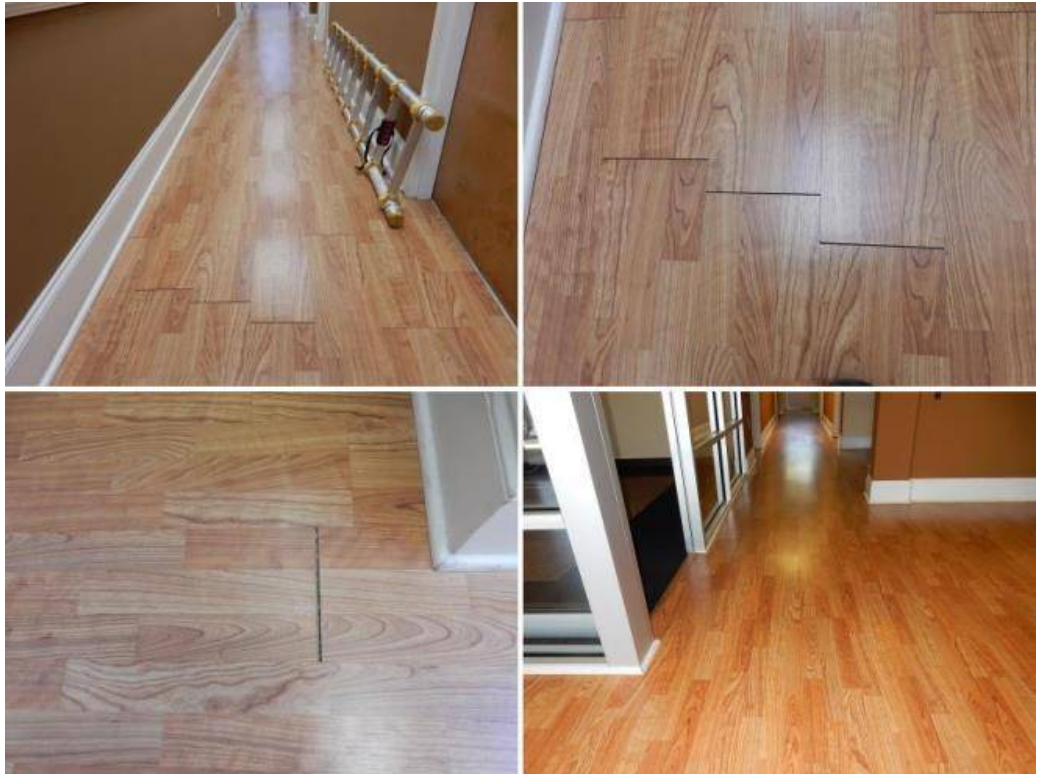
Wood and carpet flooring noted in the building on both floors. Loose wood flooring noted throughout the lower floor. The wood flooring is laminated. It appears the flooring was not properly glued to the cement slab. You should have a qualified contractor investigate this to determine what correction will be needed. See photo.

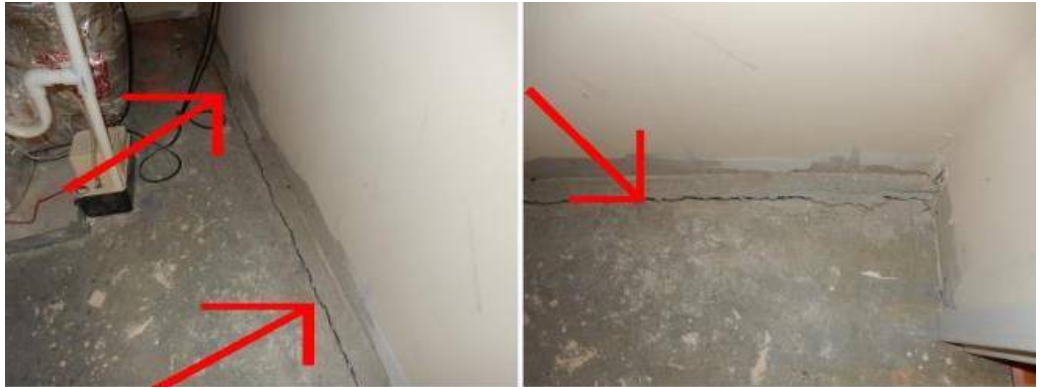
Separation or displacement crack noted in the utility room floor, second floor unit 1300. Could not determine the cause. You should have a qualified structural engineer and or the owner provide you with further investigation regarding this. See photos.

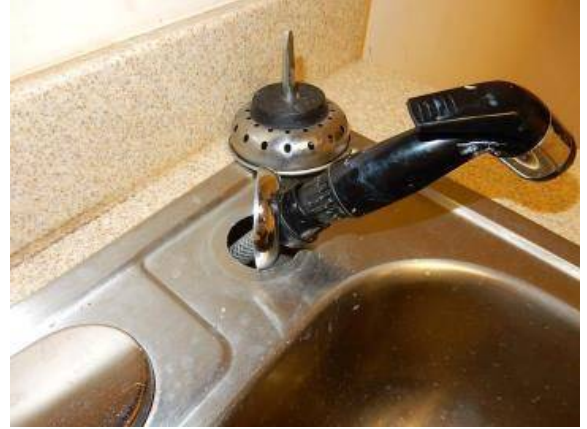
The spray hose is not properly connected in the front left kitchen area. See photo.

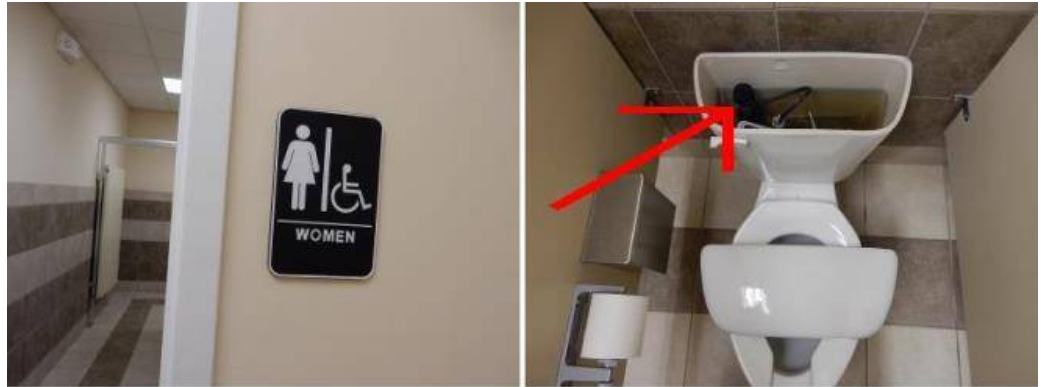
Flush valve will not turnoff in the woman's restroom, main floor.

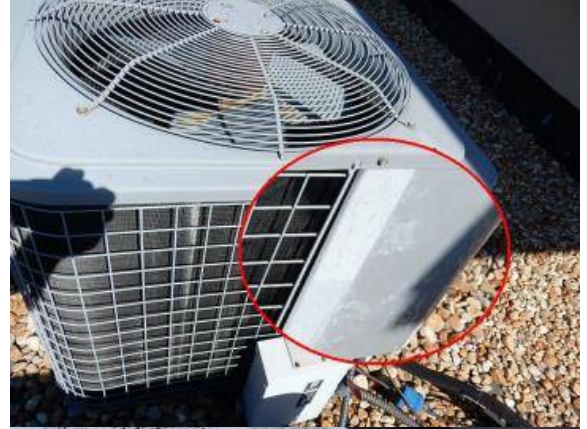
Appears to be the original. However, the inspection plate was not legible. See photo.

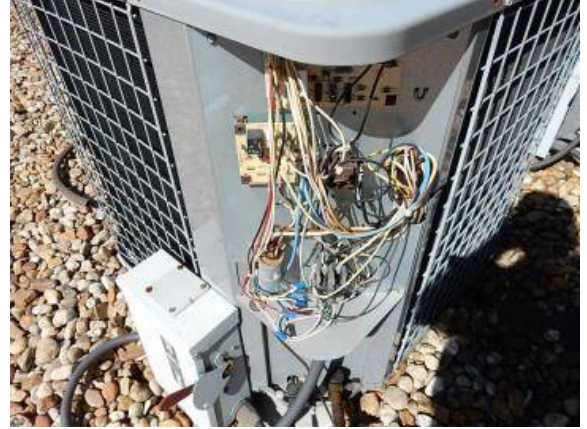
The cover that covers the wiring and controls was off. It appears there has been a repair. Have the owner address this. See photo.

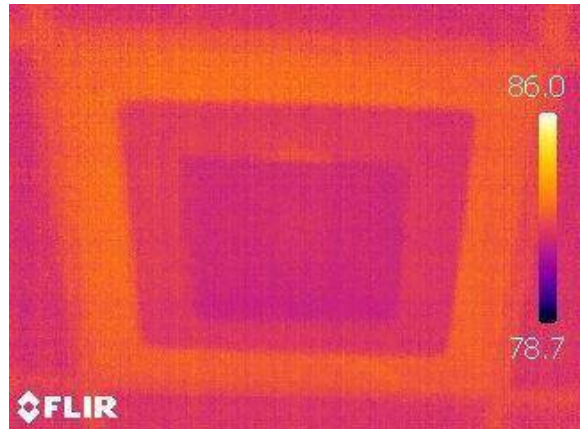
240 Volt.  
Unknown.  
The A/C unit for the upstairs back rooms was not functioning at the time of the inspection. Further investigation needed. Have the owner address this.

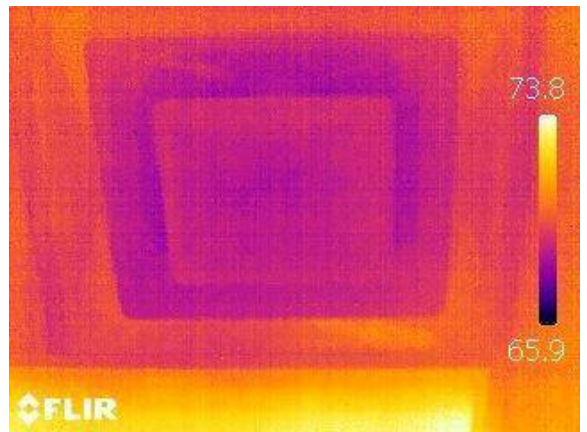
**POWER SOURCE:** 240 Volt.  
**MANUFACTURER:** Unknown.  
**CONDITION:** A/C unit is not cooling properly. Refrigerant appears low. Recommend servicing A/C system and checking for refrigerant leaks.

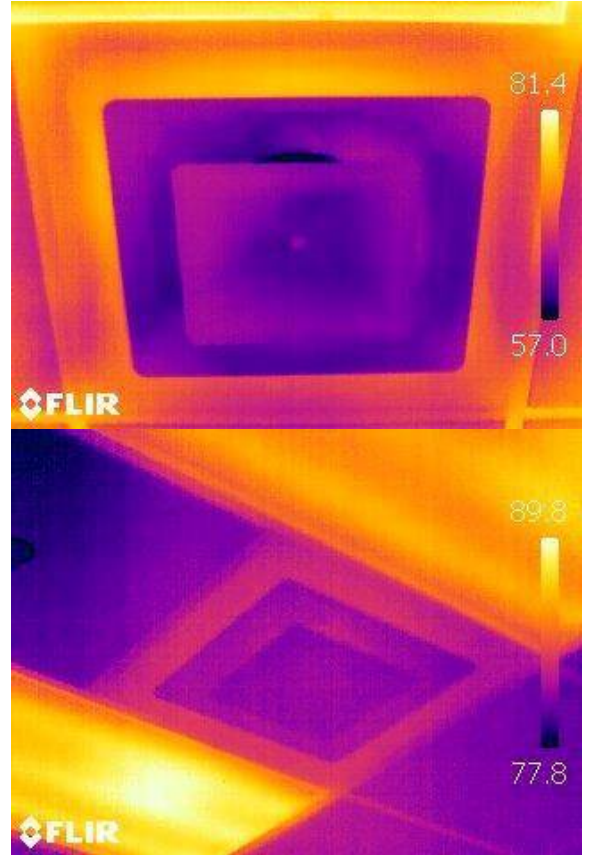
The A/C unit # 8 for the upper back are of unit 1200 was not functioning at the time of the inspection. Have a qualified HVAC address this.

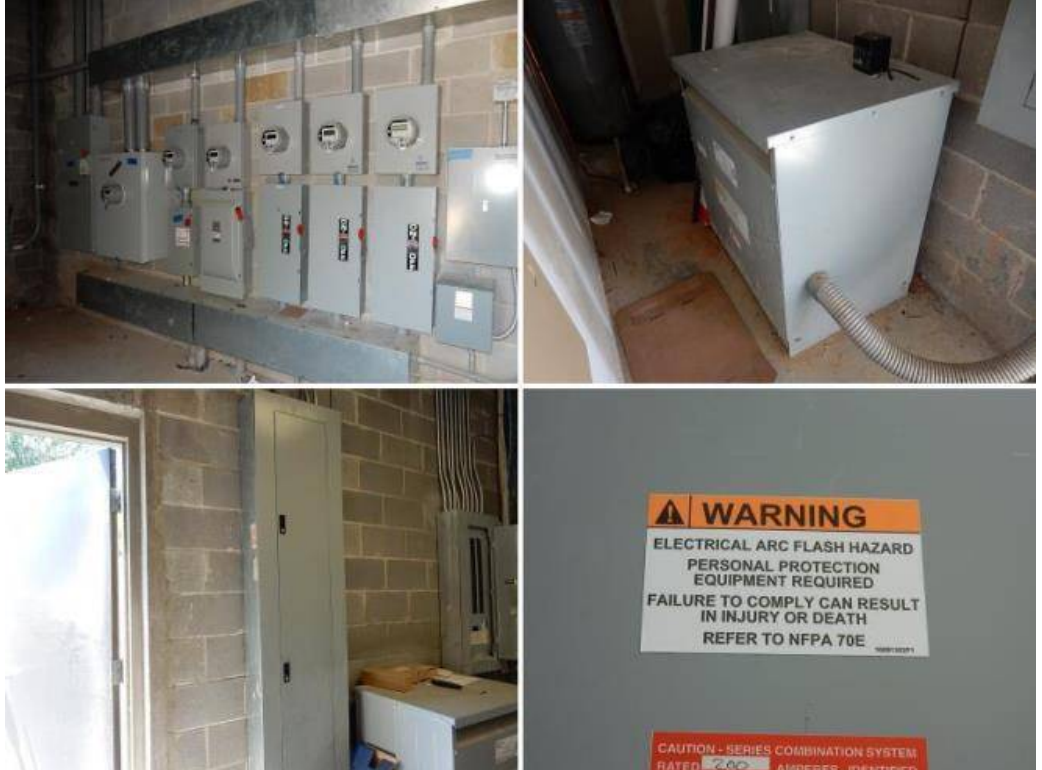
The large electrical panes in the utility rooms, the two large transformers and the electrical disconnects in the electrical room were beyond the Scope of Serviced and were not inspected. See photo. Have a Licensed and qualified electrician address this. The utility rooms are in the back of 1200 and 1300.

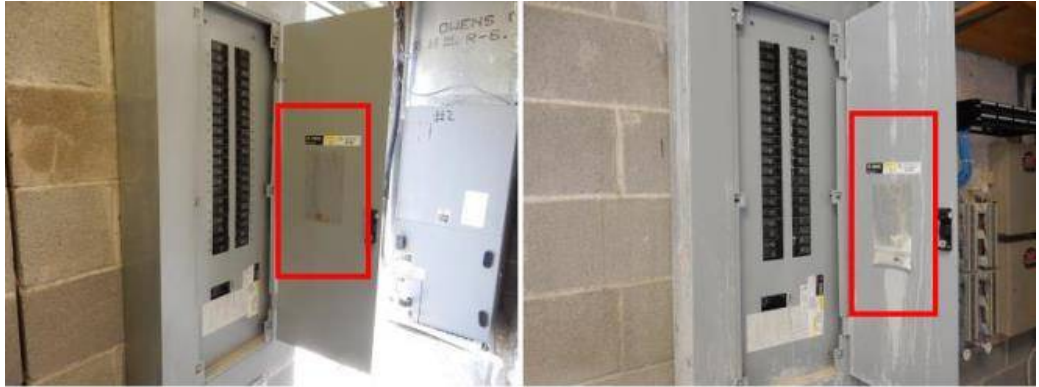
Panel is without the benefit of complete labeling. All circuits should be labeled for the benefit of the occupants.

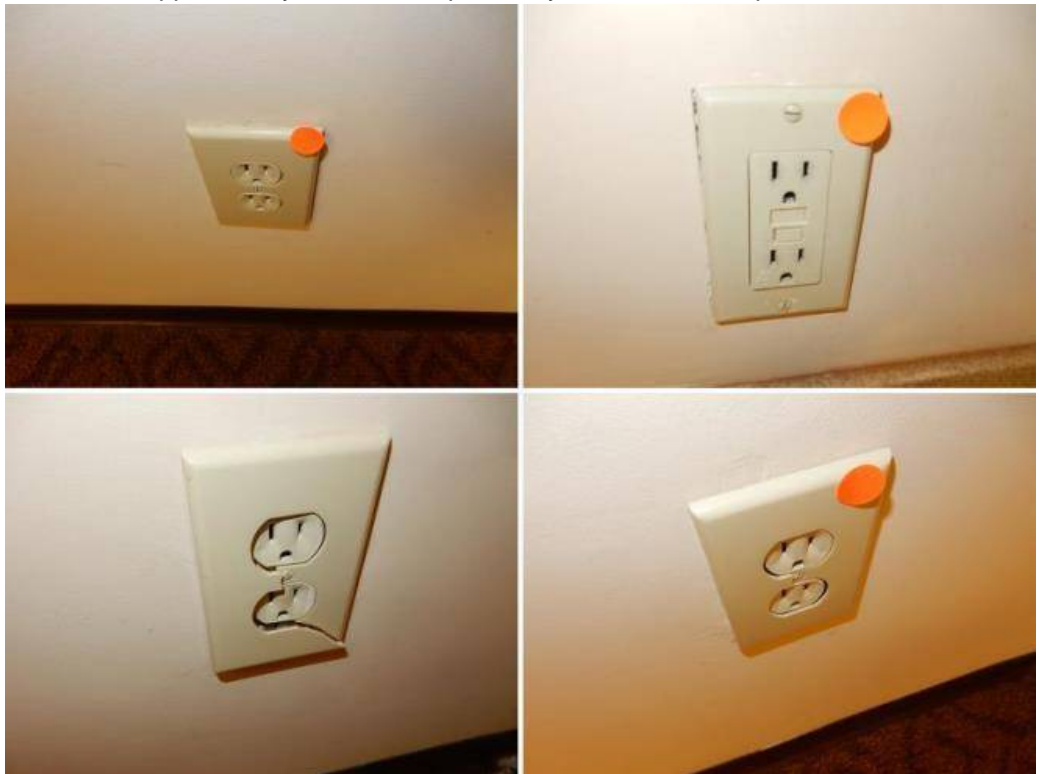
Loose wall receptacles noted in several areas of 1200 and 1300. Loose receptacles, outlets and wall switches can be hazardous. Movement can damage the wires and/ or receptacle, resulting in arcing. Have a licensed and qualified electrician make further evaluation and corrections as needed.

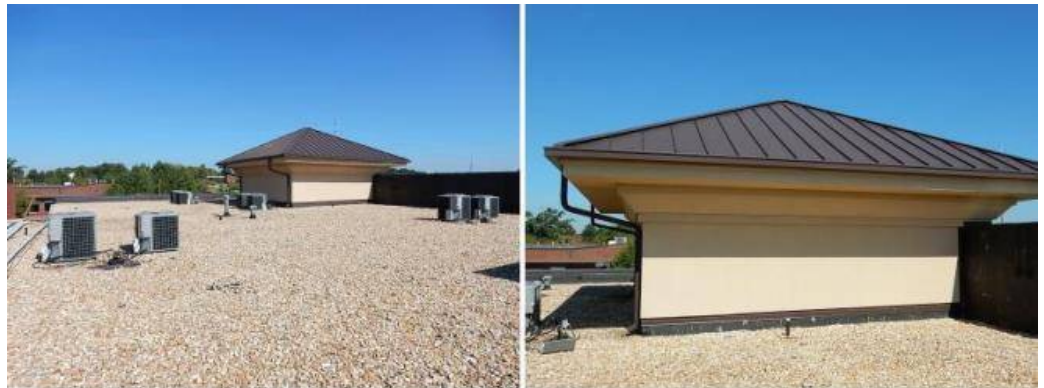
It is unclear what purpose the structure serves on the roof over unit 1200. See photo.
