# CHRIS CURLES and ASSOCIATES Inc. INSPECTION SERVICES

## Inspection Report.

DATE: March 20xx.  
CLIENT: Mr. J. Doe  
SITE: ADDRESS: 1xxx .Address  
CITY/STATE/ZIP: Atlanta, GA.  
EMAIL: NA.  
PHONE: NA.

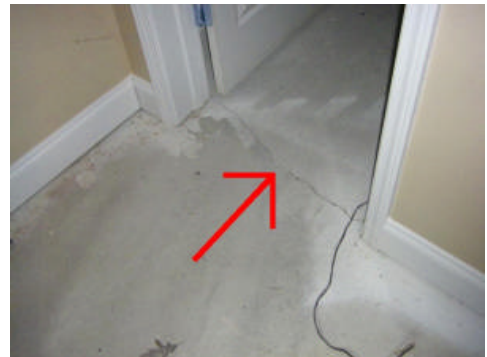
Cracks noted in the basement floor/slab appear to be drying cracks and should be monitored. Patch or repair as needed.

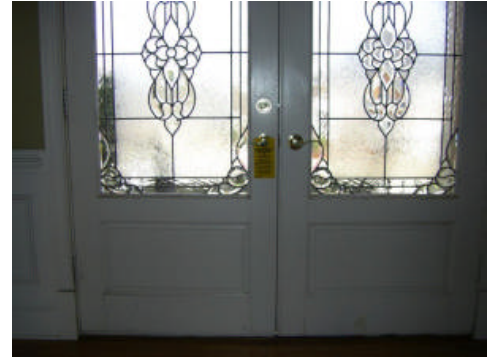
**MAIN ENTRY DOOR:**

Budget for repairs to the weatherstripping at the front entrance door. The goal of weatherstripping is to prevent rain and water from entering dwelling. A secondary goal of weatherstripping is to keep interior air in, thus saving energy with heating and air conditioning.

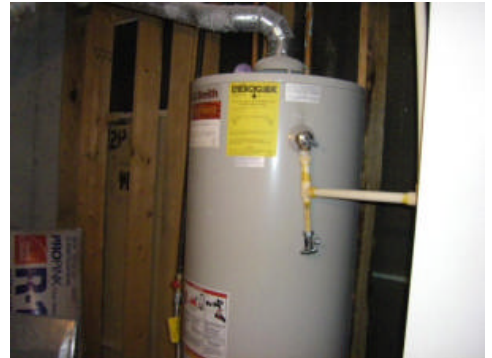
The water heater is located in the utility room.

The pilot/ gas was off to the water heater at the time of the inspection. The water heater was not tested. **NOTE:** Pilots are not lit by the inspector.

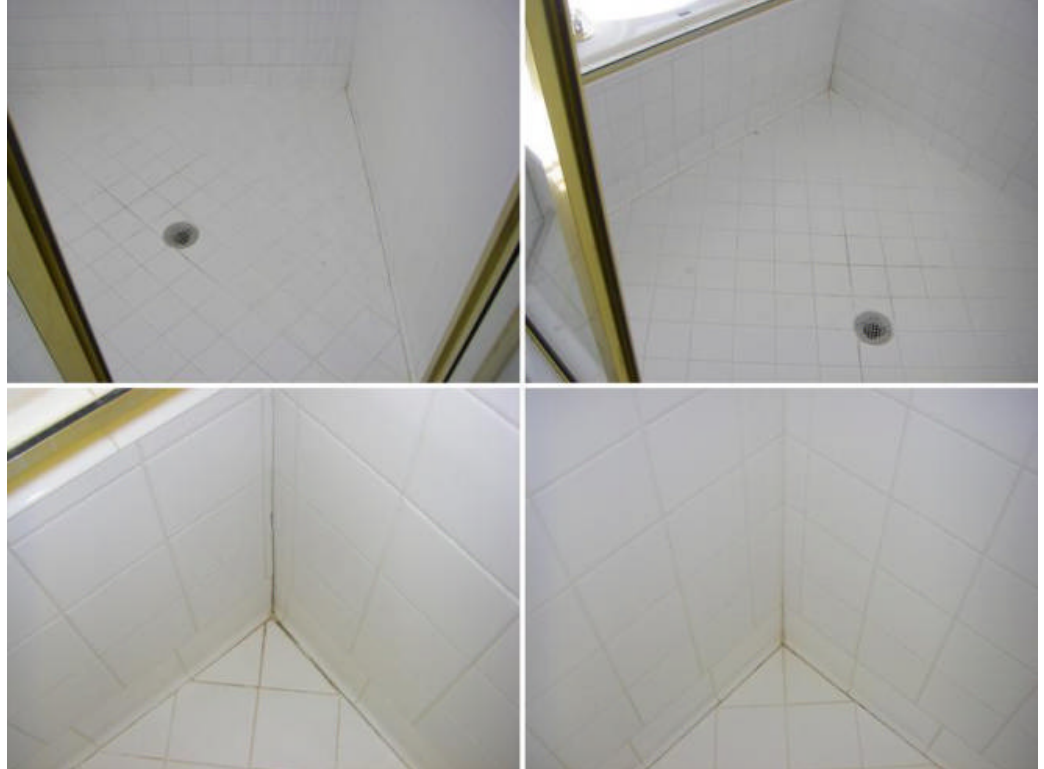
**BATH ROOMS:**

Budget for improving the caulking and grouting in the master bath shower stall around the drain and sides to prevent leaking into the ceiling or framing below.

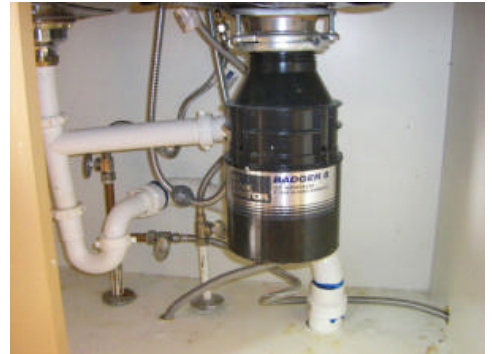
Unit makes unusual noises. Budget for replacement. Also, the disposal is backing up into the left sink. Have a plumber address this condition.

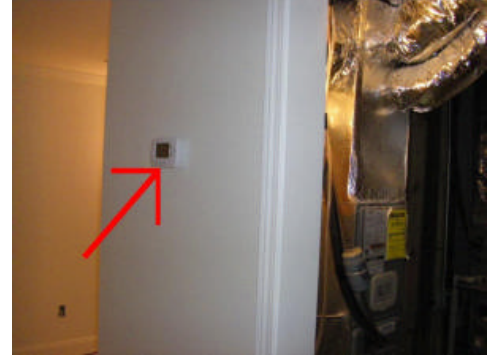
**THERMOSTAT:**

The thermostat for the lower living area is located in the storage/ utility area. This control should be moved to a location in the main living area. Have a qualified HVAC contractor address this condition.

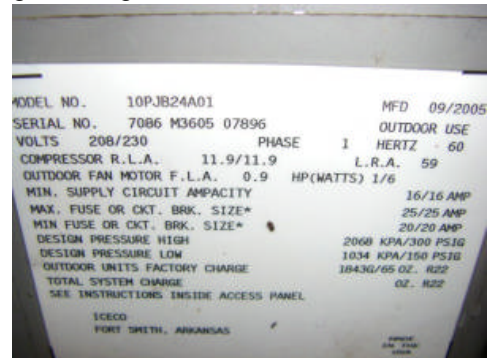
**CONDITION:** Recommend servicing A/C system and checking for refrigerant leaks.

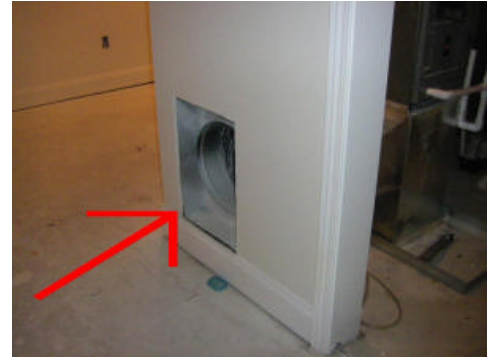
The return for the lower level is poorly located in the storage/ utility area. Have a qualified HVAC contractor relocate the return to the main living areas.
