CHRIS CURLES and ASSOCIATES Inc. INSPECTION SERVICES

XXXX Smith Lane Atlanta GA XXXXX

The Smith Family Inspection Report.

DATE: June XXXXX.
CLIENT: The Smith Family.
SITE: ADDRESS: XXXX Smith Lane.
CITY/STATE/ZIP: Atlanta, GA. XXXXXX.

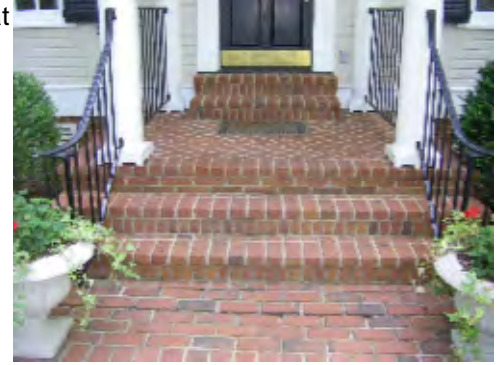
Concrete pad with brick pavers noted at the front entrance.

Front entrance landing appears to be serviceable at this time with no major deficiencies. Minor pointing with cement will be needed between the bricks to help prevent additional deterioration.

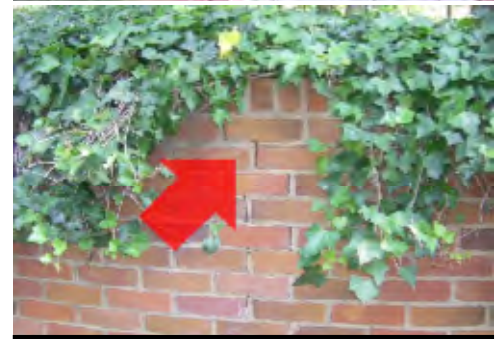
Right retaining wall. Displacement

Lateral displacement was noted in the retaining walls on either side of the driveway. The displacement appears to be caused by a build up of water and hydrostatic pressure along the back side of the wall. No drainage or weep holes were noted in the wall to help relieve the pressure. Possible failure noted in the left retaining wall, as viewed from the front of the home. Conditions should be monitored in both walls. Budget for repairs. See photographs.

Displacement in the right retaining wall.

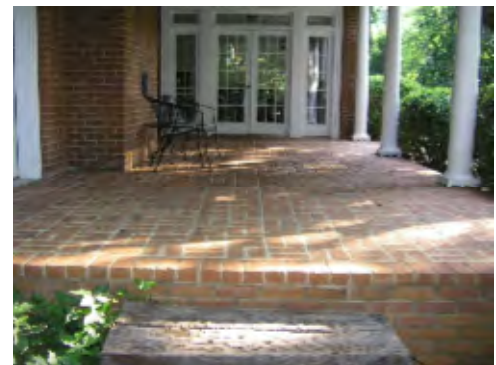
Brick pavers noted in the patio along the back of the home under the deck and at the foot of the deck stairs.

Settlement and displacement was noted in the brick patio at the foot of the deck stairs. The displacement has caused trip hazards in several areas. Also, the guardrails are not secured and are unsafe. Budget for correction to the patio and rails.

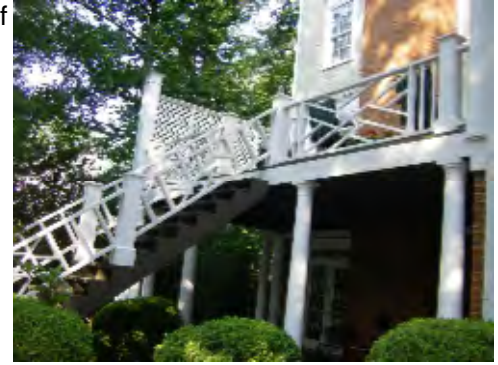
Wood framed deck noted at the back of the home.

The openings in the guardrails are greater than 4" as recommended for safety. The ladder style of rail may pose a safety hazard to children. Recommend additional pickets or lattice or redesign. **Safety concern.**

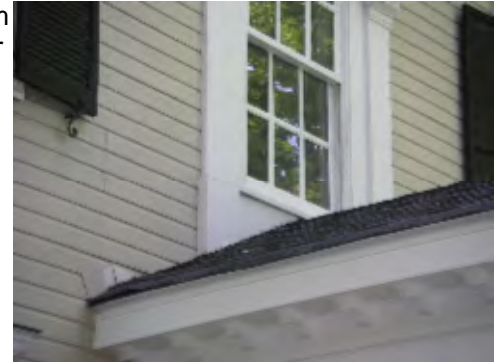
EST. AGE: Recently replaced. Consult with owner regarding terms of replacement i.e. warranty, age, cause for replacement, etc.
STYLE: Hip.
PITCH: Steep. Visibility was limited.
SHINGLES: Composition shingles noted on the structure.
ROOF ACCESS: The roofing materials were viewed from the ground and from windows. A ladder was used to access the roof along the back of the home and over the sunroom.

ROOF FRAMING: Rafter construction noted throughout the attic area.
FRAMING STATUS Roof framing appears to be serviceable at this time with no deficiencies noted.
ROOF STATUS: Roofing appears to be serviceable at this time.

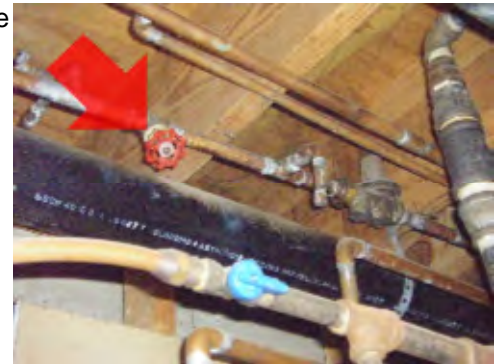
The main water turn off is located in the basement utility room.

CONDITION: Water service appears to be serviceable at this time.

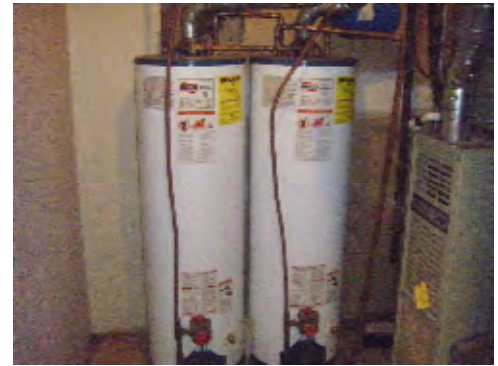
The water heater is located in the basement.

Appears serviceable. Pressure relief valve noted but not tested.

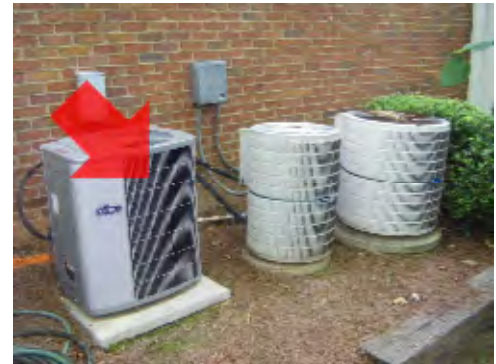
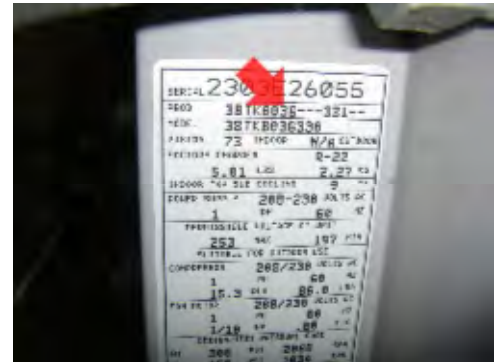
POWER SOURCE: 240 Volt.
MANUFACTURER: Carrier.
CONDITION: A/C unit appears functioning as intended at this time.
APPROXIMATE AGE: Replaced.
CAPACITY: 3 Tons.

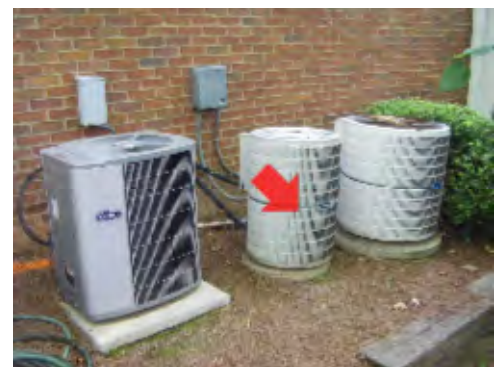
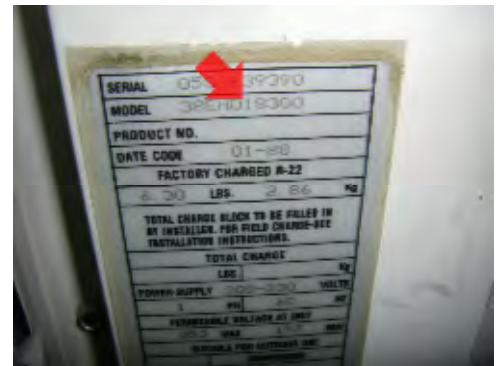
POWER SOURCE: 240 Volt.
MANUFACTURER: Carrier.
CONDITION: A/C unit appears functioning as intended at this time.

APPROXIMATE AGE: Original.

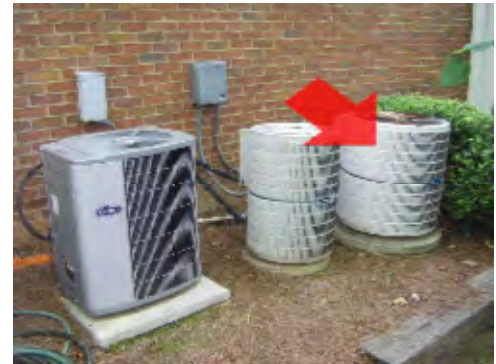
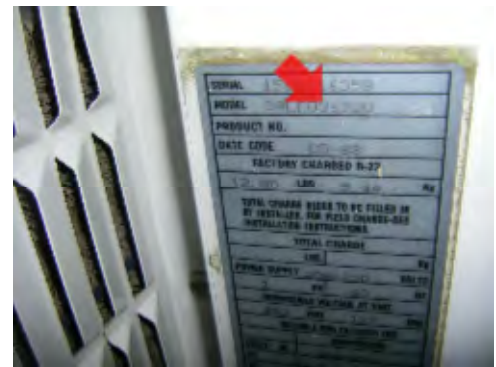
POWER SOURCE: 240 Volt.
MANUFACTURER: Carrier.
CONDITION: A/C unit appears functioning as intended at this time.
APPROXIMATE AGE: Original.
CAPACITY: 3 Tons.

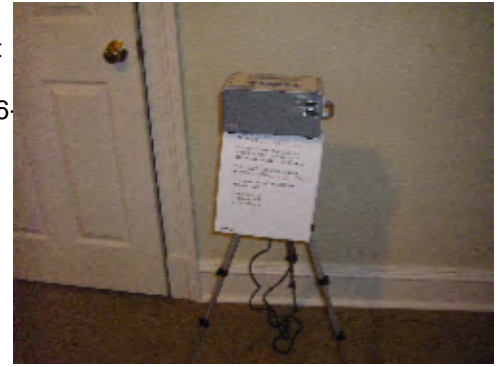
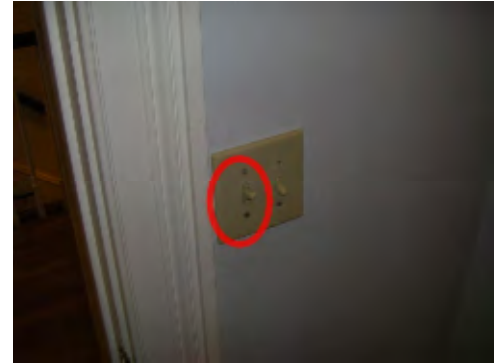
A mold like substance was found in the utility room near the electrical panel. Two samples was taken. The results of the samples will be provided at a later date. To learn more about Mold in the home go to: www.epa.gov/mold/moldresources.html.
