CHRIS CURLES and ASSOCIATES Inc. INSPECTION SERVICES

Inspection Report.

DATE: January.
CLIENT: The Grand Family.
SITE: ADDRESS: 12345 Address.
CITY/STATE/ZIP: Marietta, GA .
EMAIL: XXXXXXXXXXXX.com.
PHONE: 770-xxx-xxxx.

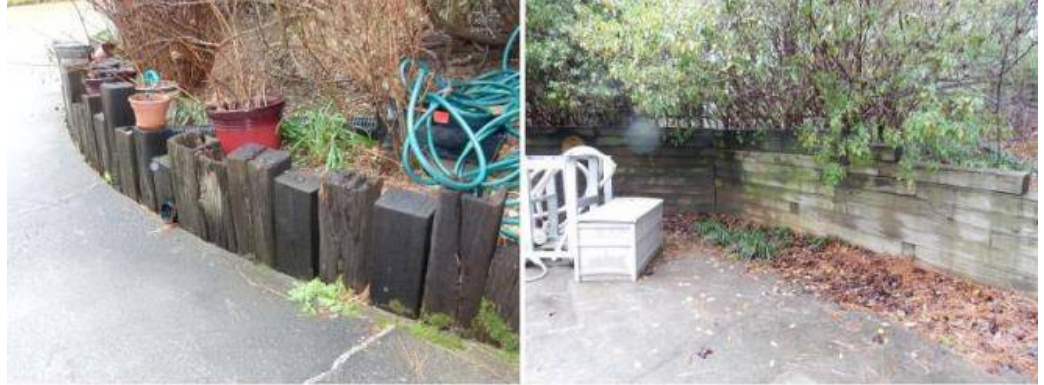
Crosstie retaining wall noted at the driveway. Wood (landscape timber) retaining wall noted pool.

Water damage was noted in the crosstie retaining wall. It should be mentioned that most cross ties used for retaining walls and landscape timbers are 30 to 50 years of age. The decay noted in the cross ties should be monitored. Replacement will be needed. See photo

The retaining wall at the pool have failed and should be investigated by a qualified contractor. See photos. Replacement needed.

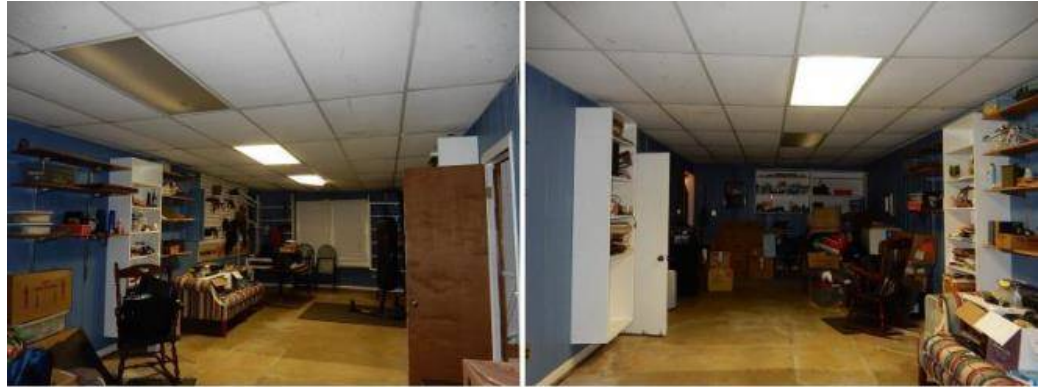
Basement is finished. When interior walls of the basement are finished the foundation and framing can not be viewed for inspection. Basement is only partially accessible due to owners belongings and furnishings.

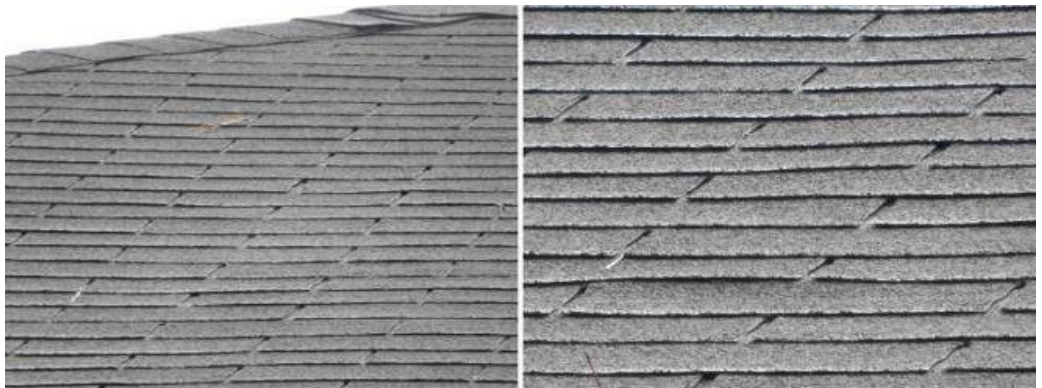
The age of the roofing materials are unknown. May be the original. Have the owner or a qualified roofer address this.

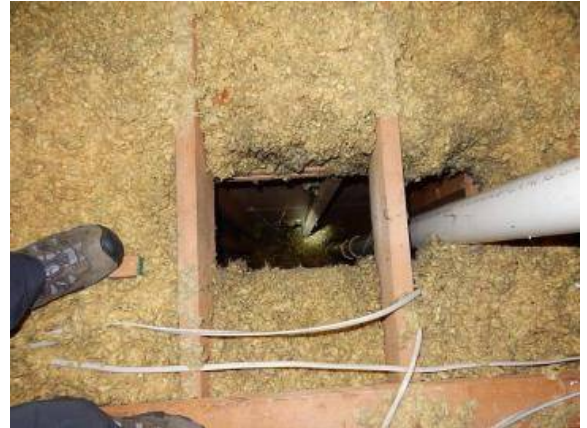
The roofing materials were viewed from the ground.
Rafter construction noted throughout the attic area.
Roof framing appears to be serviceable at this time with no deficiencies noted.
Open utility chase (s) noted in the attic. See photo. Recommend having a qualified contractor or handyman seal or close open chase (s) to help prevent possible fire transfer into the attic and or unwanted drafts. This is a safety recommendation. NOTE: This standard may not have been enforced by local building officials when this building was constructed.

Budget for locating and closing any opening between the fascia and roof decking that will possible allow insects or rodents to enter the attic. See photo.
The roof was not walked on. A licensed roofing contractor should be called to make further evaluation as needed. See attic report.

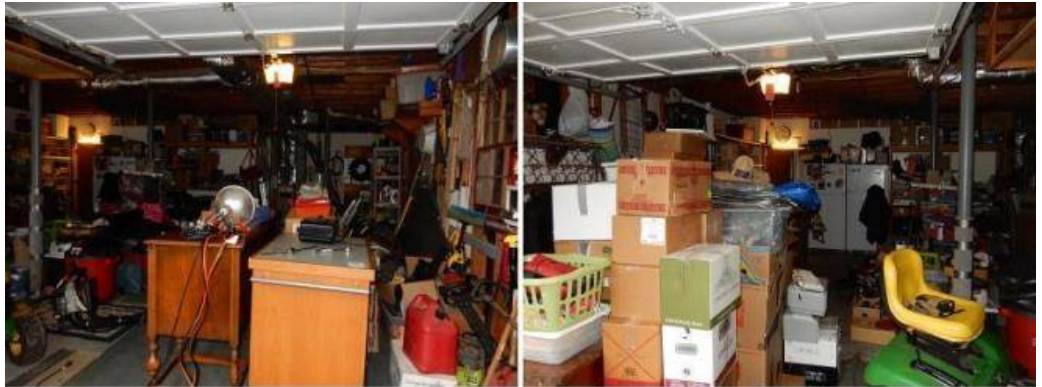
Some areas of the garage interior were not visible for inspection due to owner's stored belongings. The slab appears to be serviceably where visible. See photos.

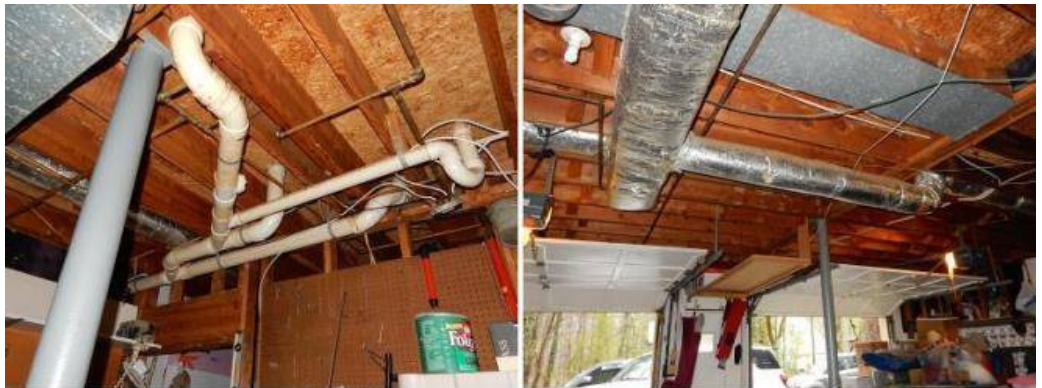
The interior of the garage is unfinished. The framing is exposed. It is recommended that you have a qualified plumber install a fire extinguishing sprinkler system overhead for safety.

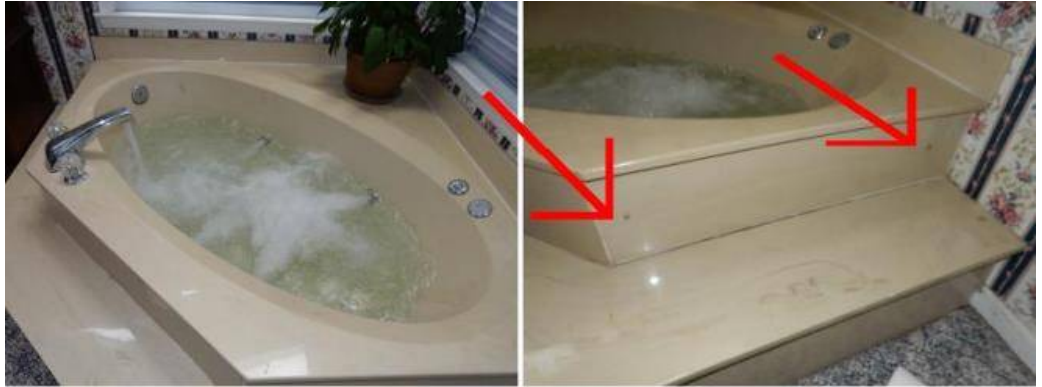
Master bath jetted tub appears to be functioning as intended. Budget for servicing. Could not remove the access panel to the jetted tub motor for inspection. See photo. Removing may damaged the caulking.

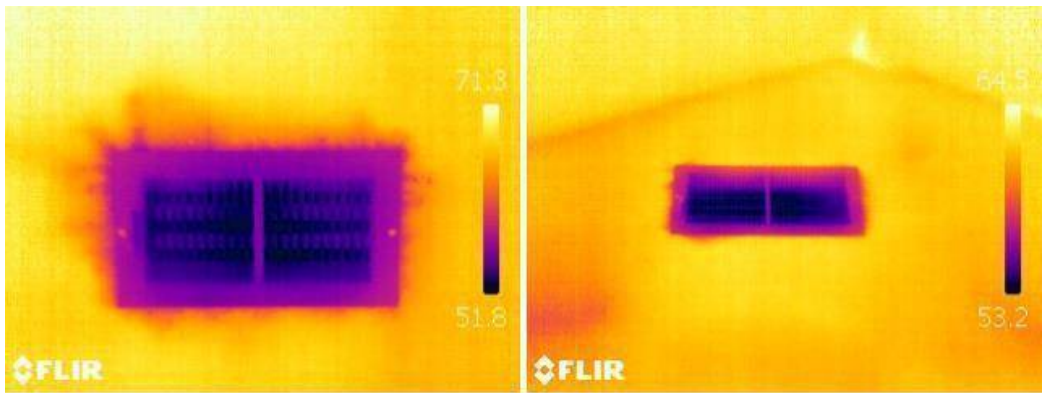
A/C was not fully tested. The A/C was turned on only to see if the system was functional. Unit appeared to be functional. However, the system should be serviced and inspected by a qualified HVAC contractor before taking ownership. Due to the age of this unit it is recommended that you budget for near term replacement and obtain an extended warranty.

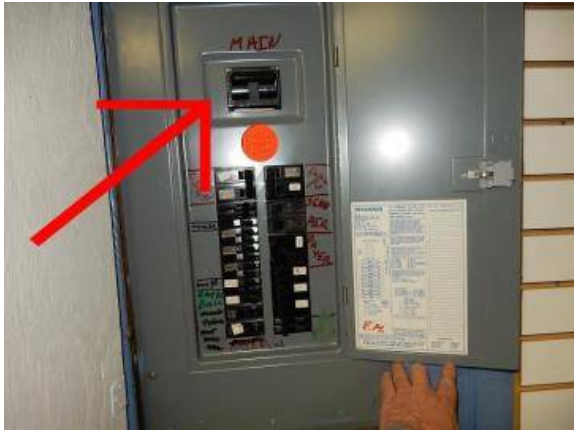
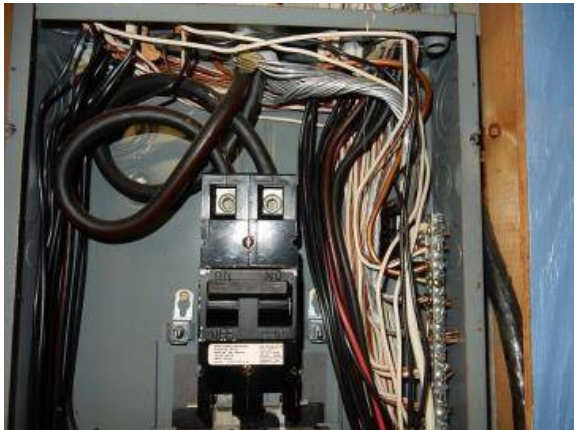
The size of the main electrical disconnect panel is 150 amps. Appears serviceable where exposed for inspection. Wiring appear to be serviceable at this time where exposed for inspection. Grounding system is present at the meter. The grounding busbar and neutral busbar are double tapped. Grounds and neutrals are combined. This was common when the home was constructed. However, the electrical standards now require a single wire under a single set screw and the grounds and neutrals on separate busbars. See Photo. However, you may want to have your electrician inspect the panel to determine if any correction is needed. You are not required to update your electrical if, or when, the code changes. Code changes apply to new construction.
