CHRIS CURLES and ASSOCIATES Inc. INSPECTION SERVICES

Inspection Report.

DATE: March xx, 20xx.
CLIENT: Mr. Biz Owner, LP.
SITE: ADDRESS: 400 Industrial Drive.
CITY/STATE/ZIP: Alpharetta, GA 30004.
EMAIL: hcccc@comcast.net.
PHONE: 800.xxx.xxxx.

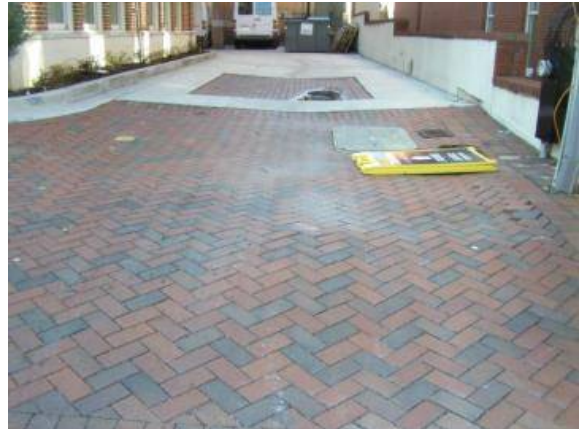
Concrete with brick inlay noted in the driveway along the right side of the building.

Settlement and brick displacement was noted in several places in the driveway along the right side of the building. The displacement in the bricks is excessive and is causing a trip hazard. (A trip hazard is defined as a change in elevation from one level to the next of more than 3/4". This can be a safety concern when accessing these areas.) See photo. The cause for the settlement and displacement is unknown. However, the common cause is non compacted soil under the affected areas. Also, it could be caused by an underground plumbing leak from the water service or sewer drain. Further investigation will be needed by qualified contractors. The bricks will need to be excavated to expose the soil and water service.

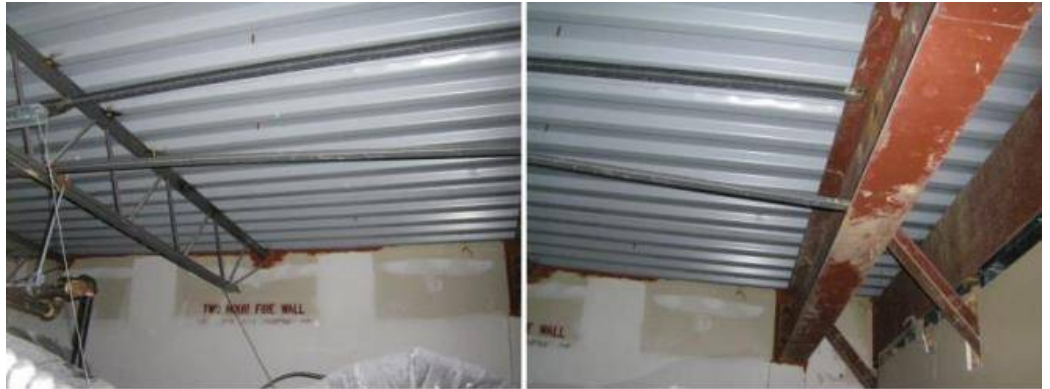
ROOF FRAMING:

The corrugated metal roofing is support by open web metal rafters supported by steel girders.

Roof framing appears to be serviceable at this time with no deficiencies noted.

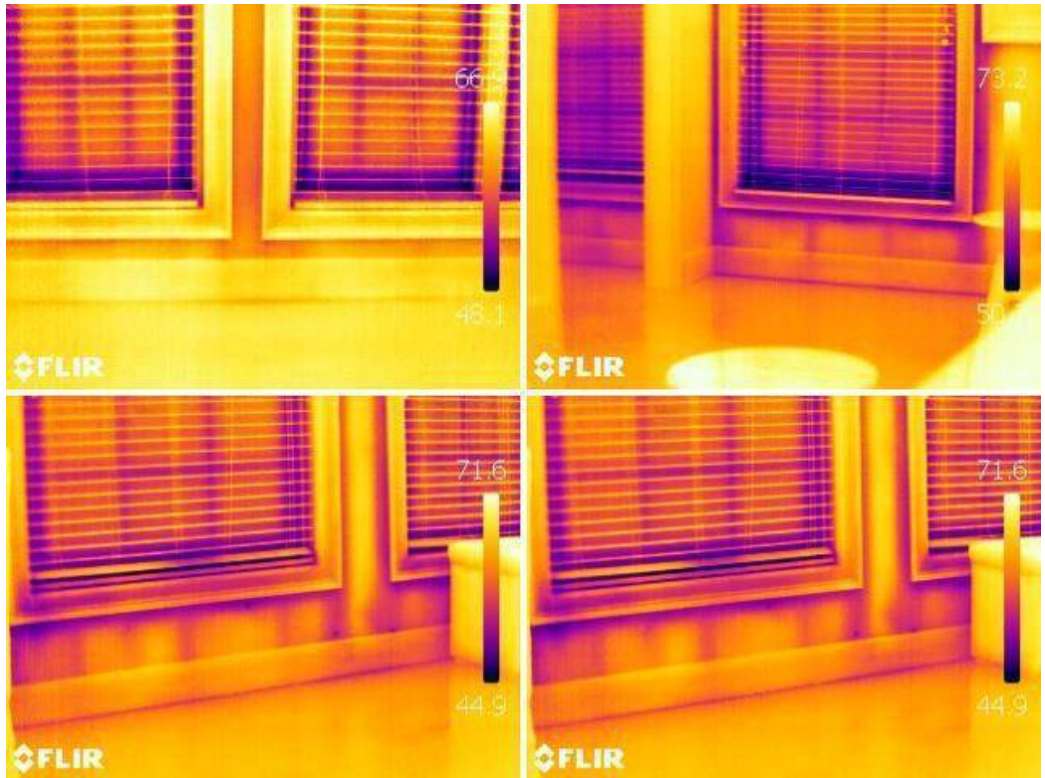
WINDOWS:

A representative number of windows were investigated and operational at the time of the inspection. As a whole, the windows appear to be functioning as intended. All sleeping area windows should be operational for emergency egress.

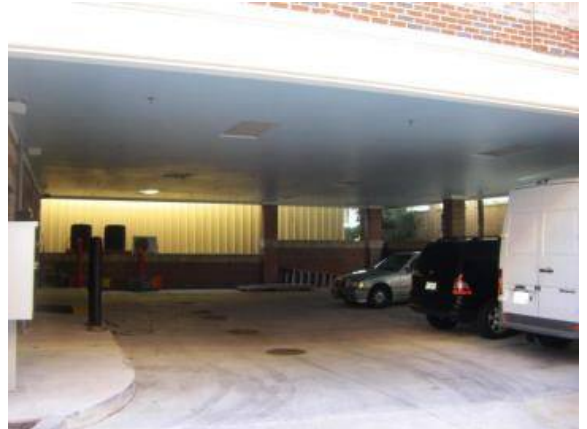
LOCATION: Open air drive under parking area noted at the back of the building.

CONDITION: Slab appears to be serviceable at this time. Cracks noted in the slab appear to be typical for the age.

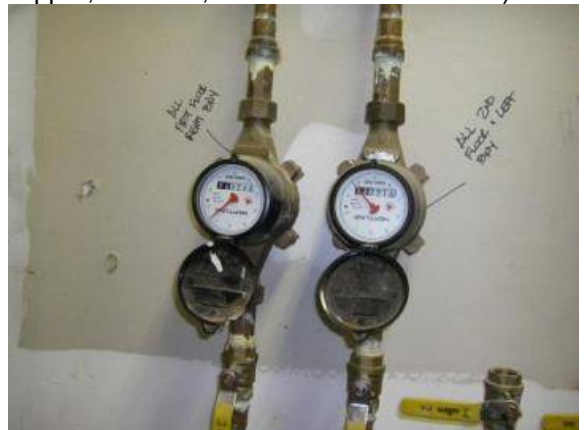
MATERIALS: Copper. (Copper water service noted in the utility room through the wall. It is assumed that the water service from the street is copper, however, this could not be verified)
WATER TURN OFF LOCATION: The main water turn off is located in the utility room at the back of the building.

CONDITION: Water service appears to be serviceable at this time.

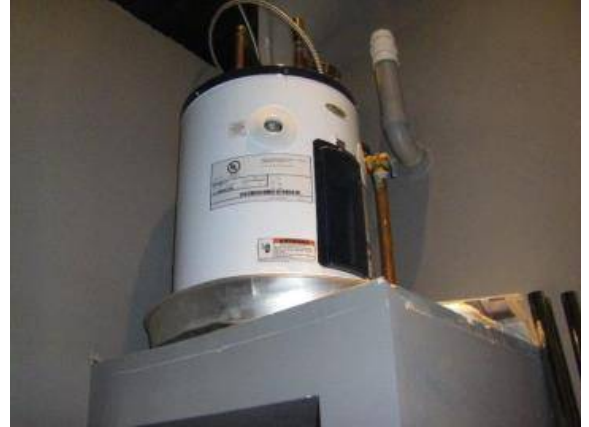
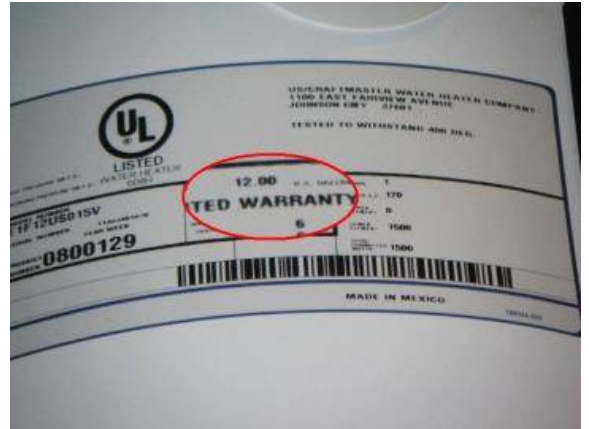
TYPE: Electric water heater observed in the utility room on the top floor.

NUMBER OF W/H One water heater located. It can be assumed but not verified that there is a second water heater on the main floor. However, it could not be located.

SIZE: 12 gallons.

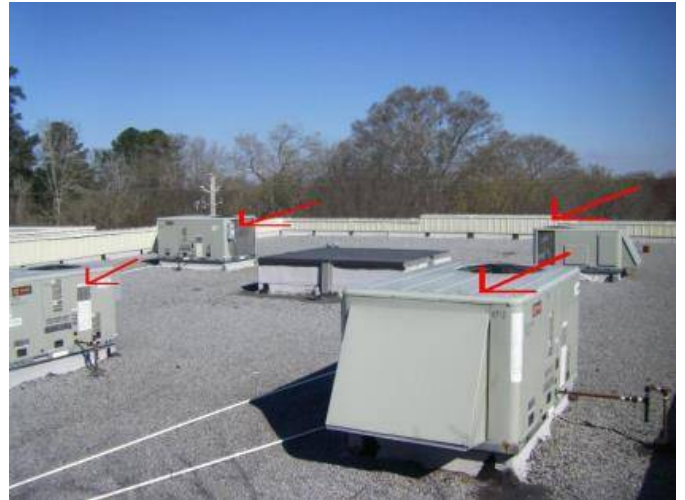
HEATING UNIT (1):

Four HVAC units noted on the roof.

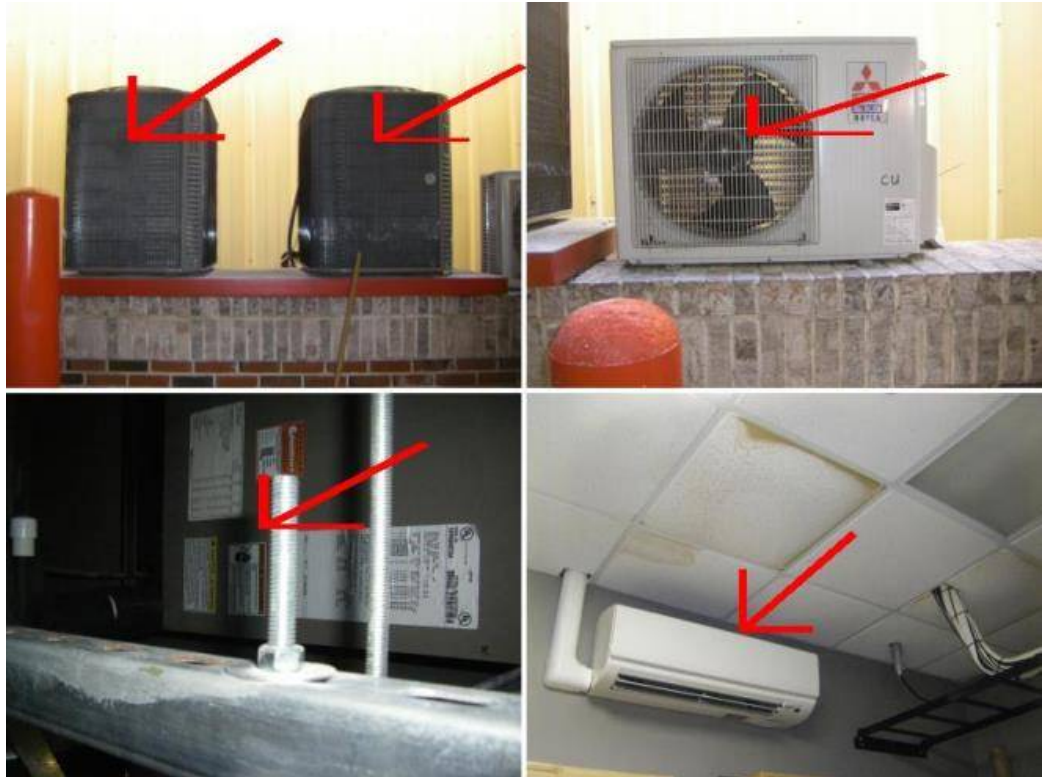
HEATING UNIT (2):

Two Heat Pumps located in the open air drive under garage area serving the first or lower floor. Two air handlers located in the ceilings on the first floor offices and storage areas. One heat pump in the covered garage serving the mechanical room. The air handler is on the wall.

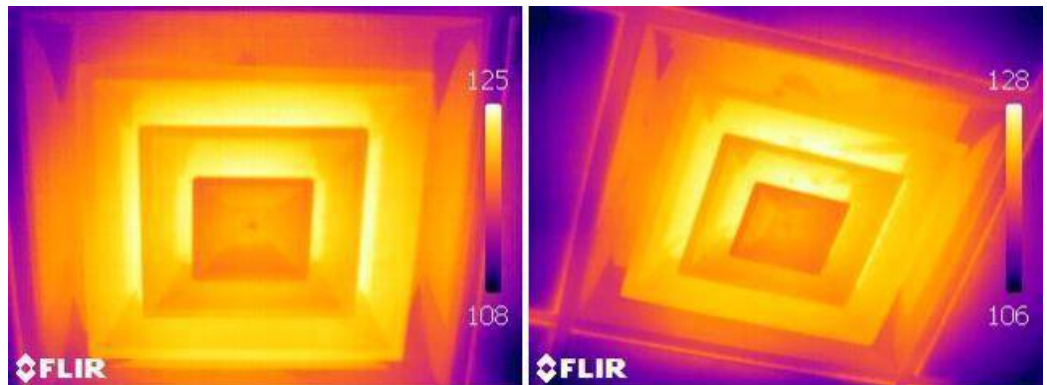
HEATING UNIT (2):

The heat pump condensing units appear to be functioning as intended as noted by the Infrared photos. Mitsubishi wall unit was functioning as intended.

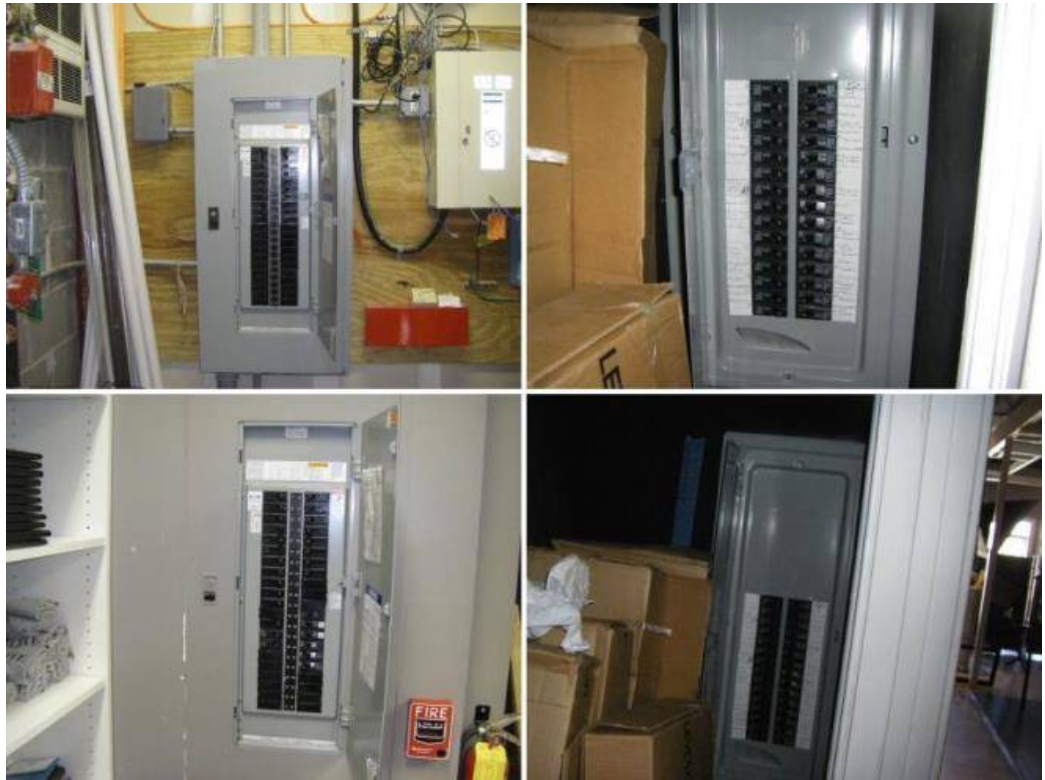
PANEL LOCATION:

Main disconnect panels are located in the utility areas.

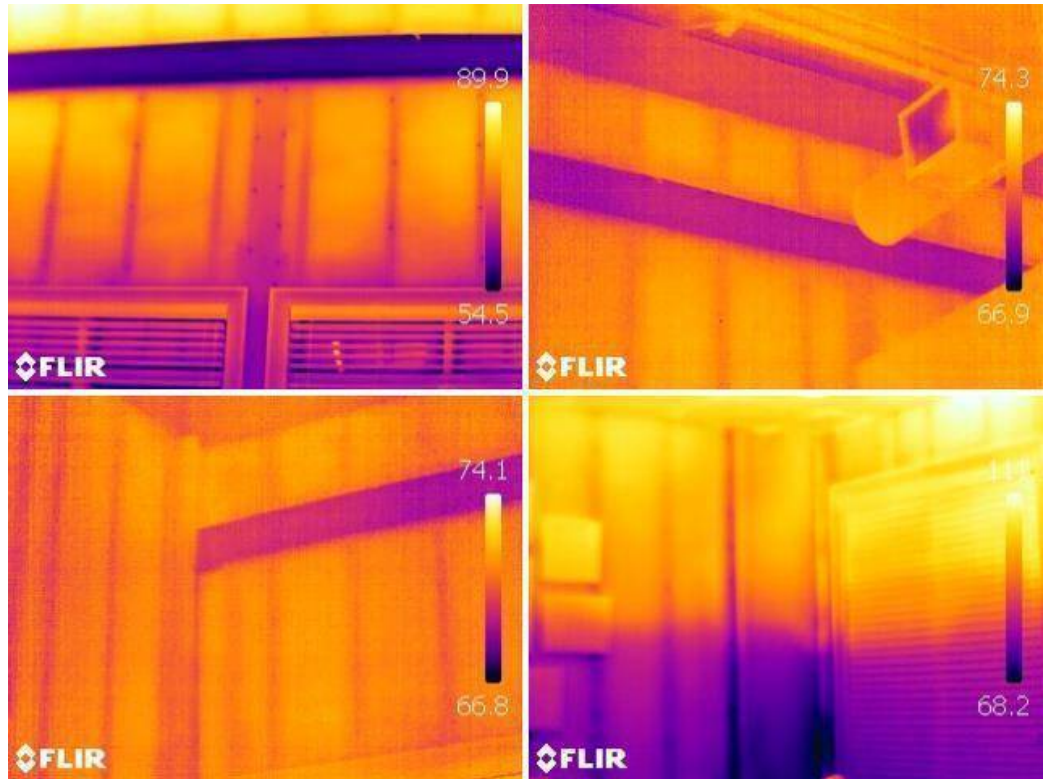
Infrared Thermal Scanning of exterior walls.

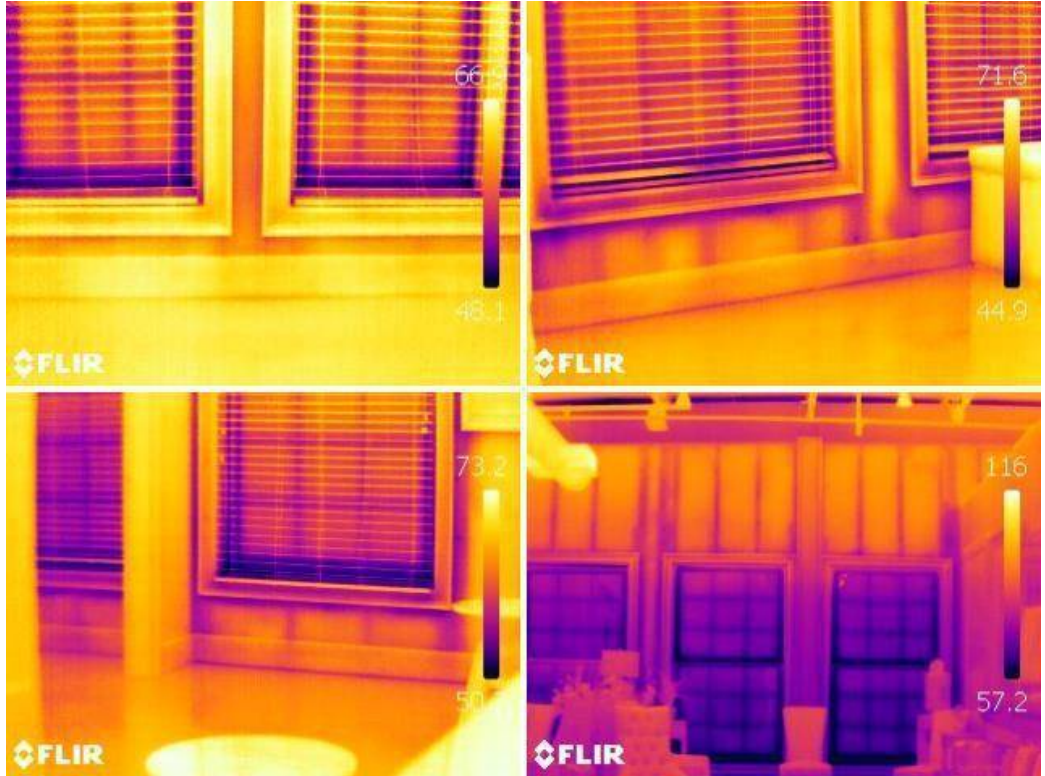
Infrared Thermal Scanning of windows.

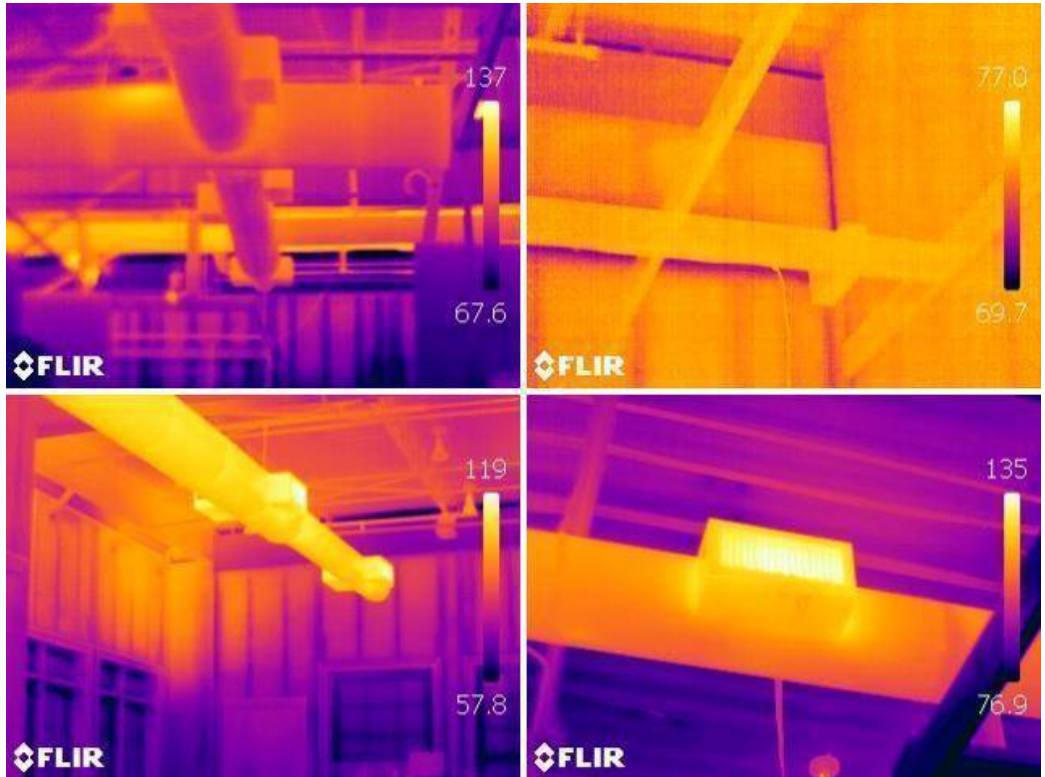
Infrared Scanning of air ducts and roof decking for leaks.
