# CHRIS CURLES and ASSOCIATES Inc. INSPECTION SERVICES

## First ABC Corp.

DATE: August 28, 20xx  
CLIENT: First ABCCorpxxxx address  
Suite 123  
Duluth, GA 30096.  
SITE: ADDRESS: 2First ABCCorpxxxx address  
Suite 123..  
CITY/STATE/ZIP: Duluth, GA 30096.  
EMAIL: [fABC@hotmail.com](mailto:fABC@hotmail.com).  
PHONE: \_\_\_\_\_

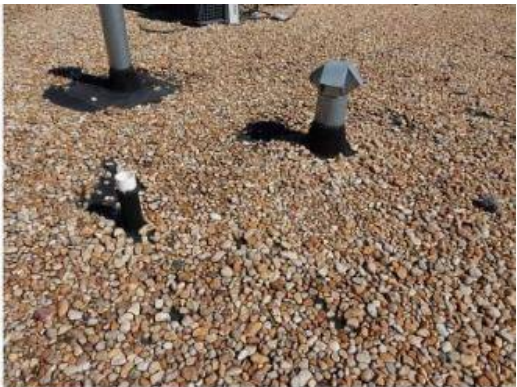
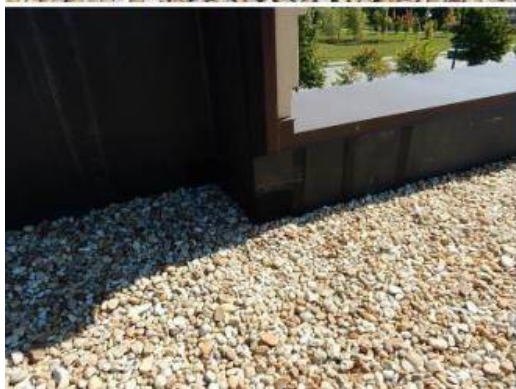
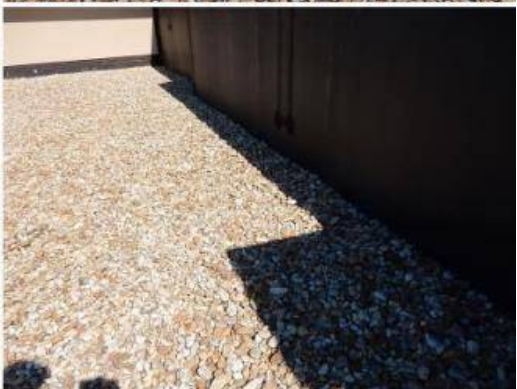
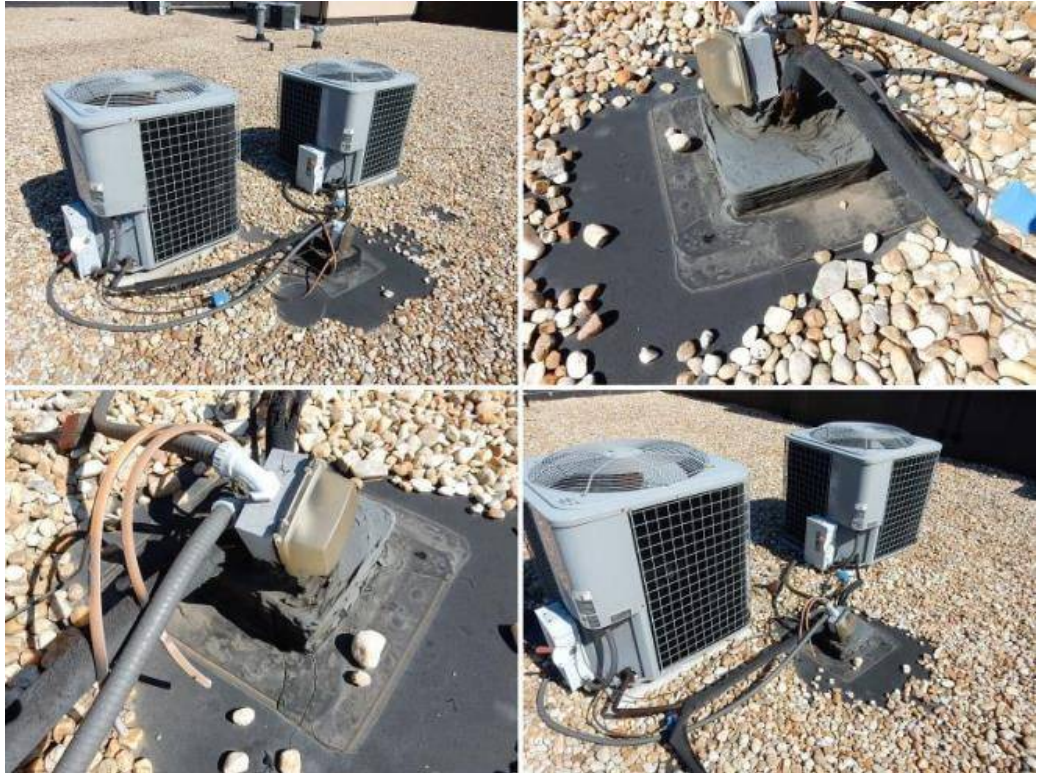
The gravel is missing in several places. Also, a low area was noted in the roof, back center. See photos. Have the POA provide you with any information regarding pending assessments for repairs to the roof. A licensed and qualified roofing contractor should be called to make further evaluation and repairs as needed.

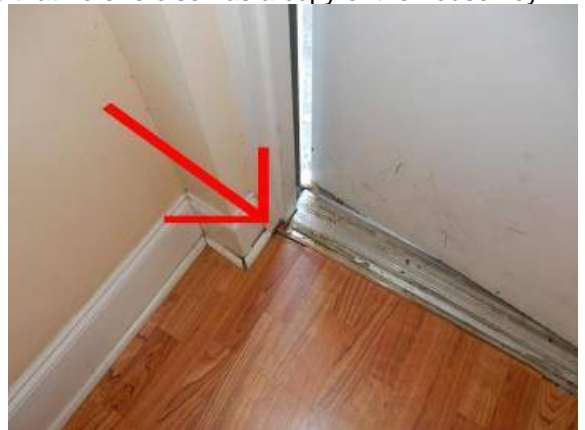
Standard rear doors to the back of the building appear to be functional at this time. Minor adjustments needed. Budget for the repairs to the weatherstripping at the back of B1300. The goal of weatherstripping is to prevent rain and water from entering dwelling. A secondary goal of weatherstripping is to keep interior air in, thus saving energy with heating and air conditioning.

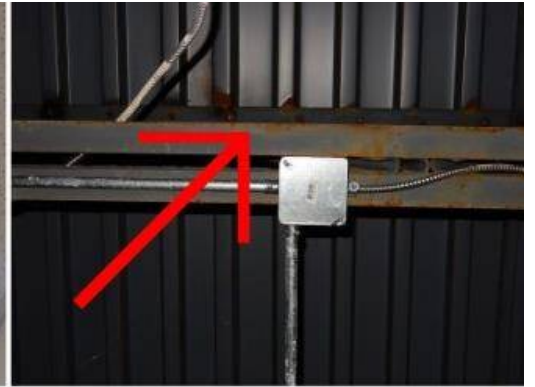
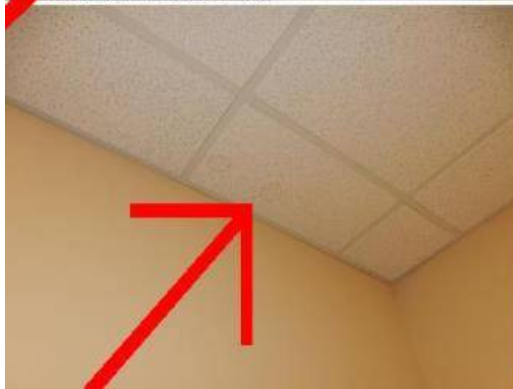
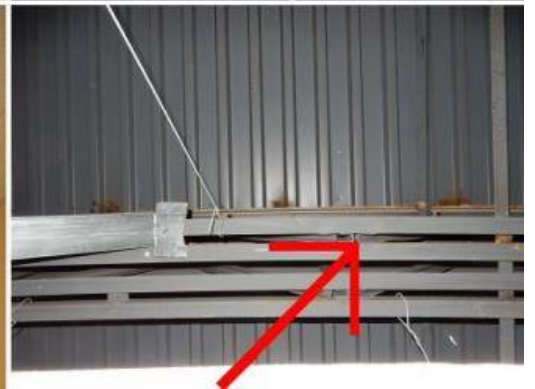
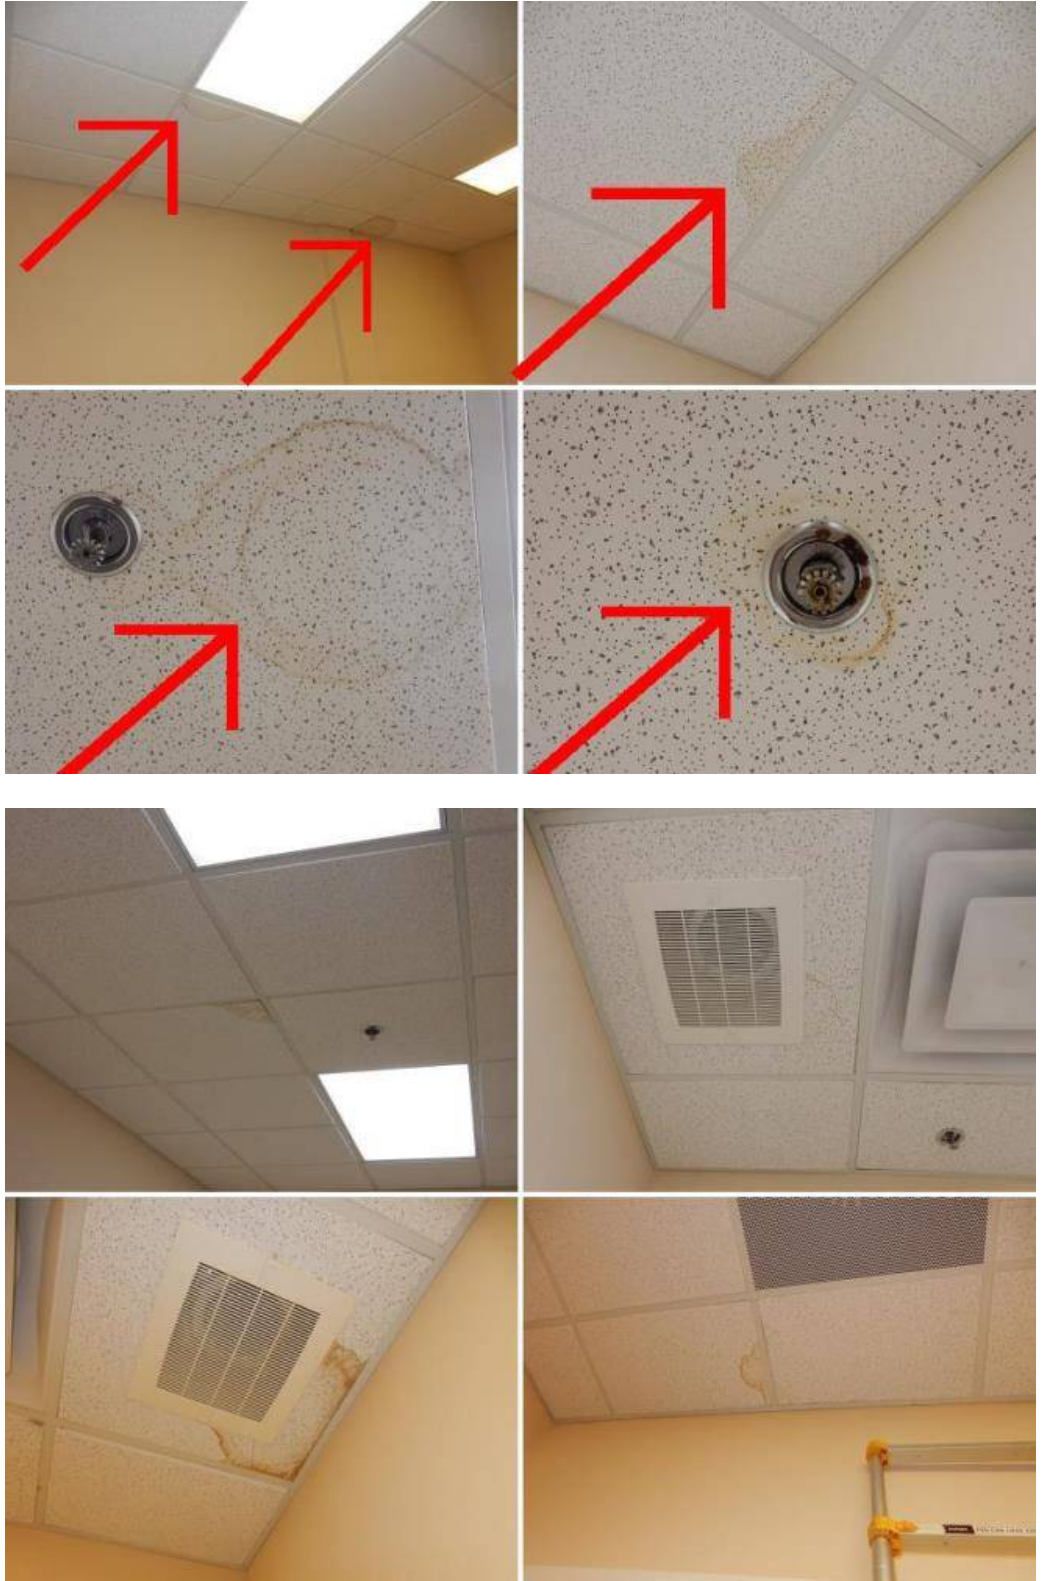
Water damage ceiling tiles noted in several offices and bathrooms on both floors. The cause for the majority of the water damage appears to be roof leaks. Unable to determine if active leakage exists. See photos. Have the owner address this. You should have a qualified roofer address this.

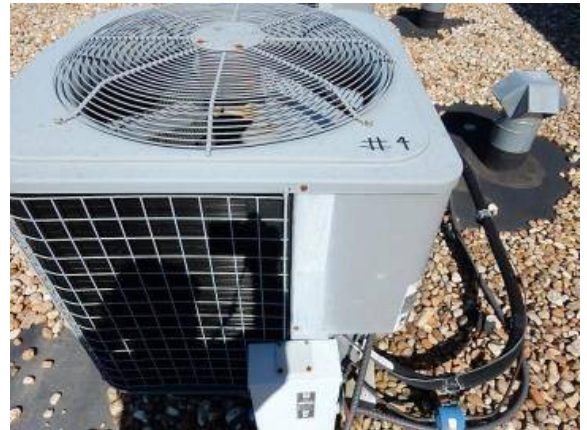
240 Volt.  
Unknown.  
The A/C unit for the upstairs back rooms was not functioning at the time of the inspection. Further investigation needed. Have the owner address this.

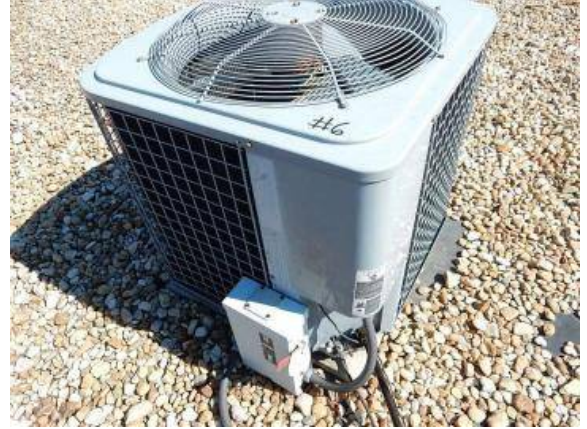
**POWER SOURCE:** 240 Volt.  
**MANUFACTURER:** Unknown.  
**CONDITION:** A/C unit is not cooling properly. Refrigerant appears low. Recommend servicing A/C system and checking for refrigerant leaks.

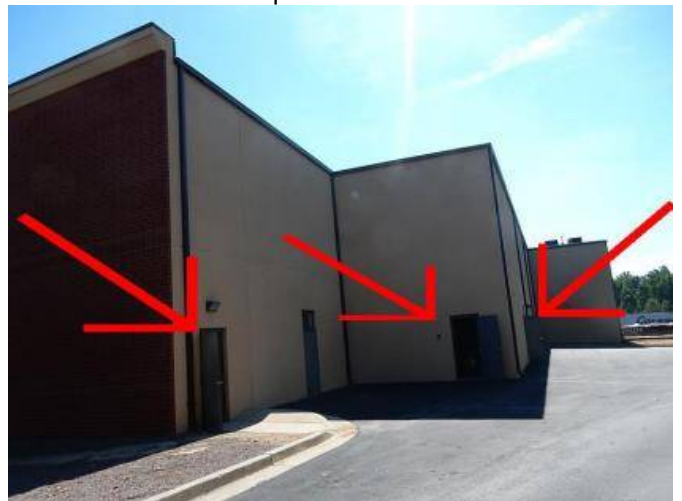
The large electrical panes in the utility rooms, the two large transformers and the electrical disconnects in the electrical room were beyond the Scope of Serviced and were not inspected. See photo. Have a Licensed and qualified electrician address this. The utility rooms are in the back of 1200 and 1300.
